**REPORT OF INVESTIGATION**

**Surface Nonmetal Mine  
(Crushed and Broken Limestone)**

**Fatal Powered Haulage Accident  
September 16, 2013**

**Con-Agg of MO, LLC  
Huntsville Quarry  
Huntsville, Randolph County, Missouri  
Mine ID No. 23-02004**

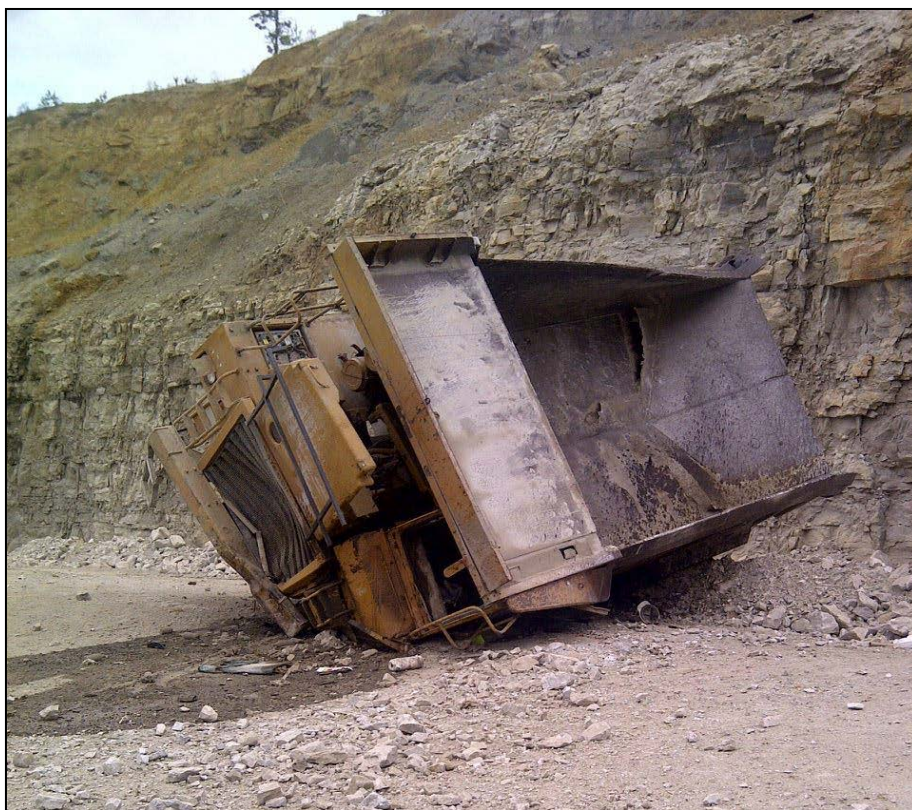
On September 16, 2013, David A. Gully, Truck Driver, age 58, was killed after the haul truck he was operating went over a highwall. Gully was operating the haul truck on the haul road out of the pit to the primary crusher.

The accident occurred due to management's failure to install and maintain sufficient berms along the edge of the haul road. Gully did not maintain control of the truck and the truck traveled through the berm. Additionally, he was not wearing a seat belt and was ejected from the haul truck which contributed to the severity of his injuries.

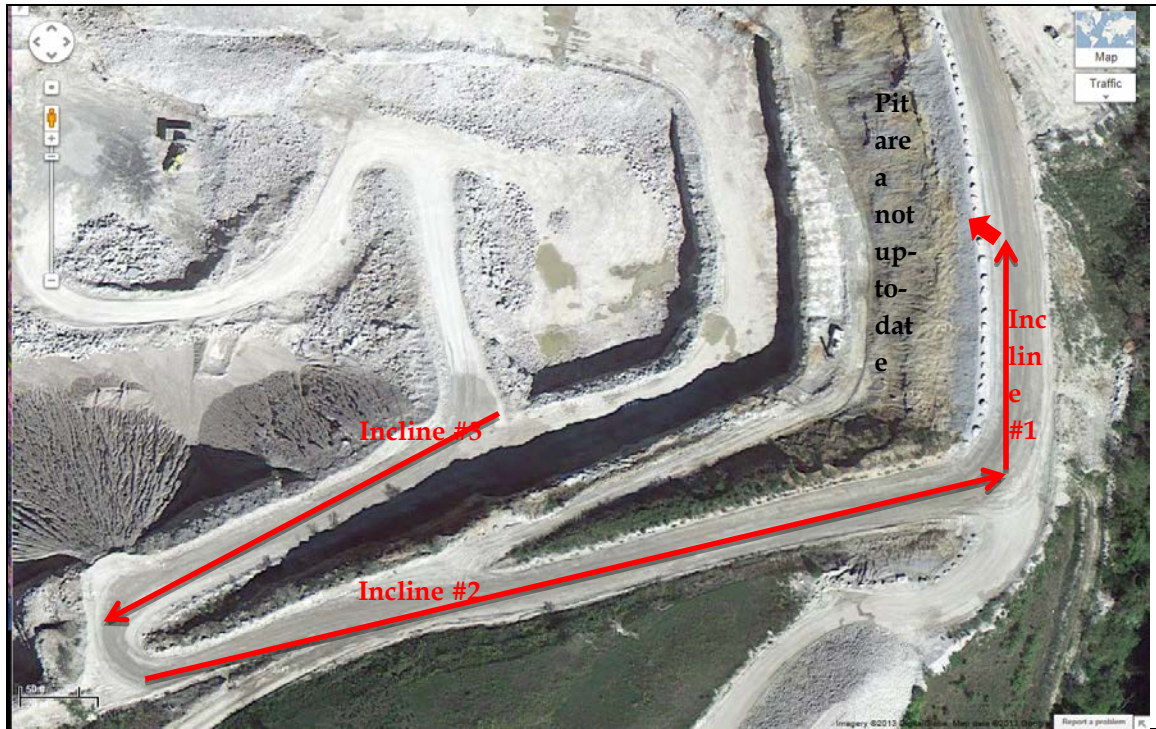
### AERIAL PHOTO OF PIT AND RAMPS

The haul road out of the pit consisted of three inclined ramps designated as incline #3, incline #2, and incline #1. Incline #3 started at the pit bottom and extended 409 feet to a nearly 180-degree turn into incline #2 which extended 840 feet to a 90-degree turn into incline #1. The truck the victim was operating traveled about 270 feet up incline #1 before crossing over the haul road and through the berm on the left side of the haul road.

The haul road along the section of incline #1, where the accident occurred, was 54 feet wide and had an inclined slope of 8 percent. The berm along the left side of the haul road consisted of large boulders of various sizes spaced 4-5 feet apart and about two feet from the highwall.

**Corrective Action:** Sufficient berms were provided along the haul road where a drop-off existed.
