Report of Investigation

Surface Nonmetal Mine
(Cement)

Fatal Fall of Person Accident

Lebec Cement Plant
National Cement Company of California, Inc.
Lebec, Kern County, California
ID No. 04-00213

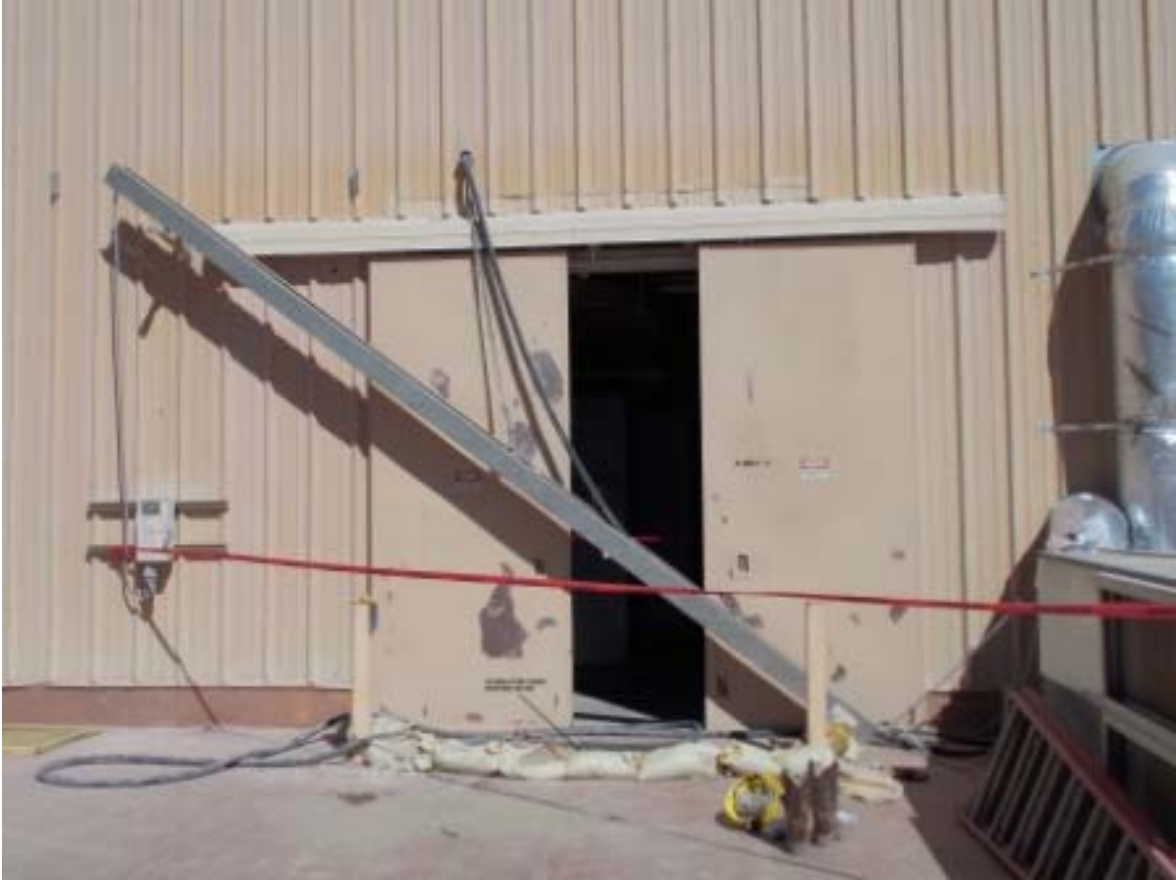
On October 17, 2013, Fernando Rivera, Journeyman Electrician, age 52, was seriously injured when he fell from a step ladder approximately six feet onto a concrete pad below. Rivera was standing on the ladder pulling electrical cable into a cable tray located on the outside of the building. The cable tray struck the step ladder after a mounting bracket broke loose, causing Rivera to fall onto the concrete pad. Rivera was transported to a hospital where he died on October 18, 2013, as a result of his injuries. Rivera was wearing a hard hat at the time of the accident.

The accident occurred because the two self-tapping screws used to mount the cable tray on the right side were not long enough to support the cable tray when electrical cable was placed in it. Both self-tapping screws on the right side mounting bracket pulled out of the sheet metal. The bottom screw also pulled out of a steel beam. The weight of the electrical cable and the physical loading of the cable put additional stress on the cable tray mounts, causing the mounting bracket screws to separate from the sheet metal and steel beam.

Additionally, the step ladder was positioned parallel to the building and the victim was working perpendicular to the ladder, placing his body at an angle to the ladder while performing the work.

Corrective Action: The cable tray has been removed from the MCC building.

Corrective Action: All persons were re-trained regarding ladder safety.
