**UNITED STATES
DEPARTMENT OF LABOR
MINE SAFETY AND HEALTH ADMINISTRATION
Metal and Nonmetal Mine Safety and Health**

REPORT OF INVESTIGATION

**Fatal Falling / Sliding Material Accident
December 13, 2013**

**Brown Brothers Sand Company
Wittichen Stephen Plants
Junction City, Talbot County, Georgia
Mine ID No. 09-00265**

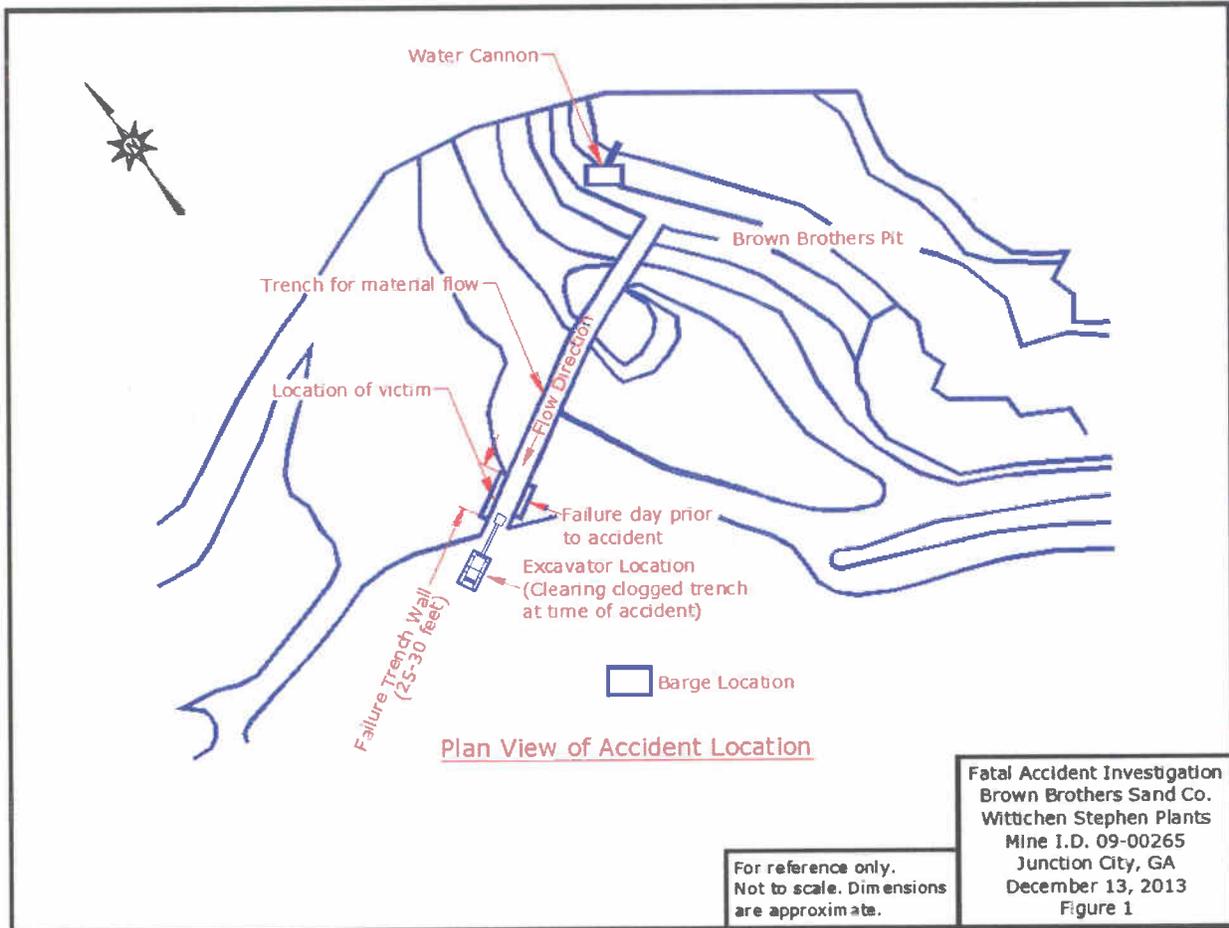
LOCATION OF ACCIDENT

On the day of the accident, the collapse occurred along the northwest side of the nearly vertical trench, approximately 45 feet upstream from the lower reach of the trench. An approximately 30 foot length of the trench wall failed. This material broke off approximately 5 feet back from the face of the pre-failure trench. The failure extended from the top to the bottom of the trench. Persons interviewed stated the failed material broke off in three distinct sections along the alignment of the trench. The southernmost portion of the failure area broke off first, followed by the middle, and then the northernmost section.

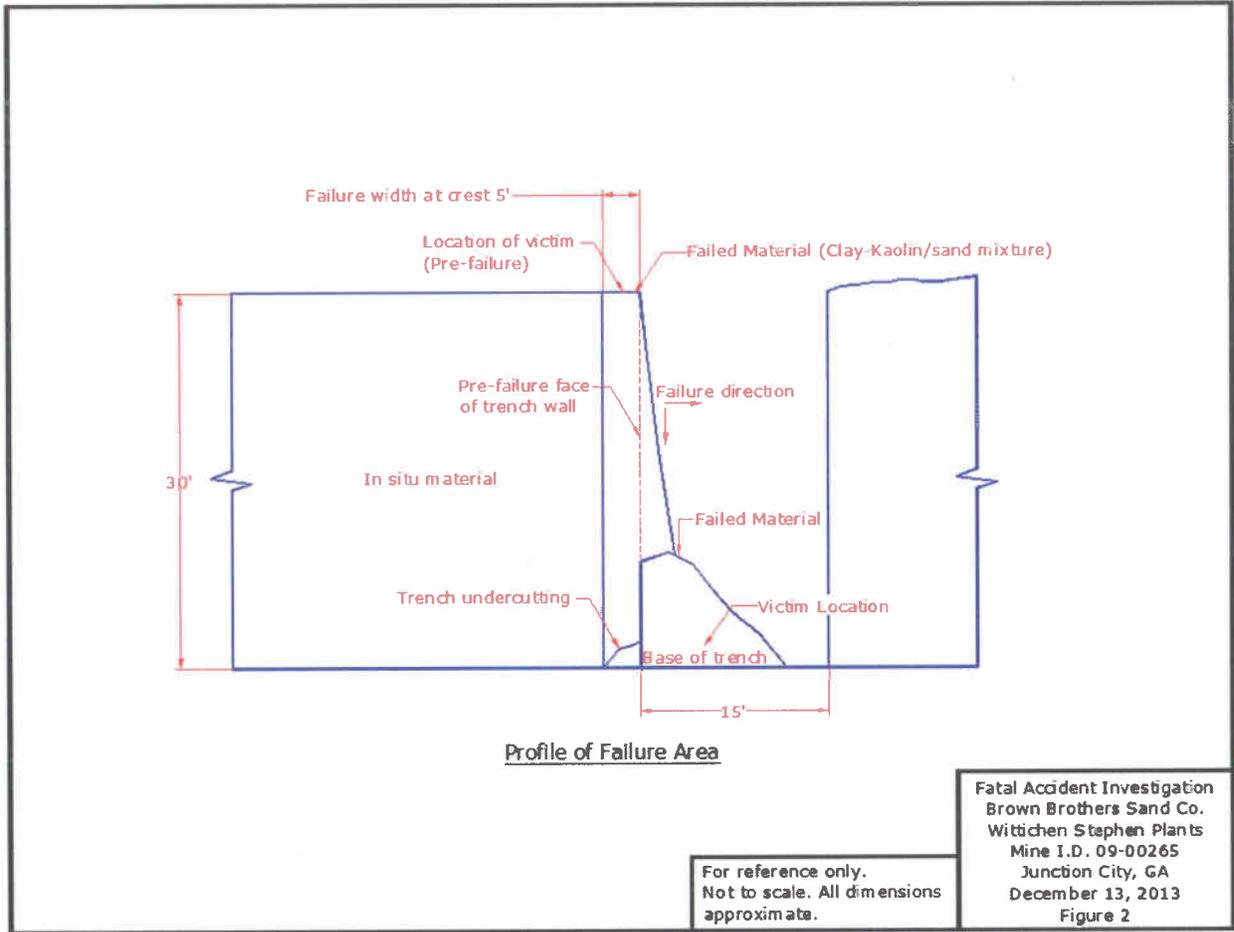
PROFILE OF FAILURE AREA

The entire failure occurred in seconds. Investigators estimated the mass of the failed material to be approximately 170 cubic yards. A soil mass of this type and volume was estimated to weigh approximately 230 tons. The remaining scarp in the location of the accident was well defined and fairly clean with no loose material evident post-failure. No secondary sloughing or cracking was observed. No tension cracks were observed at the top of the trench in the location of the failure. The failed material completely covered the victim at the base of the trench in the location of the failure. Undercutting of the trench walls was observed in the area adjacent to the failure due the flow of water through the trench during hydraulic mining operations.

The sides of the trench had not been sloped or supported. The nearly vertical angle of the sides of the trench allowed significant shear stresses to develop within the soil. These shear stresses exceeded the internal shear strength of the soil and created a failure plane along which the failure occurred. The trench wall failure was primarily caused by the undercutting of the trench wall due to material flow in the trench. The apparent cohesive strength of the material allowed the trench wall to temporarily maintain an angle greater than the angle of repose (25 to 30 degrees). The trench wall was able to stand for a relatively short period of time before failing.

Corrective Action: Management established a new mining method that eliminates the use of deep trenches. Persons experienced in examining and testing for loose ground have been designated to conduct examinations at the pit.
