Fatality #3 - February 28, 2014
Falling/Sliding Material – New York - Construction Sand and Gravel
East Coast Mines Ltd - East Coast Mines Ltd

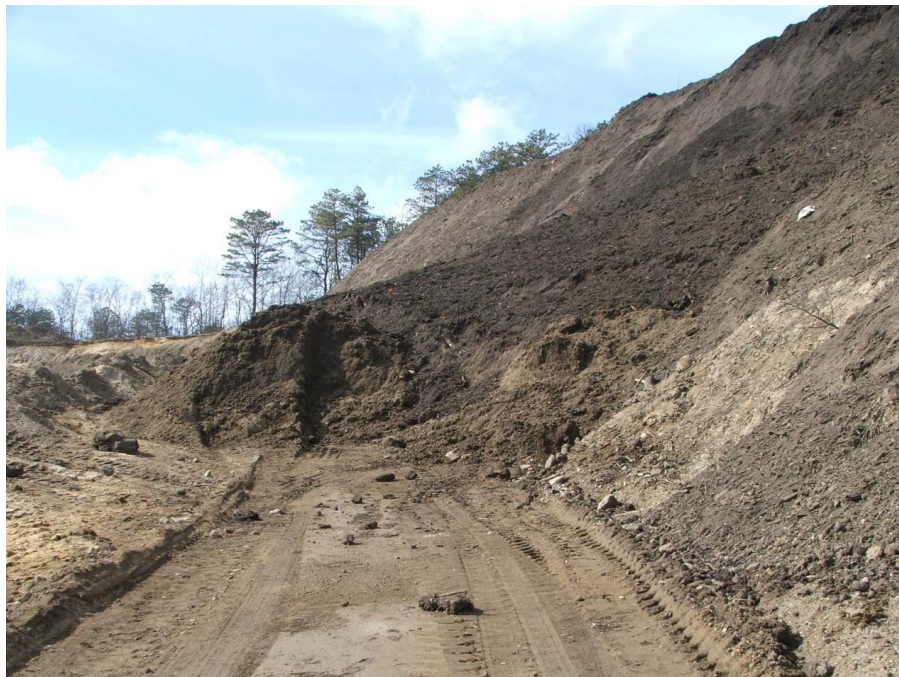
METAL/NONMETAL MINE FATALITY – On February 28, 2014, a 50-year old supervisor with 27 years of experience was killed at a sand and gravel mine. The victim was at a backfill site and approached an 80-foot high bank when it failed, engulfing him.

- Establish and discuss safe work procedures before beginning work. Identify and control all hazards associated with the work to be performed and the methods to properly protect persons.
- Task train all persons to recognize all potential hazardous conditions that can decrease bank or slope stability and ensure they understand safe job procedures for elimination of the hazards.
- Prior to beginning work and as ground conditions warrant during the shift, examine all pit, highwall, slope, and bank conditions. Be especially vigilant for these conditions after each rain, freeze, or thaw.
- Use mining methods that ensure pit, highwall, slope, and bank stability and safe working conditions.
- Correct hazardous conditions by working from a safe location.
- Stay clear of potentially unstable areas.
