REPORT OF INVESTIGATION

**Surface Nonmetal Mine
(Fire Clay)**

**Fatal Machinery Accident
April 24, 2014**

**Craig Neal and Sons, LLC
Contractor ID No. H869**

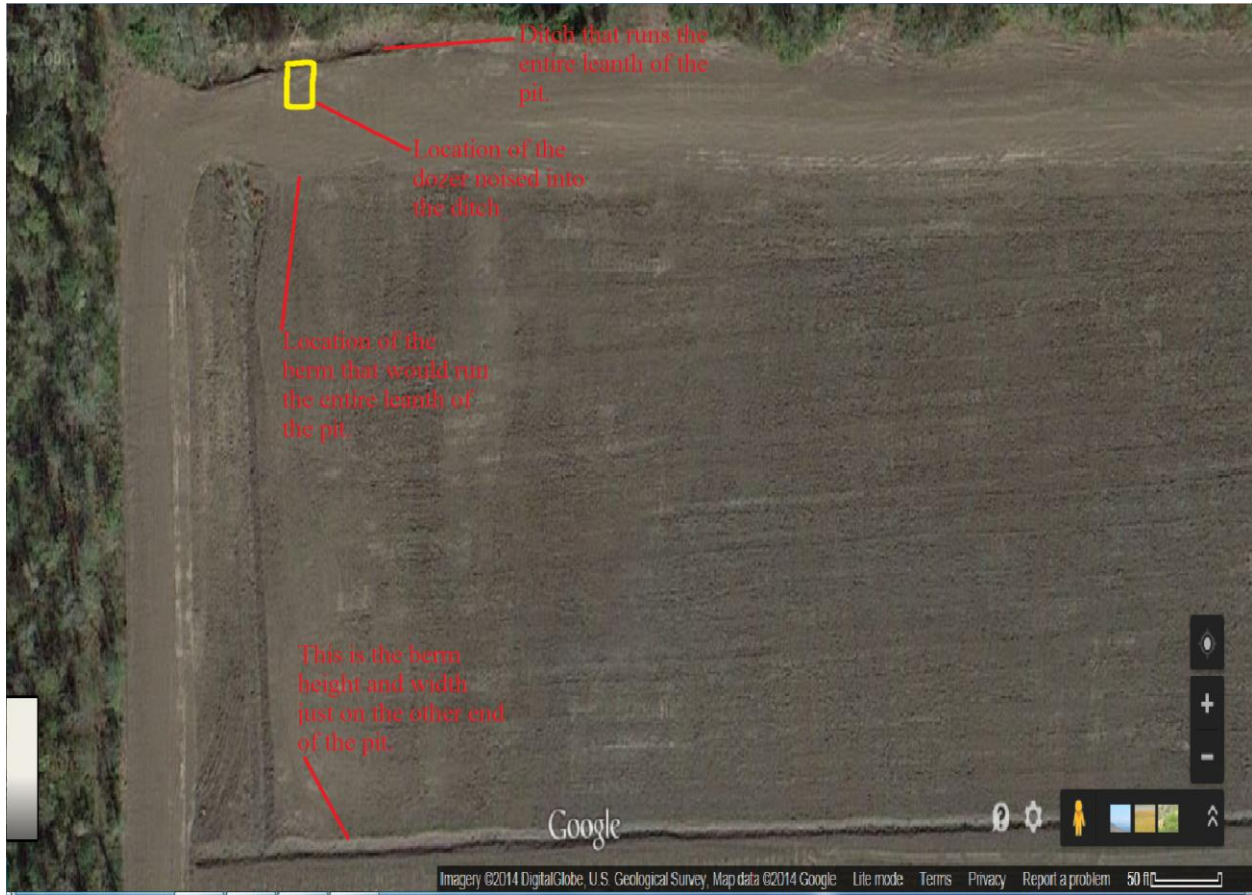
Gibson's dozer traveled over the berm, but continued 51 feet into the drainage canal before stopping. The dozer continued to run spinning mud and water into the air. Wells completed his pass around the pit and on his next approach observed Gibson's dozer in the drainage canal. Wells thought Gibson's dozer was stuck but he could not determine why the dozer was still spinning. He then saw Gibson lying on the ground directly behind the dozer.

Map of dozer location after the accident, location of the ditch that runs the entire length of the pit, and location of where the berm was on the day of the accident.
