REPORT OF INVESTIGATION

**Underground Nonmetal Mine
Limestone (crushed and broken)**

**Fatal Fall of Person Accident
February 27, 2014**

**Martin Marietta Materials, Inc.
Ames Mine
Ames, Story County, Iowa
Mine I.D. No. 13-00014**

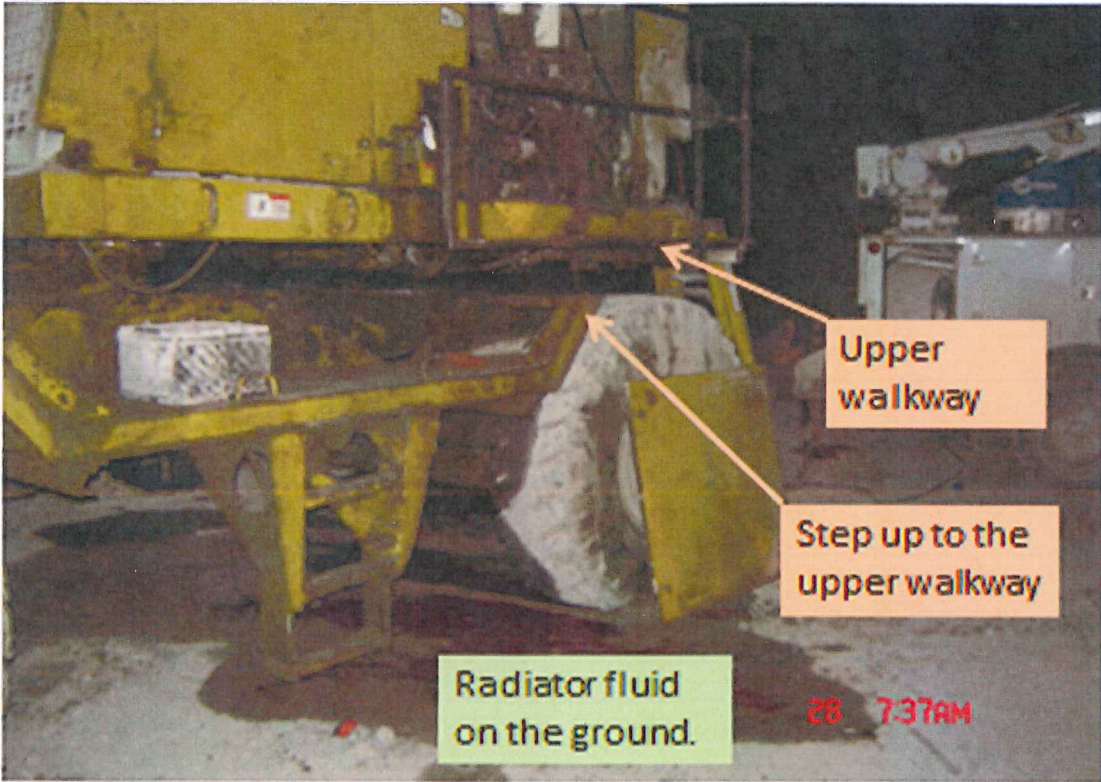
Upper walkway

Step up to the upper walkway

Radiator fluid on the ground.

ROOT CAUSE: Mine management failed to ensure that persons could safely work on the upper platform on the scaler. When the upper platform was constructed, mine management did not ensure that the grating was flush with the top edges of the framing, leaving an approximate 1 $\frac{3}{4}$ -inch high tripping hazard at the access point that was not provided with a railing, barrier, or cover to prevent a person from a slip, trip, or fall hazard.

Additionally, outside handrails were provided on both platforms but were not adequate in preventing a person from falling where the upper platform

transitioned via a step to the lower platform. The handrail height, as a person was positioned at the step, was approximately 32 inches high.

CORRECTIVE ACTION: Mine management modified the angle iron to eliminate the tripping hazard at the access point to the upper platform. Additionally, a chain was placed across the opening access as a barrier to prevent persons from falling from the upper platform. The railing on the platform was also modified by adding an additional section at the transition points between the upper and lower platforms.
