REPORT OF INVESTIGATION

**Surface Nonmetal Mine
(Gypsum)**

**Fatal Powered Haulage Accident
May 1, 2014**

**Silver State Minerals LLC
Gypsum Mountain Mine
Lovelock, Pershing County, Nevada
Mine ID No. 26-02758**

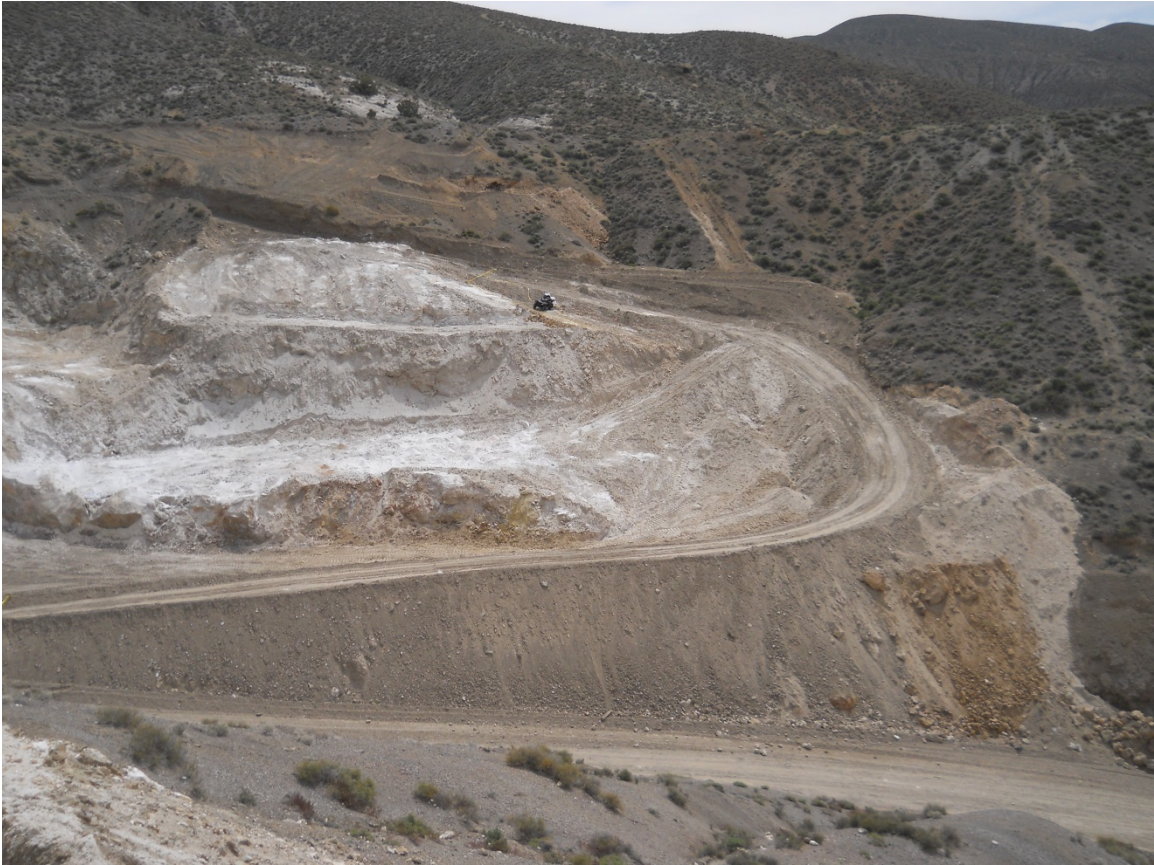
Photograph of the accident scene and road. The small object visible near the upper bench is the All-Terrain Vehicle the victim was operating.

The ATV traveled the roadway to the area above the drill pad where Hill lost control of the vehicle. The ATV rolled over downslope and was found at rest on its left side 44 feet down the roadway from where the victim attempted to turn around the ATV and 10 feet downslope from the edge of the roadway.

Tracks uphill of the accident indicate travel horizontal to the slope and multiple places where the ATV stalled and dug down into loose material in what appears to be an attempt to turn around. The ATV was found to be in two-wheel drive (all-wheel drive available) and in reverse upon recovery. Damage and transference of ground material to the ATV is consistent with a side to side rollover with at least one complete rotation.
