Report of Investigation

Surface Nonmetal Mine
(Construction Sand and Gravel)

Fatal Powered Haulage Accident
May 9, 2014

Mississippi Sand, LLC
Mississippi Sand Seagraves, Gaines County, Texas
Mine ID #4105004

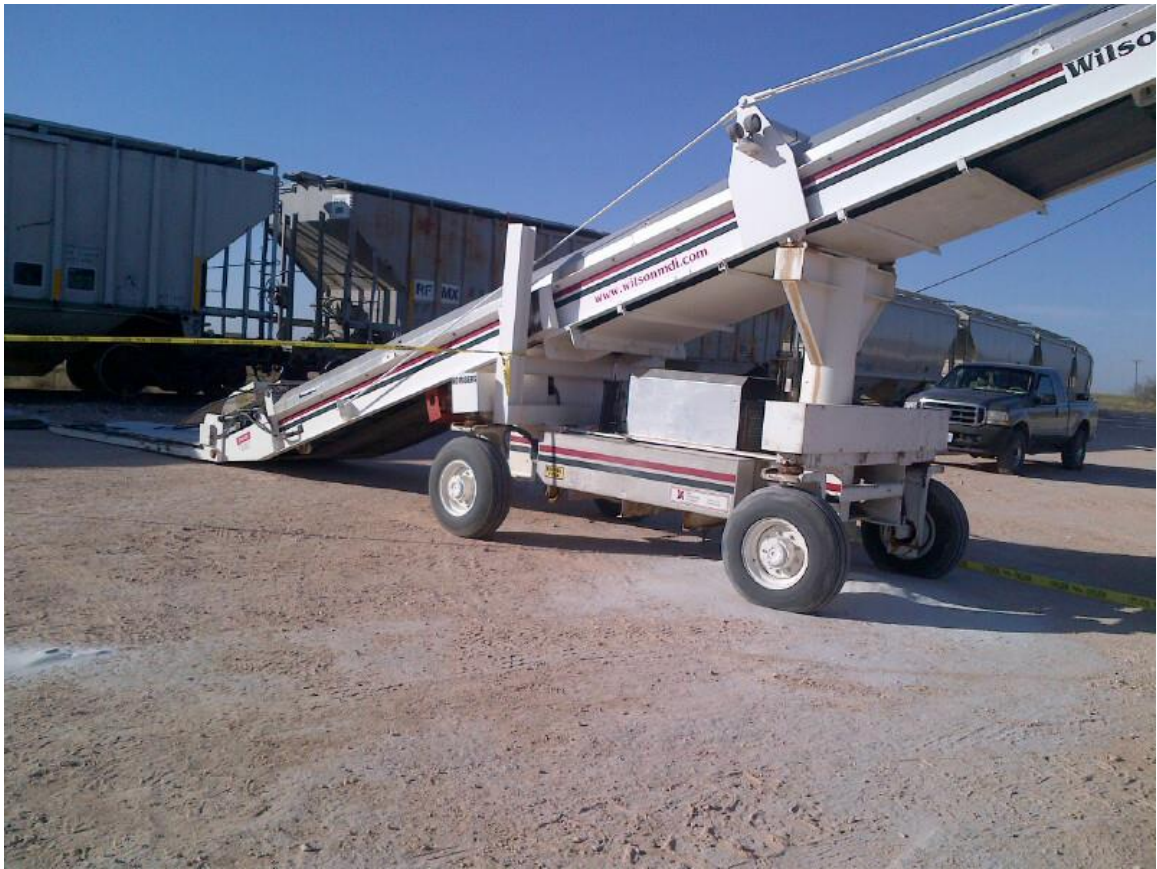
On May 9, 2014, Miguel Arenas Nino, Rail Load Out and Ground Worker, age 20, was killed when he fell onto a moving belt conveyor. Nino was operating a mobile articulating conveyor unloading sand from a rail car into a haul truck when he contacted the moving belt conveyor.

The accident occurred due to management's failure to provide emergency stop devices and/or railings on the conveyor that would have deactivated the conveyor and/or prevented the victim from falling onto the moving conveyor.

Corrective Action: Management installed handrails on the conveyor to prevent persons from contacting the moving conveyor. Safe work procedures for working near conveyors were also established and all persons were trained regarding these new procedures. Additionally, emergency stops, with panic bars, have been positioned at the throat of the conveyors.
