**REPORT OF INVESTIGATION**

**Underground Metal Mine  
Silver Ore**

**Fatal Hoisting Accident  
June 2, 2014**

**Silver Opportunities Partners LLC  
Sunshine Mine  
Kellogg, Shoshone County, Idaho  
MSHA I.D. No. 10-00089**

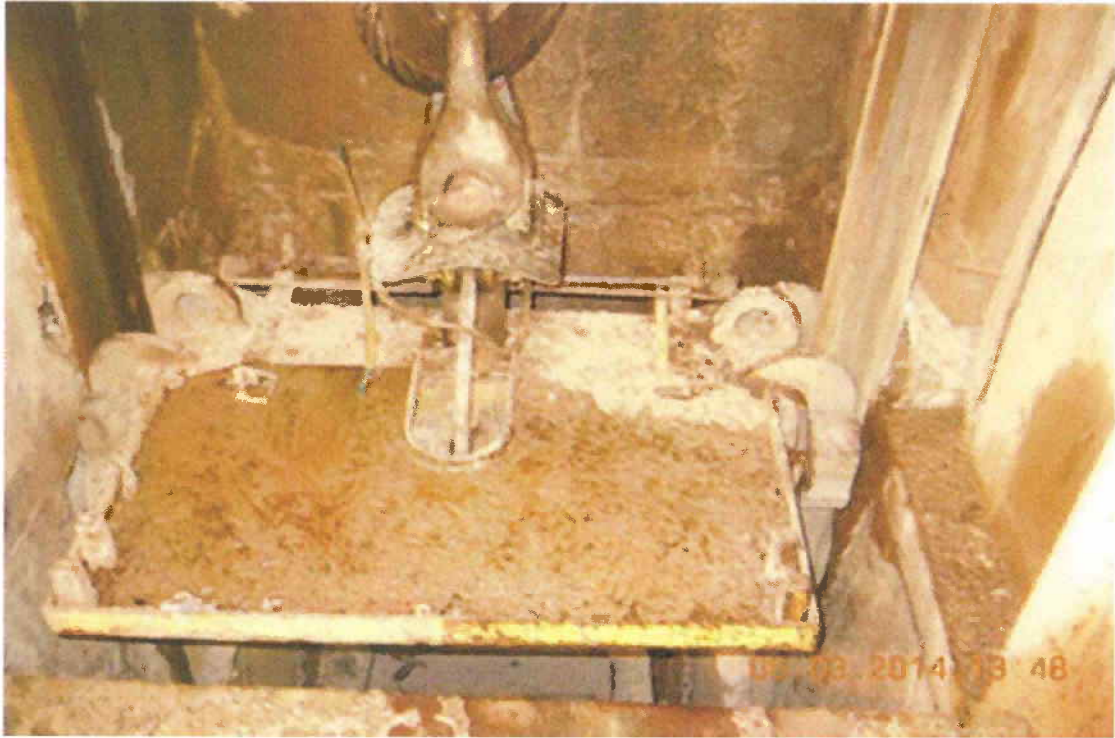
Top of the work deck in the Jewell Shaft chippy compartment

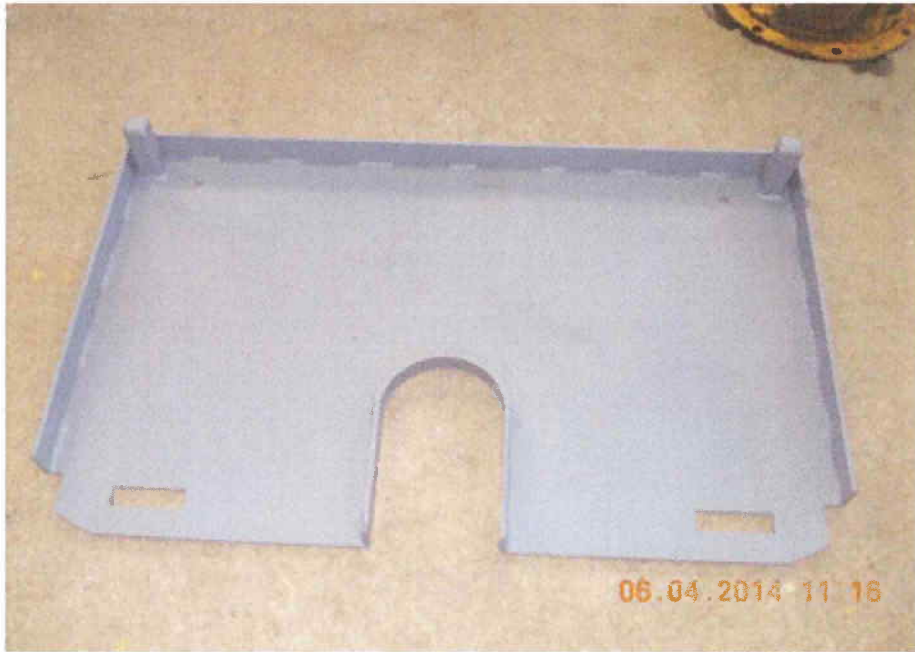
<sup>1</sup> See photo #1 in APPENDIX C

A metal canopy and work deck can be installed on each shaft conveyance so persons can stand on it to perform shaft repair and maintenance. The work deck is constructed

with two separate pieces and creates a 56 inch by 38 inch platform.<sup>1</sup> Removable handrails may be installed on the work deck.

The chippy conveyance is 5 feet deep by 43.5 inches wide. The clearance between the wall timber and the chippy conveyance is 3 inches. A metal canopy and work deck, without handrails, is installed on the chippy conveyance. The clearance between the work deck and the wall timber is 5 inches. Fall protection anchor points are attached to the suspension rope. The anchor point on the east side of the work deck is 75 inches above the work deck and the anchor point on the west side is 84 inches above the work deck. There were no noted defects to the chippy conveyance and no indication that a malfunction of the hoist contributed to the accident.

Photo #1 - Replacement platform for the chippy conveyance.

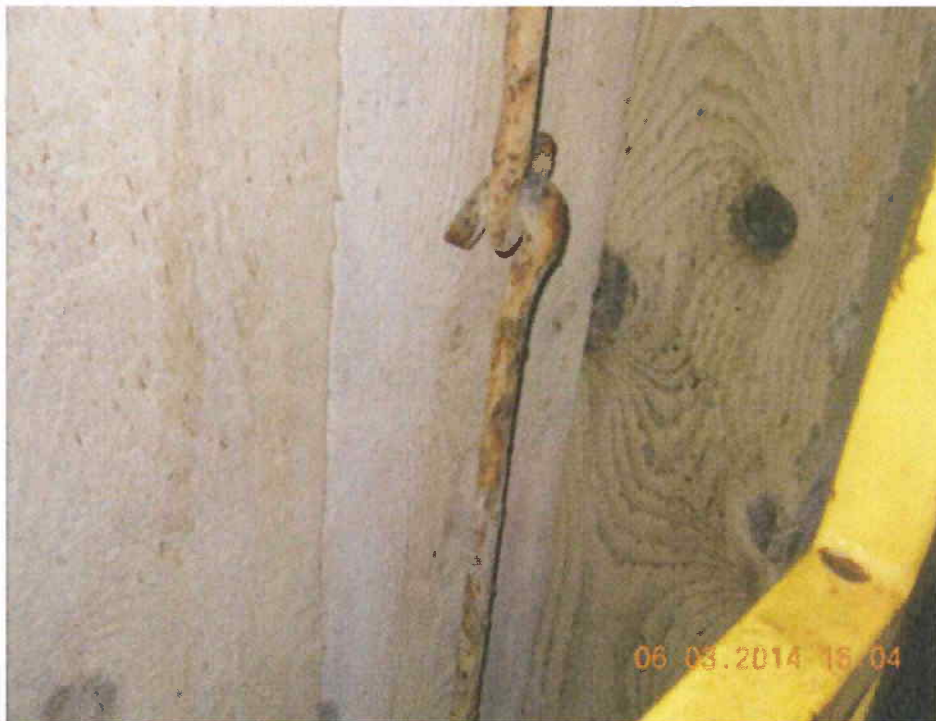
<sup>2</sup> See photo #2 in APPENDIX C

Hanging rods are metal rods that are ¾-inch diameter and hook shaped on one end.<sup>2</sup> The other end has 6 inches of thread which allows them to be bolted to the timbers. The hooks are used during the installation of the shaft wall timbers.

The threaded end of a hanging rod is inserted vertically with the hooked end hanging down, through a pre-drilled hole at each end of a top timber and secured using a nut. During the installation of new bottom timber, a hanging rod is inserted into and secured to the bottom timber with the hooked end of the rod facing upward. The connection of the rods allows the miners to temporarily “hang” the bottom timber in position for blocking

N. Rounds was wearing a fall protection harness equipped with a 6-foot shock adsorbing lanyard. The lanyard contracts to 4.5 feet when not in tension and can reach a maximum elongation of 9.5 feet. The lanyard was attached to a 1 inch diameter (“j” hook) wall plate hanging rod for timber set #114. The hanging rod was installed vertically 11 inches away from the south compartment divider beam. Timber set #114 was approximately 750 feet below the top station sub level.

Photo #2 - Hanging rods in the Jewell Shaft.

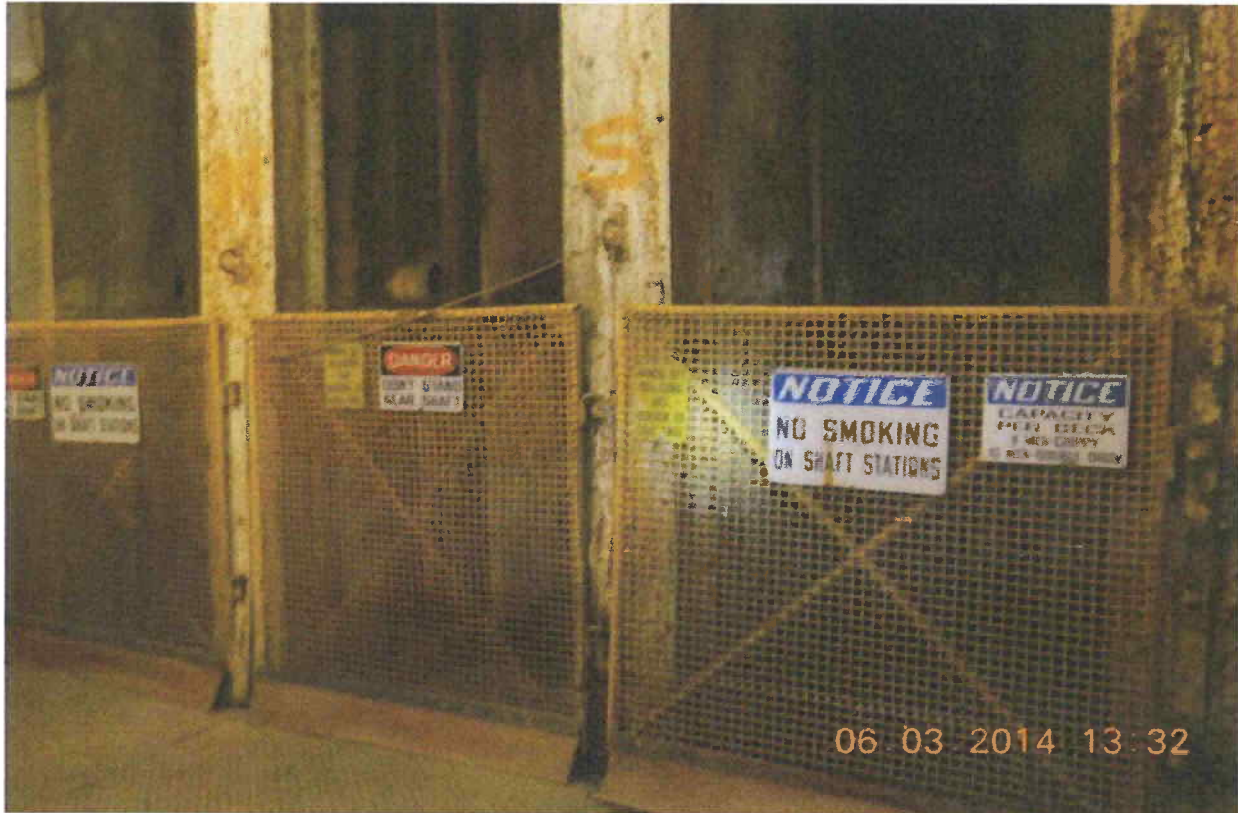
Photo #3 - The Jewell shaft is divided into four compartments: from left to right, north double drum, south double drum, and chippy compartment (where the accident occurred). The utility compartment is on the right (not shown).
