REPORT OF INVESTIGATION

Fatal Falling Material Accident  
August 2, 2014

Fossum Ready Mix  
Belzer Pit  
Glasgow, Valley County, Montana  
Mine I.D. No. 24-00420

MAI-2014-17

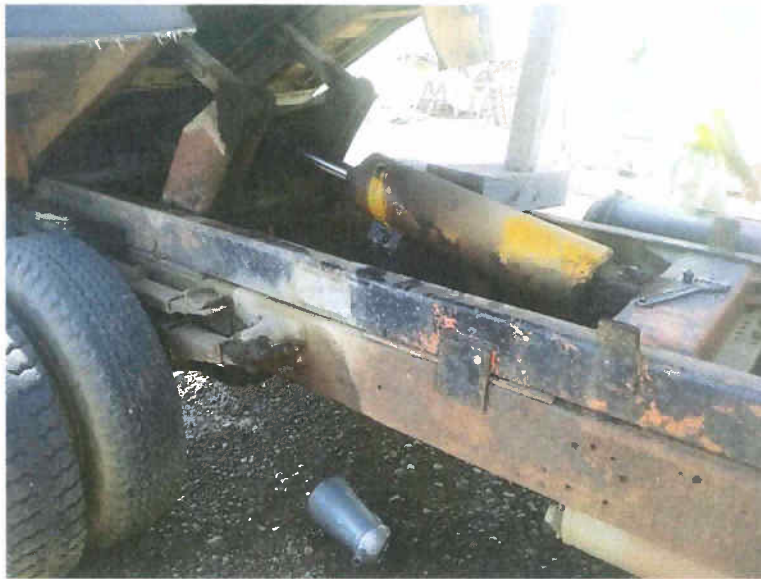
the hoist cylinder, and began filling it with hydraulic fluid from a small metal container. While Irwin was under the raised truck bed, the weathered block of wood positioned to secure the component in the raised position suddenly failed. The wood split into two pieces and the bed fell, pinning Irwin between the bed and the frame rail of the truck.

The dump truck involved in the accident is a 1965 International Harvester, Model No. 1980 Loadstar. The truck, purchased as a frame only vehicle, is a single drive axle chassis truck with a maximum gross vehicle weight rating of 25,500 pounds. The dump bed, a four ton 1954 Heil Co. Model No. A610-167, and lifting device/hoist cylinder

system were installed on the truck after purchase as an aftermarket system. The truck was modified to a dump bed approximately 40 years before the accident occurred and the dump bed had never been modified to include a means to mechanically block it.

- The dump bed raise/lower cylinder serves as the hydraulic system reservoir. There was a severe leak in the hydraulic system, as indicated by spills of fluid at several locations where the truck routinely dumped material.

- The dump bed was approximately half full of wet coarse sand which was estimated to weigh 4,000 pounds.
- The truck's dump bed had no integral mechanical blocking capabilities such as a blocking pin.

The weathered block of wood used to block the truck was 6 inches wide, 6 inches high, and 20 inches long.

**Corrective Action:** Management established procedures to ensure raised components of mobile equipment are secured to prevent accidental lowering when persons are performing maintenance. All persons received task training regarding the procedures to be used when working under raised components on mobile equipment.
