REPORT OF INVESTIGATION

Fatal Falling Material Accident
August 2, 2014

Fossum Ready Mix
Belzer Pit
Glasgow, Valley County, Montana
Mine I.D. No. 24-00420

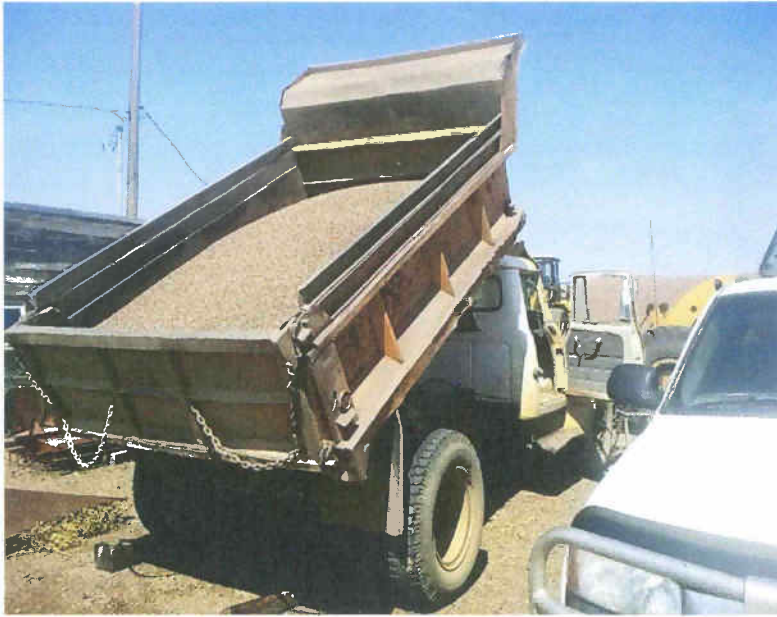
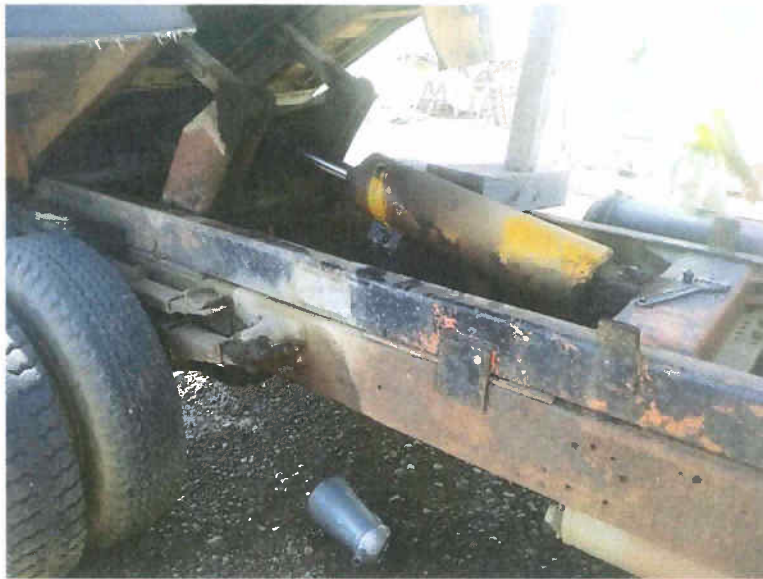
the hoist cylinder, and began filling it with hydraulic fluid from a small metal container. While Irwin was under the raised truck bed, the weathered block of wood positioned to secure the component in the raised position suddenly failed. The wood split into two pieces and the bed fell, pinning Irwin between the bed and the frame rail of the truck.

The weathered block of wood used to block the truck was 6 inches wide, 6 inches high, and 20 inches long.

Corrective Action: Management established procedures to ensure raised components of mobile equipment are secured to prevent accidental lowering when persons are performing maintenance. All persons received task training regarding the procedures to be used when working under raised components on mobile equipment.
