REPORT OF INVESTIGATION

**Underground Nonmetal Mine
(Salt)**

**Fatal Powered Haulage Accident
September 26, 2014**

**United Salt Corporation
Hockley Mine
Hockley Texas, Harris County, Texas
Mine ID No. 41-02478**

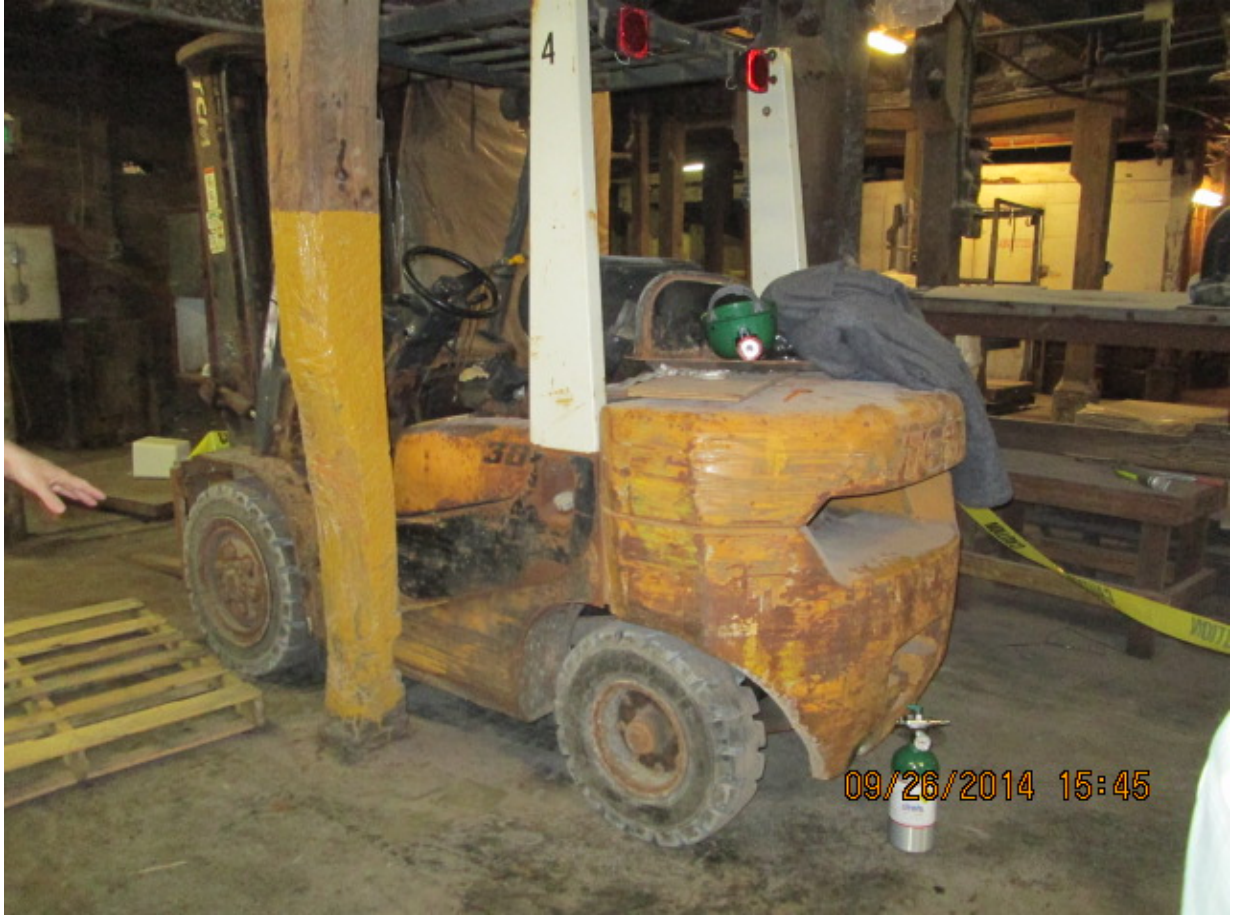
On September 26, 2014, Mark G. Benoit, Mechanic, age 55, was killed while performing maintenance on a forklift in a mill building. Benoit was adjusting the directional solenoid on the transmission from the ground when the forklift began to move forward, pinning him between a wooden support pillar and the forklift's Falling Object Protective Structure (FOPS).
