UNITED STATES
DEPARTMENT OF LABOR
MINE SAFETY AND HEALTH ADMINISTRATION
Metal and Nonmetal Mine Safety and Health

REPORT OF INVESTIGATION

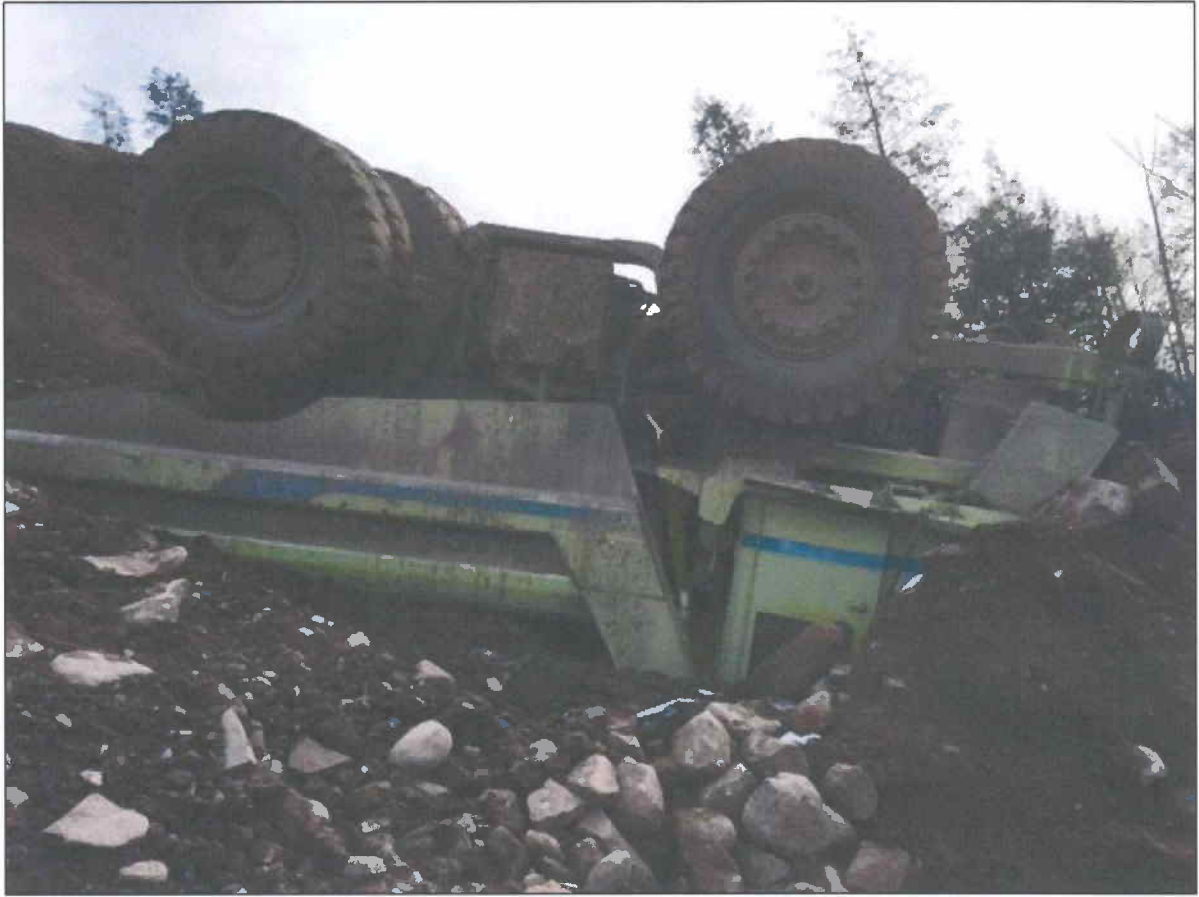
Originating Office
Mine Safety and Health Administration
Northeast District
178 Thorn Hill Road, Suite 100
Warrendale, Pennsylvania 15086
Donald J. Foster Jr., District Manager

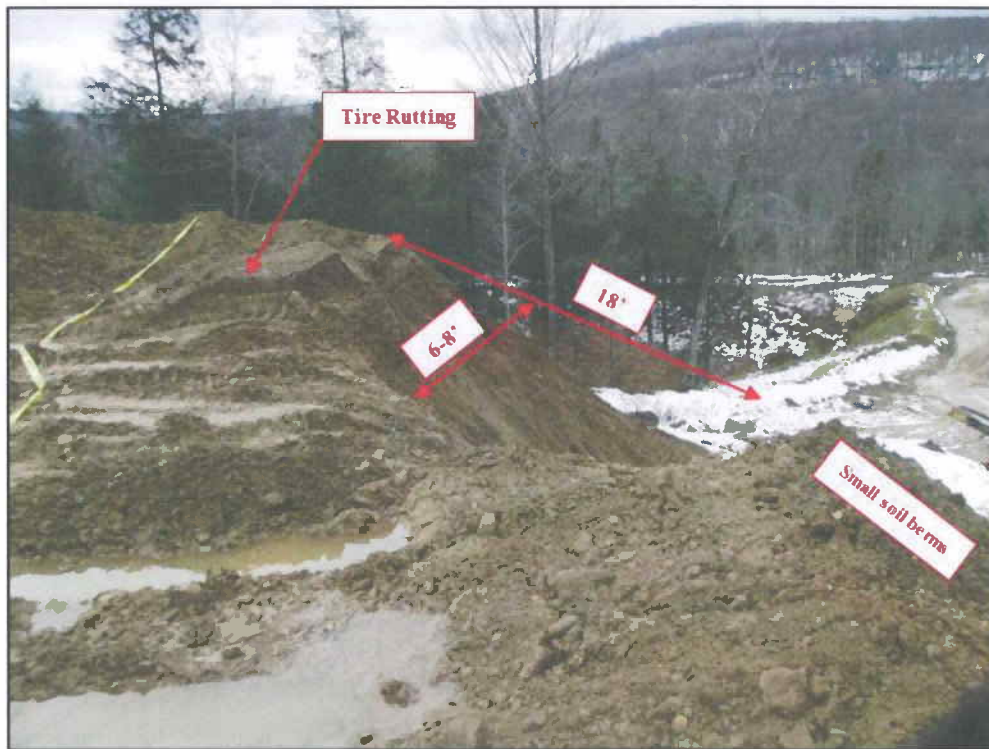
Figure 10 - Localized slope failure which occurred beneath the rear tires of the haul truck. Deep tire ruts show minimal strength of wet, soft, cohesive material comprising the dump surface and soil berms.

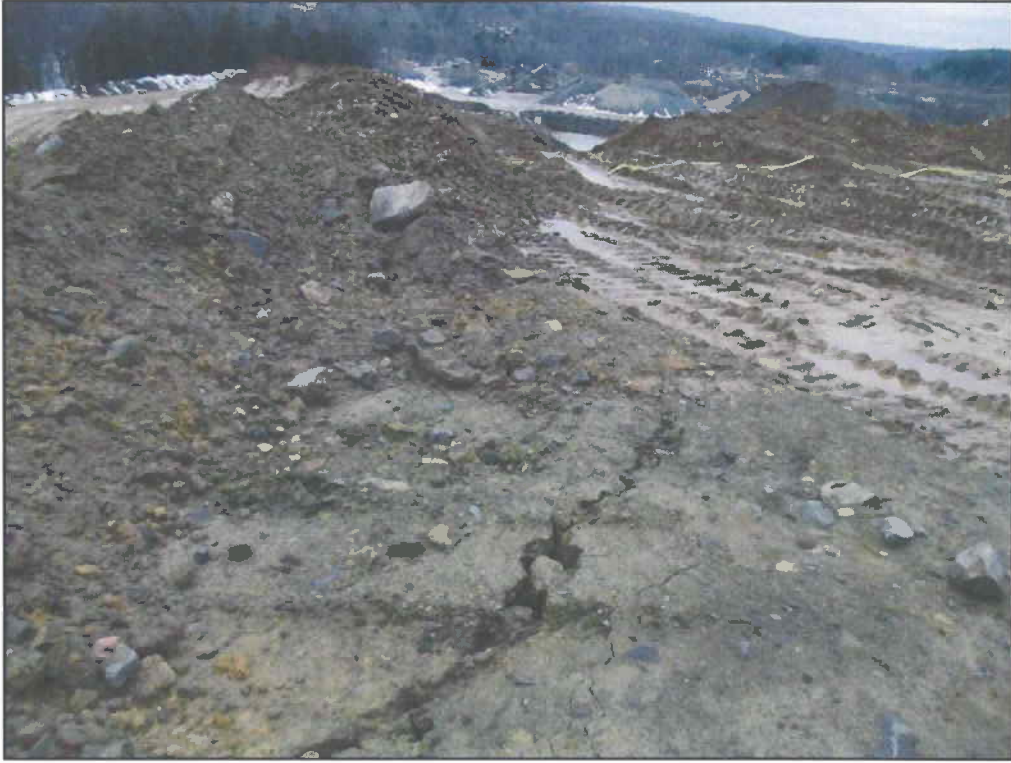
Figure 11 - Cracking observed on the surface of the dump.
