REPORT OF INVESTIGATION

**Fatal Machinery Accident
December 29, 2014**

**Zeotech Corporation
Tilden Plant
Tilden, McMullen County, Texas
Mine ID No. 41-03374**

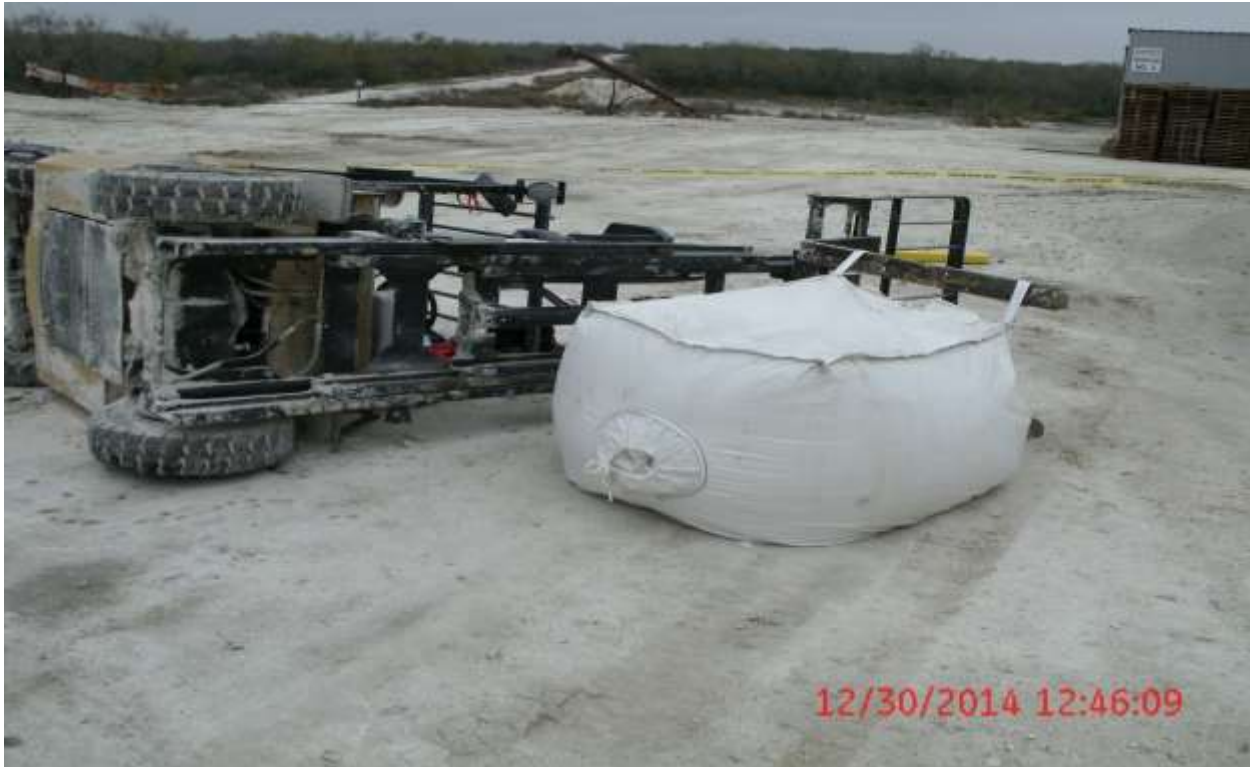
On December 29, 2014, Adrian Moreno, Warehouse Bagger, age 21, was killed while operating a forklift carrying a bulk bag of dust. The forklift went out of control and overturned onto its left side. Moreno was a new miner and had only worked at the mine for six days prior to the day of the accident. He had not completed the 24 hours of required new miner training. The day of the accident was his seventh day on the job.

The accident occurred due to management's failure to provide Moreno task training for the safe operation of the forklift. The victim was a new miner and had not received task training in the possible hazards of operating a forklift, a task in which he had no previous experience. As a result, Moreno failed to maintain control of the forklift at all times while he was operating it. Moreno was not wearing a seat belt.
