REPORT OF INVESTIGATION

Surface Nonmetal Mine
(Crushed & Broken Granite)

Fatal Machinery Accident
November 10, 2014

R&S Stone, Inc.
R&S Stone, Inc.
Floyd, Floyd County, Virginia
Mine I.D. No. 44-02991

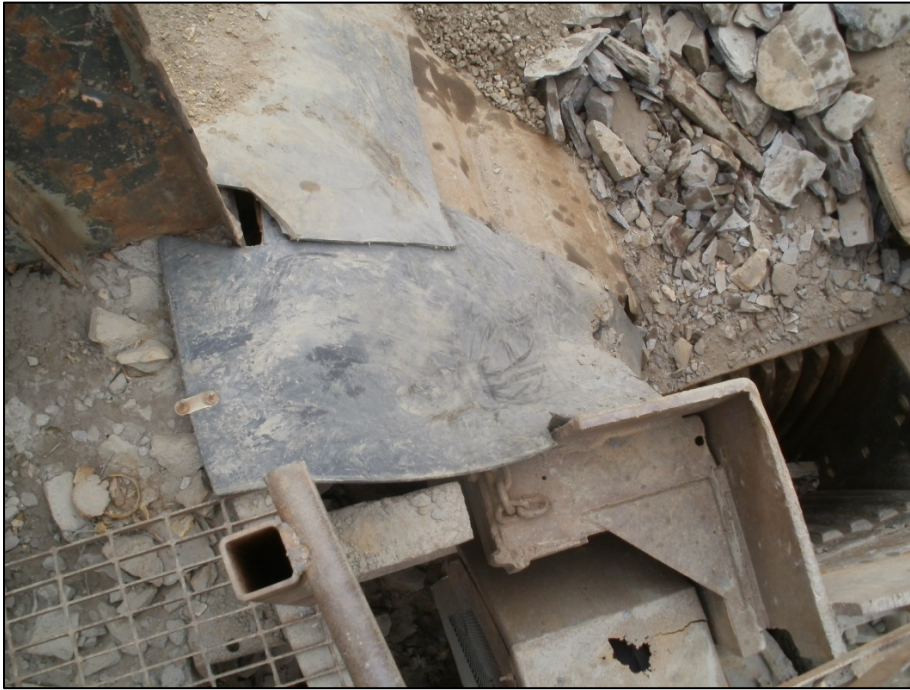
On November 10, 2014, Hixon slid approximately 12 feet downward on a piece of rubber belting, and climbed into the jaw crusher (see Figure 1). A noncontributory citation was issued for a violation of 30 CFR 56.11001. Hixon was not protected from hazardous movement of either the crusher components or the drill bit while he was in the crusher. While standing on a rock, Hixon used a torch to attempt to cut the drill bit free from between the jaw plates. Soon after Hixon started to cut the bit, the bit was forcibly ejected from the crusher and struck him (see Figure 2).

Figure 1 – Path that Hixon traveled from the adjacent walkway.

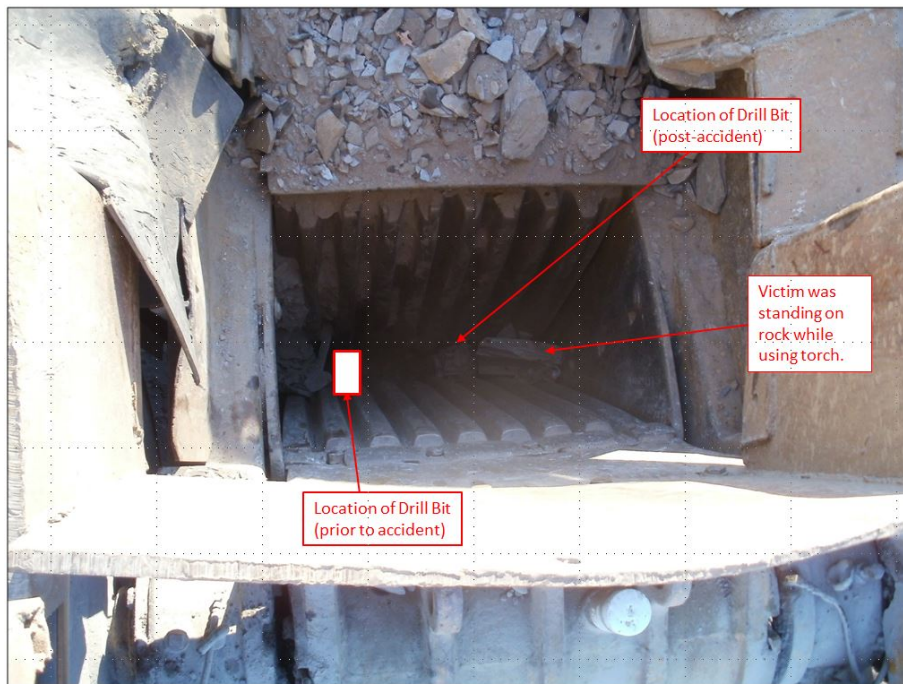
1. No blocking was used to protect the victim from hazardous movement of either the jaw crusher components or the drill bit.
2. The haul truck dumped rock directly into the pan feeder which fed the jaw crusher. The mine operator did not use a grizzly or other recommended type of feeding unit to prevent unwanted items such as a drill bit from entering the crusher.
3. The rotating mass of the crusher applies a large amount of compressive force to any object stuck in the jaw. When an object, such as a drill bit, is jammed in the crusher, this compressive force supplies enough energy to propel an object from the crusher when that object is loosened.

Figure 2 – View of the jaw crusher showing position of the victim and the pre-accident and post-accident positions of the drill bit.

Corrective Action: Management established policies and procedures to ensure that miners would not enter the jaw crusher to free any jammed material or objects and trained miners on these procedures. The onsite Kobelco SK400 excavator, equipped with a 10,000 pound hammer, will be used to dislodge any items that become wedged through the crusher plates.

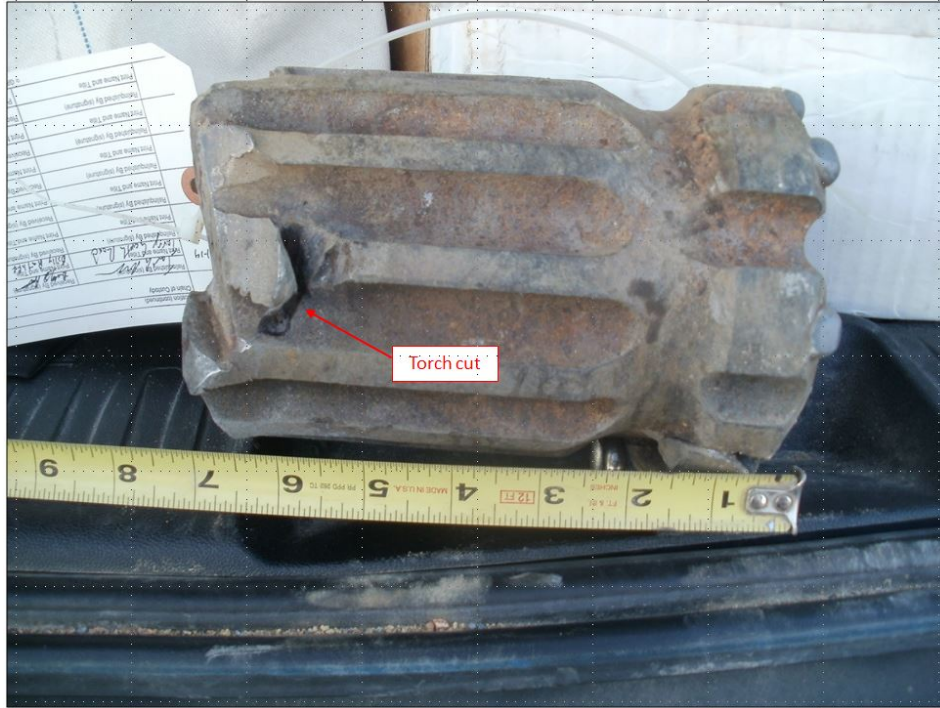
After the shot, one of the missing drill bits was found while the excavator was loading trucks. The second bit lodged lengthwise in the primary jaw crusher. This is the drill bit involved in the accident. The drill bit was a 5-inch diameter by 7-inch long Model T51 DC Retractable bit, manufactured by Atlas Copco (see Figure 3). The drill bit weighed approximately 27 pounds.

Figure 3 – Close-up photo of the drill bit.

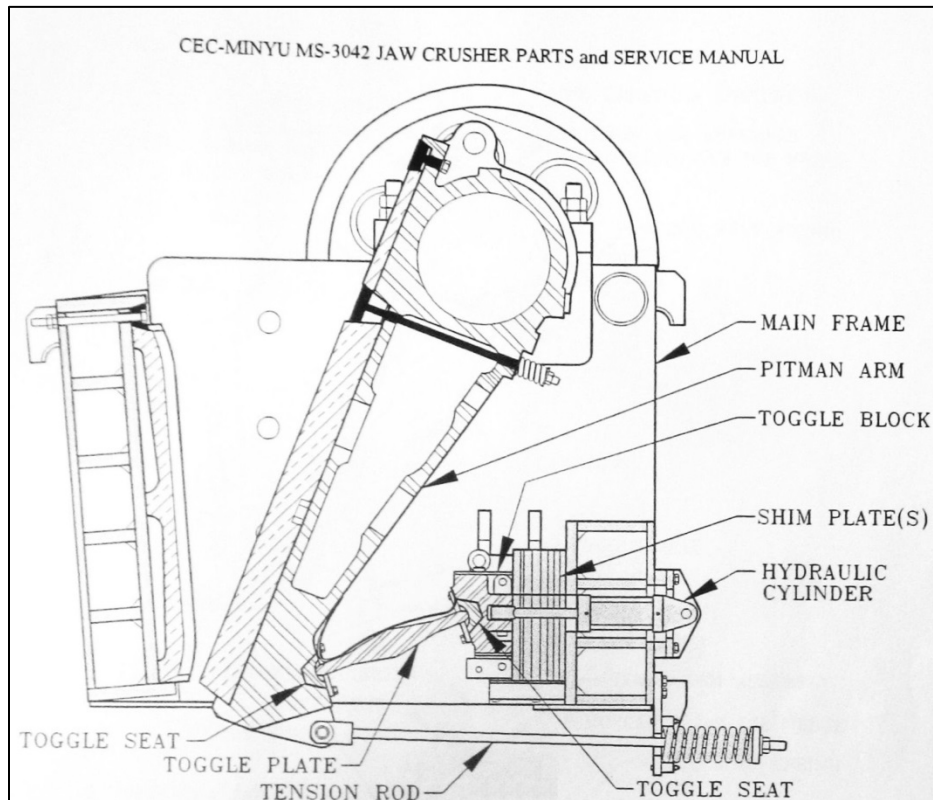
The Model MS-3042 jaw crusher involved in the accident was manufactured in November 1995 by Minyu Machinery Corp., LTD, located in Taiwan, Republic of China. The jaw crusher was the primary component of a portable rock crushing unit that included a vibrating rock feed table. The complete unit was assembled in 1996 by Construction Equipment Corporation (CEC) of Lake Grove, Oregon. The unit was purchased by the current mine operator in 1998. Figure 4 shows a cross-section of the jaw crusher.

Figure 4 - Pictorial cross-section of the Minyu MS-3042 jaw crusher.

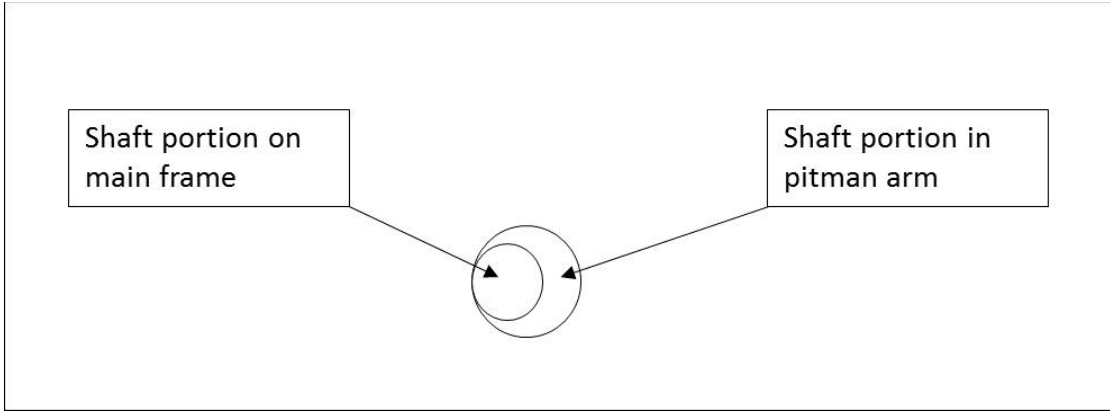
The pitman arm shaft is designed as an eccentric, a circular disk that is solidly fixed to a rotating axle with its centre offset from that of the axle, and provides the action to crush and feed the material (rock) into the crusher. By design, the diameter of the eccentric of the pitman arm shaft is larger than the diameter of the shaft mounted to the crusher frame. As the shaft rotates, the eccentric portion of shaft rotates within the pitman arm. Figure 5 is a representative illustration of the end view of the pitman arm shaft or the eccentric.

Figure 5 - Representative illustration of the end view of the pitman arm shaft or the "eccentric."
