MNM Fatal 2014-09

- Fall of Person
- February 27, 2014 (Iowa)
- Underground Limestone Mine
- Contract Mechanic
- 27 years old
- 3 years of experience

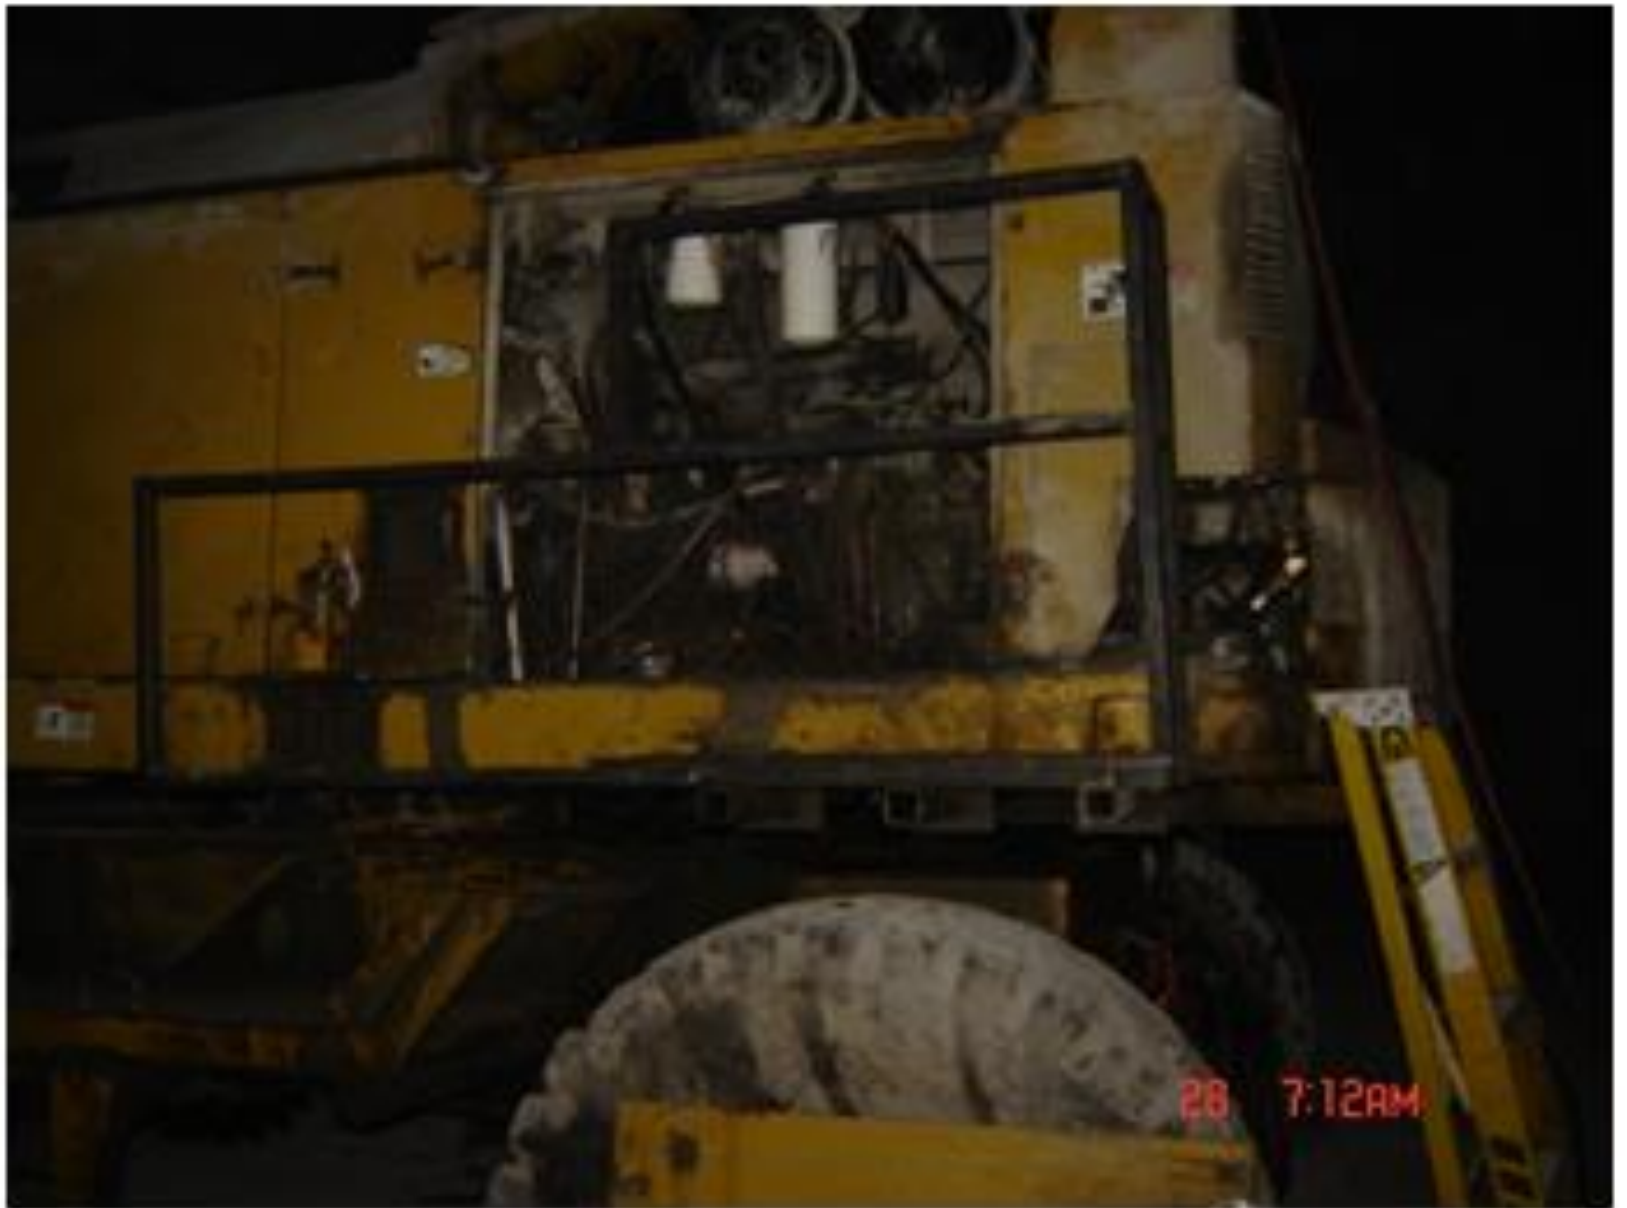
The scaler had a multi-level platform system. The lower platform was originally constructed and installed by the manufacturer. The upper platform, constructed by the mine operator in June 2013, was affixed to the scaler at the engine compartment. The upper platform was framed in 2-inch wide angle iron and filled with grating for a walking surface. However, the grating wasn't flush with the top edges of the framing, leaving an approximate 1³/₄-inch high tripping hazard at the access point. This access point was not provided with a railing, barrier, or cover to prevent a person from a slip, trip, or fall hazard.

While outside handrails were provided on both platforms, they were not adequate in preventing a person from falling over the railing where the upper platform transitioned via a step to the lower platform. The handrail height, as a person was positioned at the step, was approximately 32 inches high.

ROOT CAUSE: Mine management failed to ensure that persons could safely work on the upper platform on the scaler. When the upper platform was constructed, mine management did not ensure that the grating was flush with the top edges of the framing, leaving an approximate 1¾-inch high tripping hazard at the access point that was not provided with a railing, barrier, or cover to prevent a person from a slip, trip, or fall hazard.

Additionally, outside handrails were provided on both platforms but were not adequate in preventing a person from falling where the upper platform transitioned via a step to the lower platform. The handrail height, as a person was positioned at the step, was approximately 32 inches high.

CORRECTIVE ACTION: Mine management modified the angle iron to eliminate the tripping hazard at the access point to the upper platform. Additionally, a chain was placed across the opening access as a barrier to prevent persons from falling from the upper platform. The railing on the platform was also modified by adding an additional section at the transition points between the upper and lower platforms.
