# **MNM Fatal 2014-11**

- Powered Haulage
- May 1, 2014 (Nevada)
- Gypsum Mine
- Co-owner
- 57 years old
- 7 weeks of experience

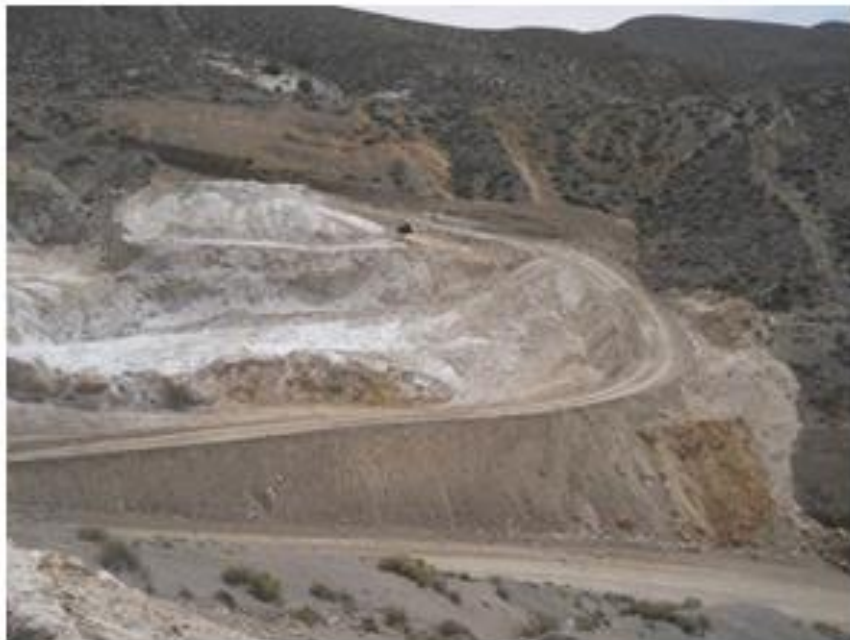
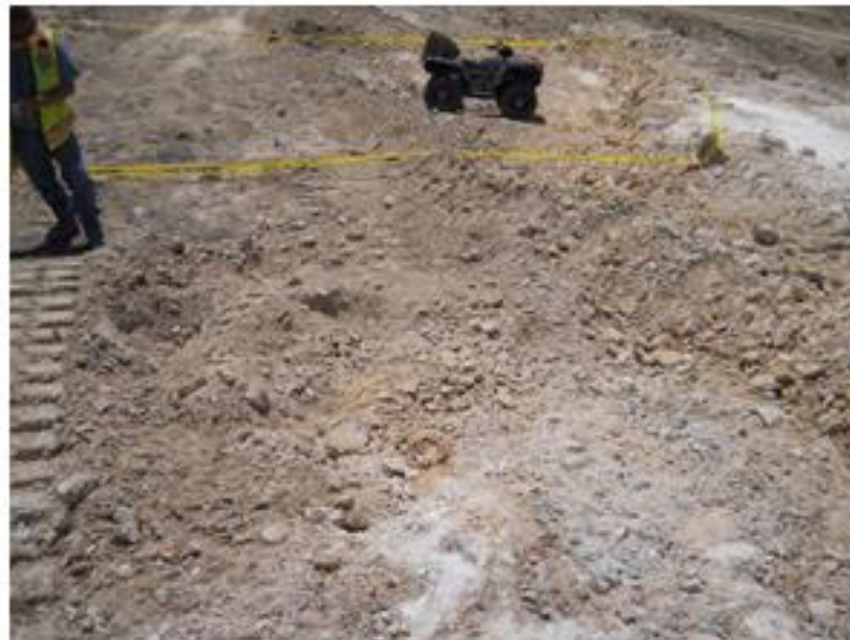
Tire marks indicate that he drove the ATV uphill when the vehicle's wheels started to spin and dig into the ground. The victim was unable to continue in the direction he had been going and attempted to turn around. When he backed up, he lost control of the ATV, rolling it side over side at least once before it came to rest. The victim was pinned beneath the front left fender and wheel.

The victim was operating the ATV in two-wheel drive (All Wheel Drive available) on a very steep roadway. He was operating the ATV in climbing and descending grades, attempting to turn on steep grade, and operating on loose terrain even though the ATV manufacturer expressly warns against operating an ATV under these conditions. A combination of these factors contributed to the ATV rolling over onto the victim. Additionally, the victim did not wear a helmet or other protective gear that may have protected him from injuries resulting from the accident.

Root Cause: Management failed to ensure that the victim, who did not have the experience to operate the ATV in difficult terrain, was provided task training to safely operate the ATV.

Corrective Action: The mine operator submitted a Part 48 training plan that was approved by the District Manager on May 13, 2014. All persons performing work at the mine were provided all required training in accordance with the approved plan. A record of all persons trained was submitted for review to MSHA.
