MNM Fatal 2014-20

- Fall of Person
- October 10, 2014 (Pennsylvania)
- Cement Operation
- Truck Driver
- 66 years old
- 11 years of experience

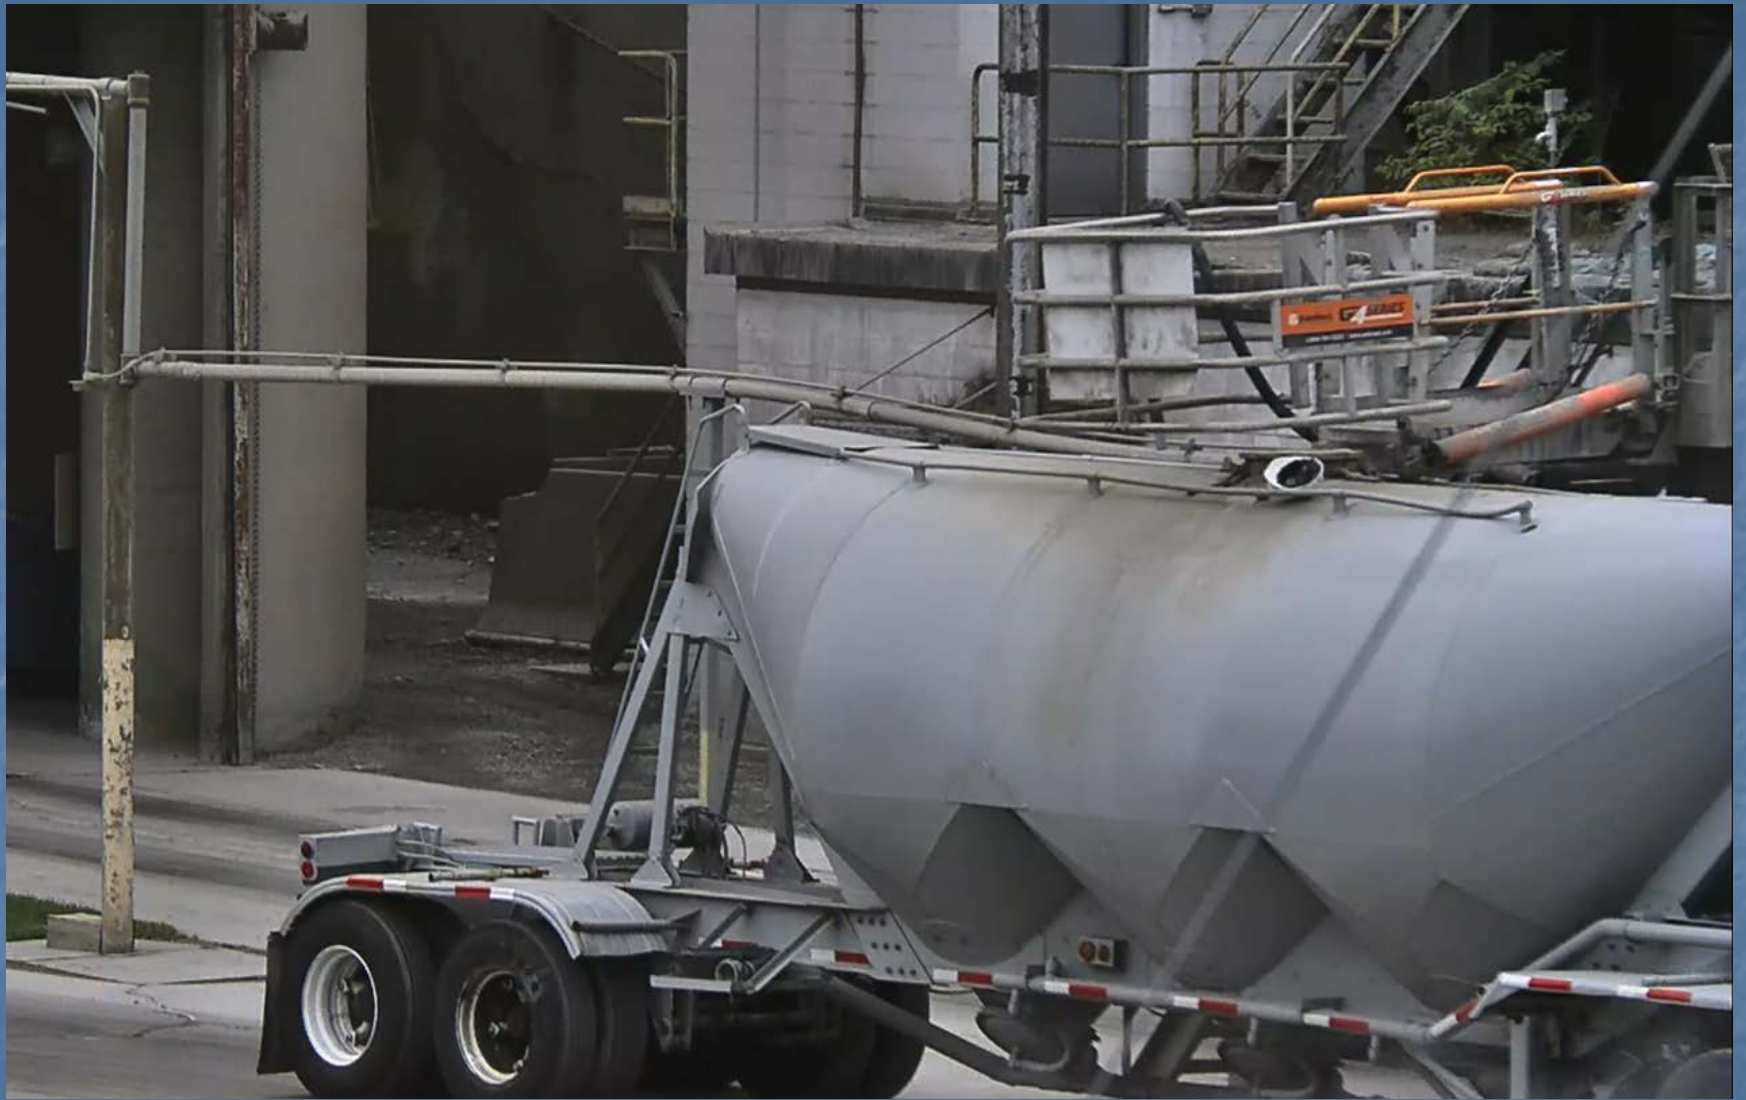
The victim was killed at a cement operation. He was standing inside a loading rack safety cage attempting to close the center hatch on top of a bulk tanker truck. He was unable to close the hatch due to the position of the truck's trailer. The fill port on the trailer was not centered within the confines of the safety cage. Consequently, he had to raise the safety cage to access the hatch. After the victim raised the safety cage, he tripped and fell through the opening, between the raised safety cage and the rounded side of the tanker truck, approximately 11 feet to the ground below.

The accident occurred due to mine management's failure to establish procedures to ensure that truck drivers properly align the bulk tanker trucks under the loading rack at close hatch station No. 1 in order to safely close the hatch on the trucks. In addition, contract management failed to have policies in place to ensure that truck drivers used fall protection where there was a danger of falling from performing work on top of bulk tanker trucks at the plant.

Root Cause: Mine management failed to establish procedures to ensure that truck drivers properly align the bulk tanker trucks under the G4 SafeRack system at close hatch station No. 1 in order to safely close the hatch on the trucks.

Root Cause: Contract management failed to establish policies requiring their truck drivers to wear fall protection when there was a danger of falling from performing work on top of bulk tanker trucks at the plant.

Corrective Action: To ensure proper alignment of bulk tanker trucks, mine management installed cement barriers and painted delineating lines along the roadway leading to close hatch station No. 1. In addition, overhead cameras have been installed at close hatch stations No. 1 and No. 2, complete with video display monitors, to enable truck drivers to view the top hatch and properly position their trucks under the G4 SafeRack system. Multilingual warning signs have also been posted at the scale house and bulk load out station exits to warn truck drivers of the hazards associated with misalignment of bulk tanker trucks.

Corrective Action: Contract management established a written policy and safe work procedures, including the use of fall protection when there is a danger of falling from performing work on top of bulk tanker trucks at the plant. All contract truck drivers were trained in these new policies and procedures.
