MNM Fatal 2014-21

- Falling, Rolling or Sliding Rock Material
- November 18, 2014 (Louisiana)
- Alumina Milling
- Job Site Supervisor
- 42 years old
- 19 years of experience

Overview

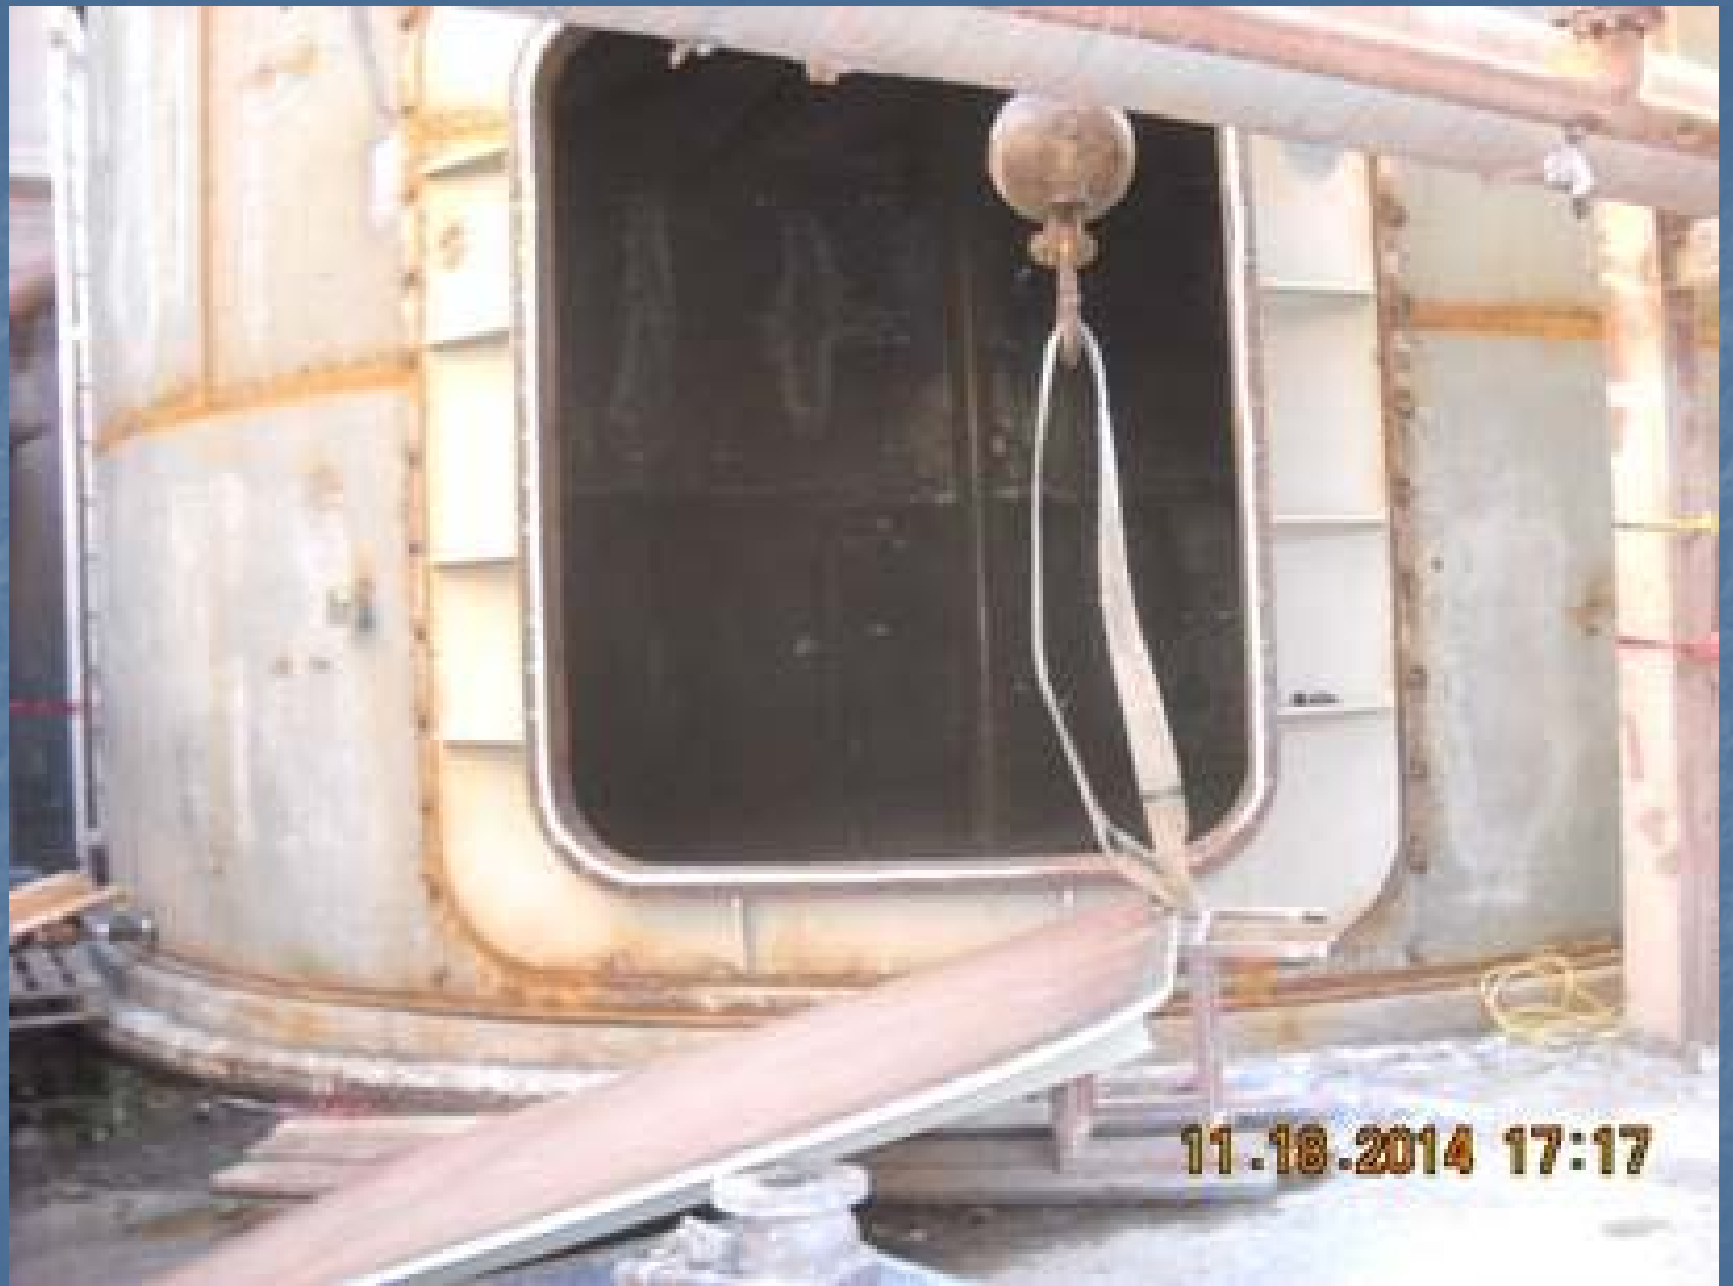
Jerry L. McClelland, Contract Superintendent for Turner Industries Group LLC (Contractor ID# HPQ), age 44, was killed while installing a door on the side of a digester filtrate tank on November 18, 2014. McClelland was standing in front of the suspended door when the lifting lug broke, causing the 2,620 pound door to fall and strike him.

The door fell because the welds attaching the lug to the door stiffener were undersized for the encountered stresses. Further, the welds were irregular in shape and contained defects, such as lack of fusion, porosity, and undercutting, which adversely affected the weld's capacity. .
