REPORT OF INVESTIGATION

Surface Metal Mine  
(Iron Ore)

Fatal Powered Haulage Accident  
February 1, 2014

Gilbert Development Corporation (GDC)  
Comstock / Mountain Lion  
Cedar City, Iron County, Utah  
ID No. 42-01927

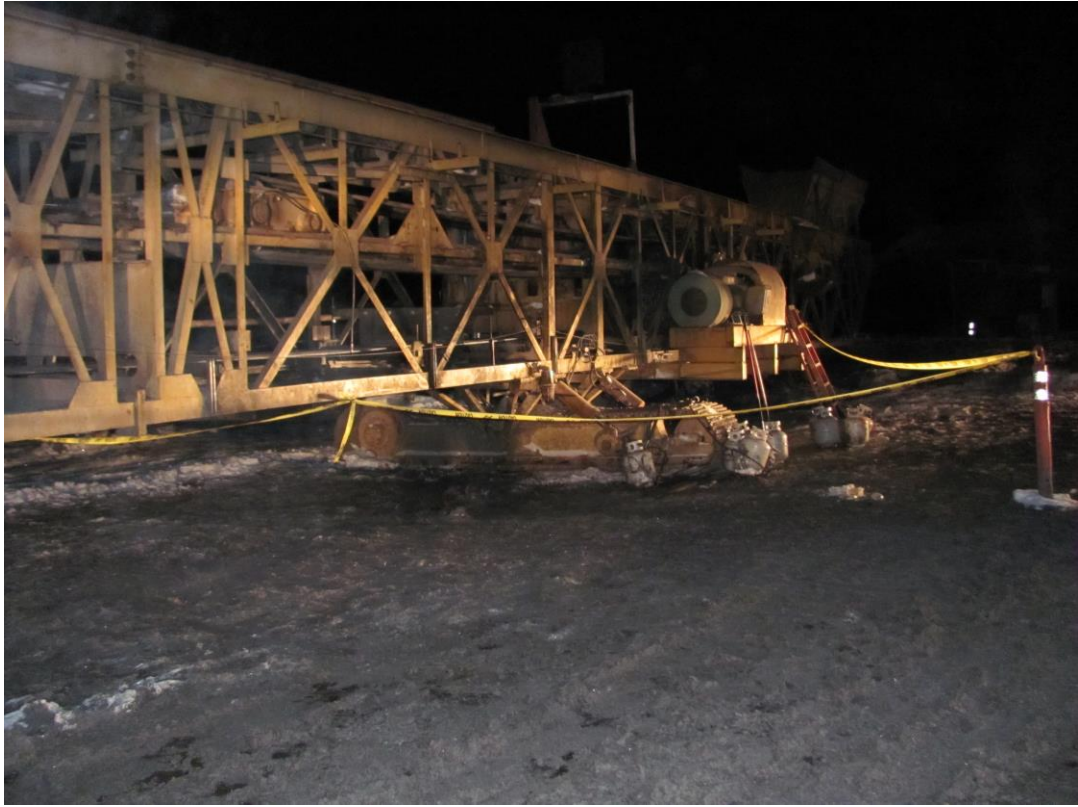
Mark F. Rowley, Rahco Conveyor Operator, age 56, was killed on February 1, 2014. He was cleaning an unguarded return idler inside the frame of a mobile stacking belt conveyor that was five feet above the ground when he became entangled between the return idler and the belt.

The accident occurred due to management's failure to establish safe work procedures to be followed while persons performed work on the belt conveyor. The victim was using a tool to clean the unguarded return idler while the belt conveyor was in motion. The belt conveyor was not deenergized and blocked against motion before the victim attempted to remove the spillage on the return idler.
