UNITED STATES
DEPARTMENT OF LABOR
MINE SAFETY AND HEALTH ADMINISTRATION
Metal and Nonmetal Mine Safety and Health

REPORT OF INVESTIGATION
Surface Nonmetal Mine
(Construction Sand and Gravel)

Fatal Falling/Sliding Material Accident
February 28, 2014

East Coast Mines Ltd.
East Coast Mines Ltd.
East Quogue, Suffolk County, New York
MSHA I.D. No. 30-00865

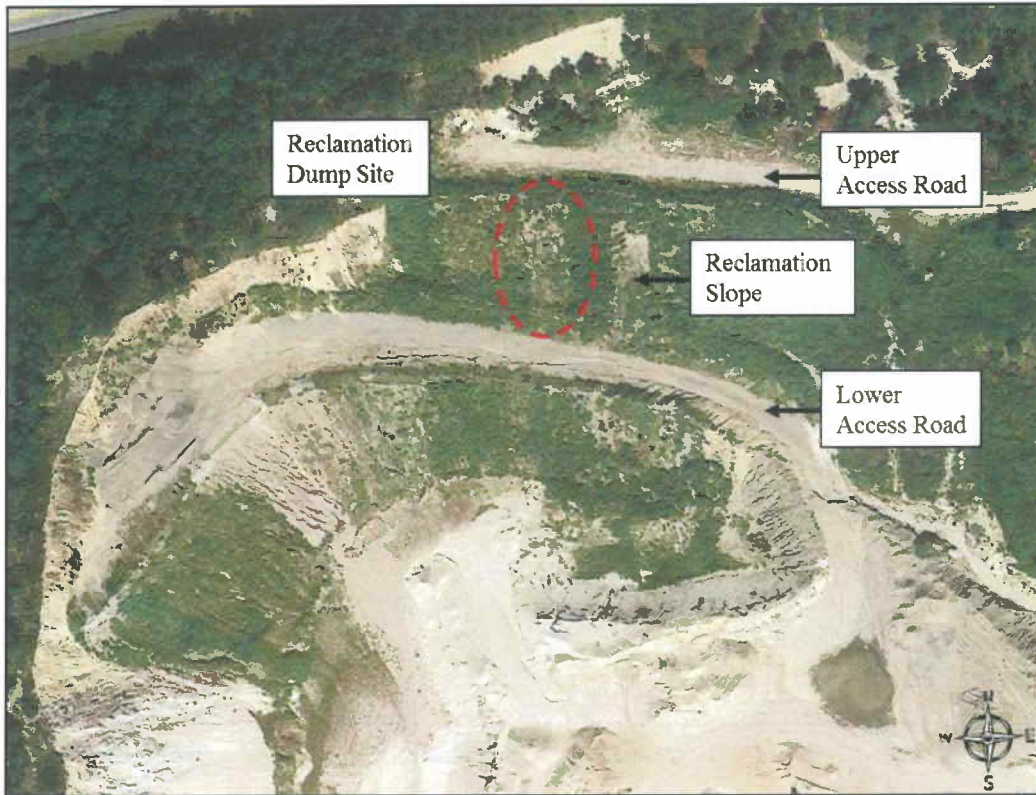
At the time of the accident, the northwest corner of the open pit had been mined to completion and was being reclaimed by the mine operator (see Figure 1). The reclamation process involved hauling truckloads of backfill material along the upper access road and dumping it at the top of the final sand embankment. A front-end loader was then used to push the material over the edge of the embankment.

Figure 1 – Aerial view of the northwest corner of the mine (September, 2013).
The approximate location of the failure zone is highlighted in red.

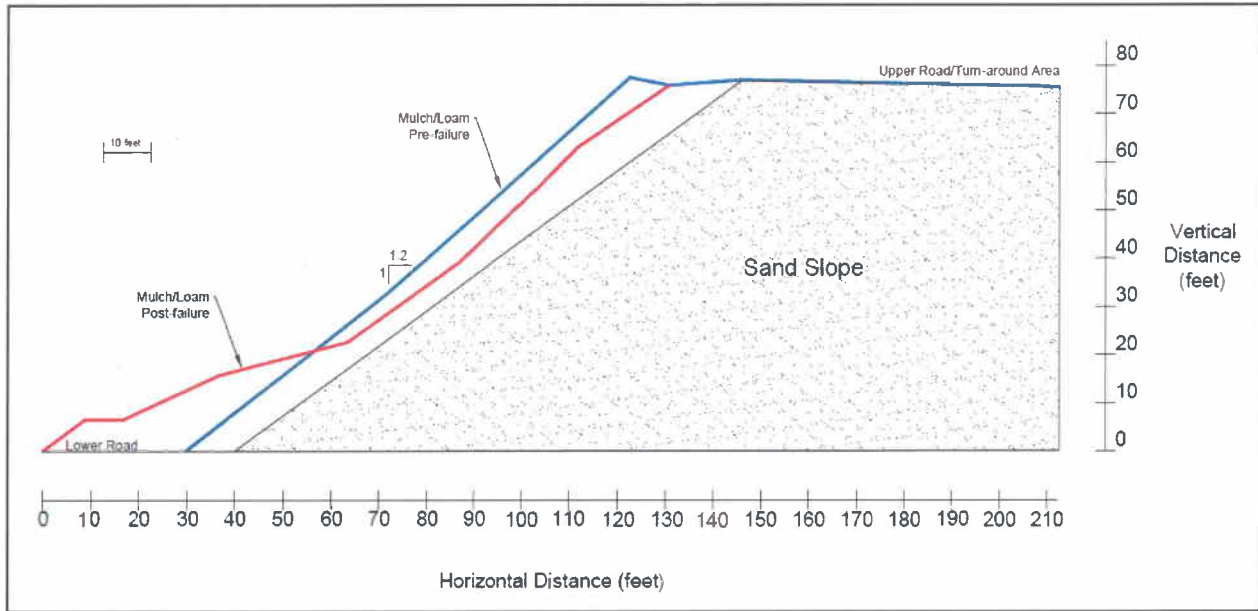
The slope was measured to be 80 feet high (see Figure 2) at the failed area, approximately 180 feet east of the western edge of the area being reclaimed. The failure plane was limited to the reclamation material and did not extend into the final sand embankment remaining at the completion of mining. The reclamation slopes were measured to be 1.2 H:1V (i.e., horizontal : vertical) or about 40 degrees at the areas directly adjacent to the failed area. Based on the final sand slope contours obtained from the mine operator, the thickness of the reclamation material over the sand slope was estimated to be between 10 and 20 feet.

Figure 2 - Typical cross-sections for the slope conditions prior to and post failure.

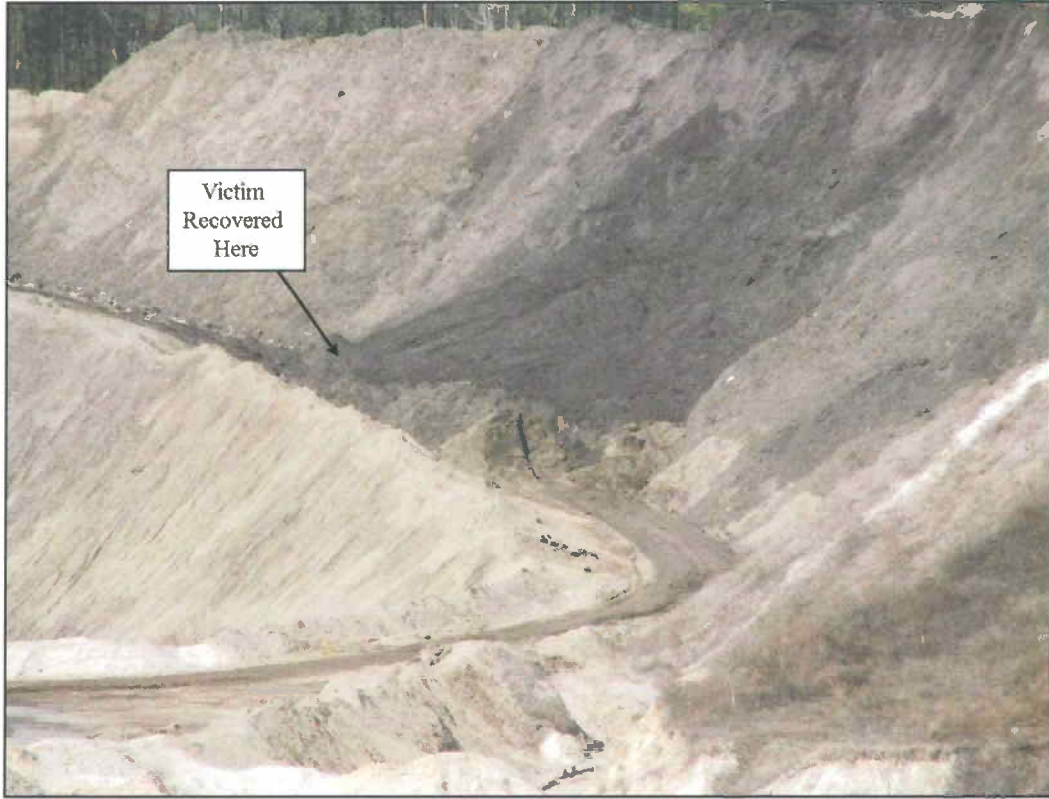
The remaining void left by the sliding material was 88 feet wide at the top of the slope. The slide debris was approximately 110 feet wide at the bottom of the slope (see Figure 3). The slide debris covered a portion of the 30-foot wide lower access road at the base of the slope. The estimated amount of material displaced during the failure was approximately 1,600 cubic yards. Water was not observed seeping from the failure area or along the portions of the slope that did not fail. Slight bulges were observed toward the bottom of the reclamation slope on both sides of the failure area. At the top of the slope, investigators observed tension cracks, up to several inches wide, in the reclamation material. However, they did not observe any significant vertical displacement along these existing cracks. Tension cracks are common at similar dump sites and necessitate the use of dozers or front-end loaders to push the material over the top of the embankment.

Figure 3 – View of reclamation dump site and failure looking toward the northwest.

Corrective Action: Management modified the reclamation plan at the mine to include using additional material fill to form a flatter slope which can be maintained using a dozer. In addition, management abandoned the lower access road by permanently blocking the east and west approaches to the roadway. These revisions eliminate the need for persons to travel near the base of the slope.

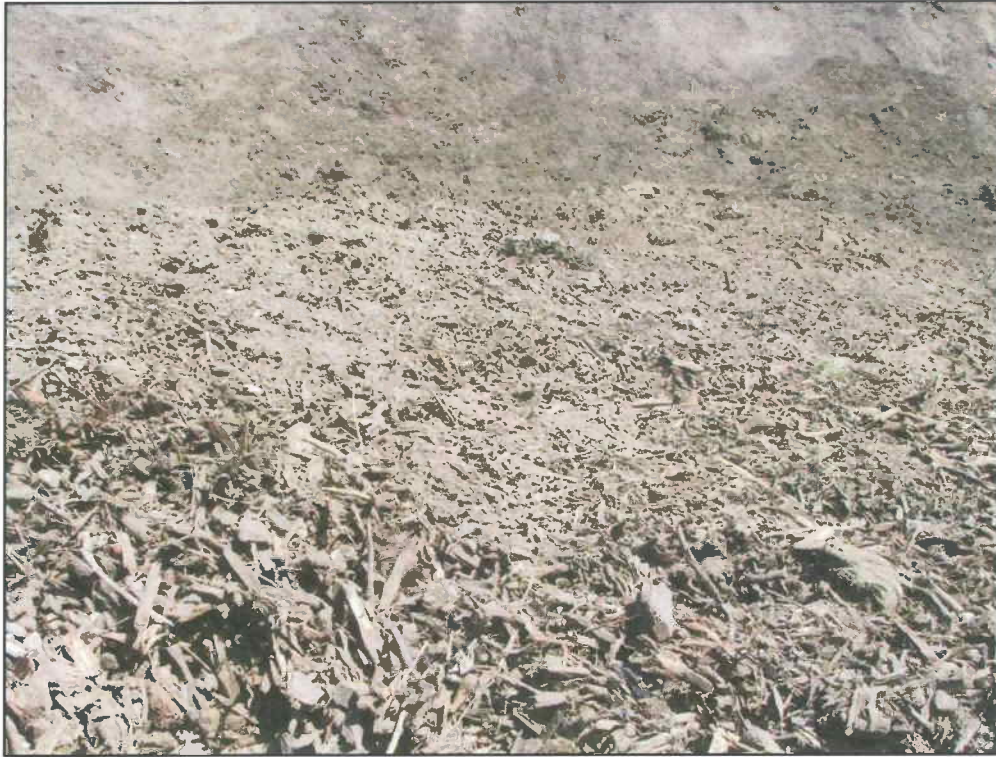
According to the mine operator, the material being used to reclaim the area was a mixture of approximately 70 percent loam and 30 percent mulch (see Figure 4). Due to its composition, the loam/mulch mixture behaved differently than a typical soil backfill under similar placement conditions. That is, when dry soil is dumped, it naturally settles to its angle of repose, or the maximum angle that a stable slope will maintain due to friction between soil particles. The loam/mulch mix contains organic material which causes it to lose volume and generate heat as it decomposes. The slight bulges on both sides of the failed area may be due to the changing material characteristics from decomposition.

The relatively slow decomposition of the mulch portion of the reclamation material (shrinking volume) could have caused the areas that did not fail to shift slightly downward over the three-year-long reclamation process. The moisture content, the frozen condition, and the fibrous nature of the loam/mulch mixture could have allowed the material to hold itself in a slightly over-steepened state. The material dumped on the day of the accident added an additional load and could have created a slope that was marginally stable. The relatively warm material (woody mulch) may have thawed the frozen mulch already in place. A combination of these factors caused a temporary reduction of shear strength within the reclamation material causing the marginally stable slope to fail.

Figure 4 – Close-up view of failed backfill material composed of loam and mulch.
