REPORT OF INVESTIGATION

Surface Nonmetal Mine  
(Sand and Gravel)

Fatal Machinery Accident  
April 17, 2014

Hafenstine Plant #1  
Hafenstine Construction Company  
Alma, Wabaunsee County, Kansas  
ID No. 14-01708

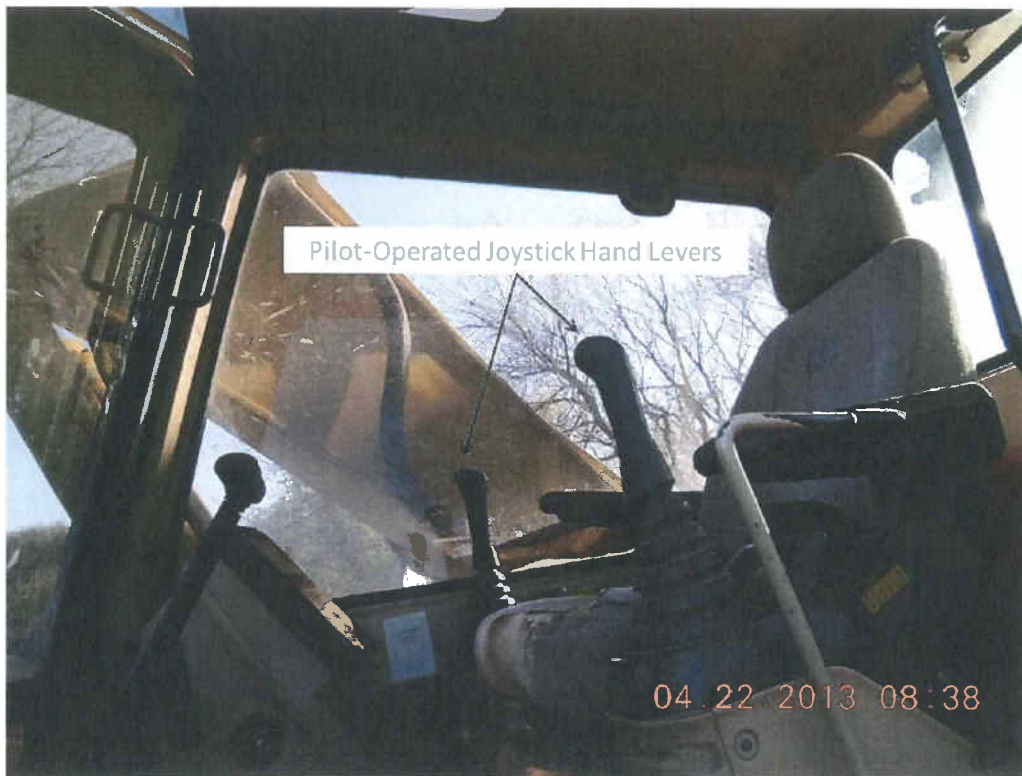
3) IMPLEMENT AND SWING SYSTEM DESIGN: The implement and swing systems used two pilot-operated joystick hand levers oriented in a standard backhoe loader pattern to control the boom, stick, bucket and upper structure swing features (see Photo No. 1, Photo No. 2 and Figure No. 1). Oblique movement of either joystick hand lever correspondingly operated two functions simultaneously.

Photo No. 1: Oblique View of Operator's Cab Showing Layout of Implement and Swing Hand Controls

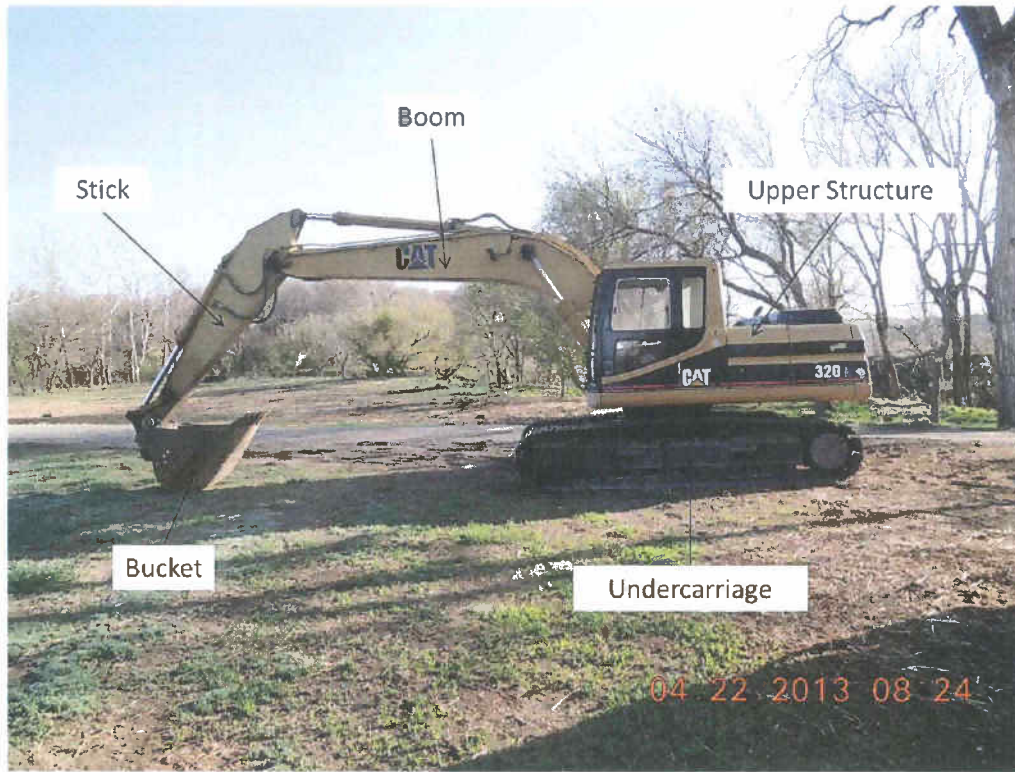
Photo No. 2: Identification of General Excavator Components

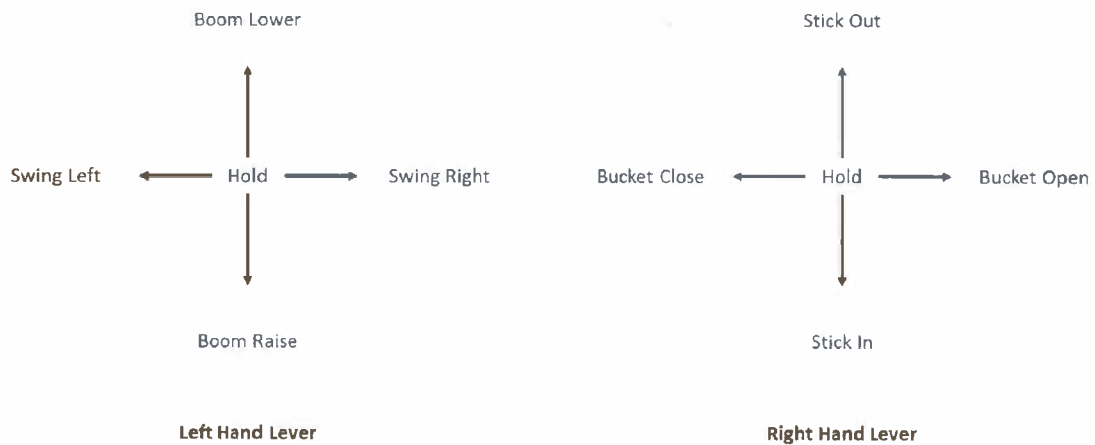
Figure No. 1: Patterns of Implement and Swing Hand Control Levers (Standard Backhoe Loader System Patterns)
