**REPORT OF INVESTIGATION
Underground Metal Mine
(Lead/Zinc)**

**Fatal Fall of Roof Accident
January 21, 2015**

**The Doe Run Company
Fletcher Mine
Bunker, Reynolds County, Missouri
MSHA I.D. Number 23-00409**

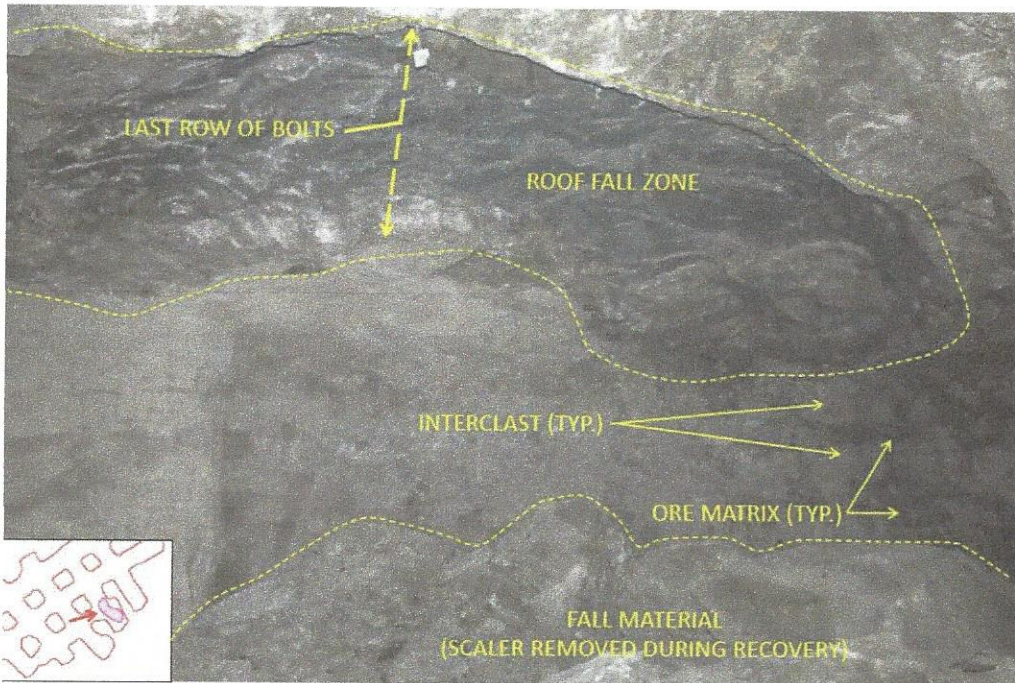
Figure 2

The accident occurred in the RC3CPO Northeast working section. The roof fall was approximately 55-foot long and 20-foot wide. The height of the fall extended to a maximum of six feet at the center of the cavity. The majority of the fall cavity ranged in height from 2 to 4 feet. The single-level drift, where the fall took place, was being advanced to the southeast (Figure 1). The fall area is described as the drift at pillar number 7517B (Side B). The roof at the accident scene consisted of brecciated dolomite that fell in large pieces (Figure 2). The estimated weight of the fallen material was approximately 175 tons.
