REPORT OF INVESTIGATION

Surface Nonmetal Mine
(Sand and Gravel)

Fatal Powered Haulage Accident
March 17, 2015

Ulrich Gravel Inc.
Ulrich Pit
Ord, Valley County, Nebraska
Mine ID No. 25-00888

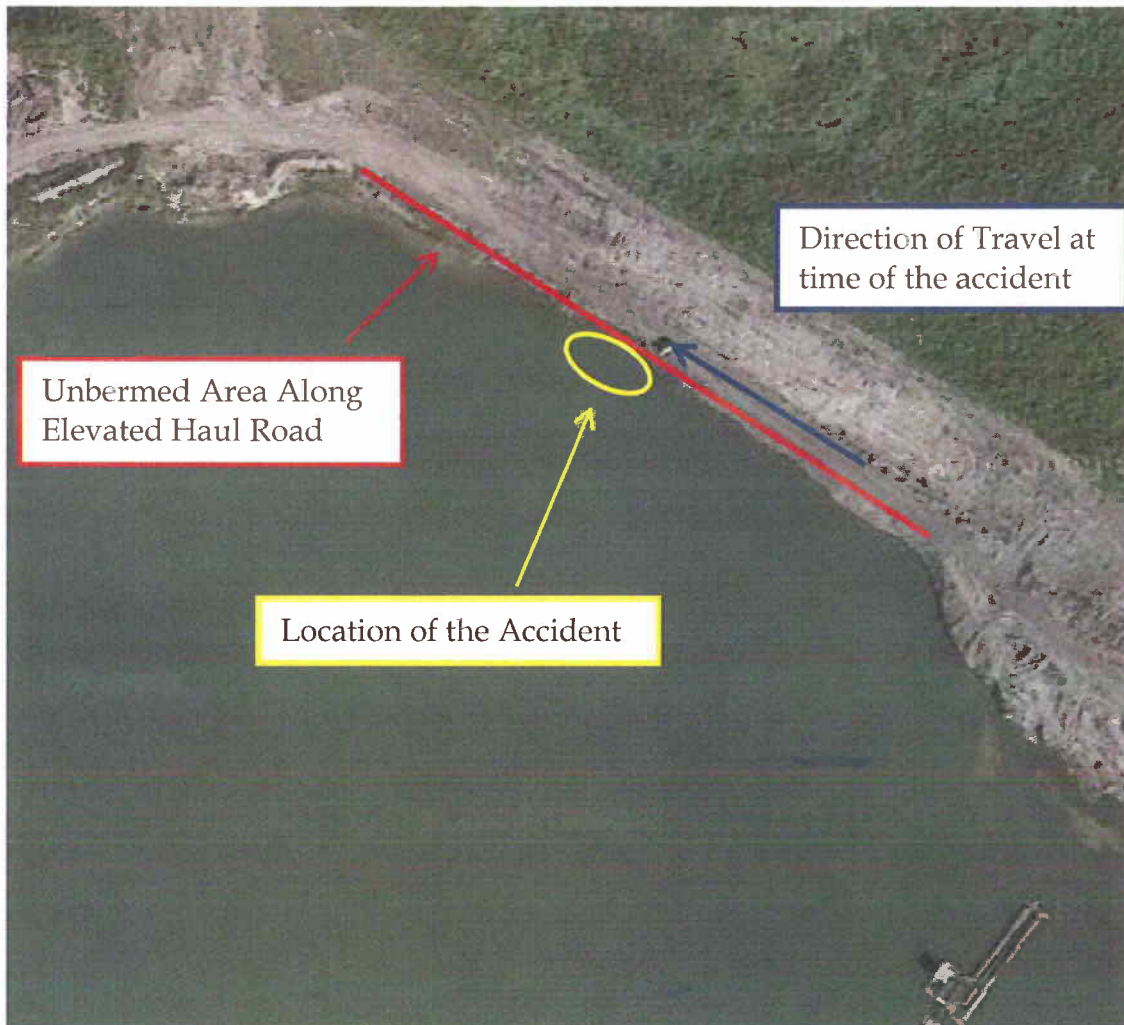
FIGURE 1 - Schematic of the Accident Location

The accident took place on the east side of the Ulrich Pit's dredge pond in the Wetland Project Area. The haul road had been recently established along the elevated embankment. The elevated haul road was approximately 19.5 feet wide and 850 feet long from the load-out to the stockpile. The haul road was located 270 yards across the dredge pond from the tipple.

The elevated haul road consisted of packed dirt and ran adjacent to a pond. At the location of the accident, the pond had a 6 foot depth but the depth increased to approximately 45 feet near the center of the pond. Berms were not provided for a distance of approximately 384 feet along the elevated haul road.

Corrective Action: Management constructed adequate berms where the roadway hazardous drop-off existed.
