REPORT OF INVESTIGATION

Surface Nonmetal Mine  
(Sand and Gravel)

Fatal Falling, Rolling or Sliding Rock/Material Accident  
June 30, 2015

P. A. Landers Inc.  
CEC #4  
Plymouth, Plymouth County, Massachusetts  
Mine I.D. No. 19-01128

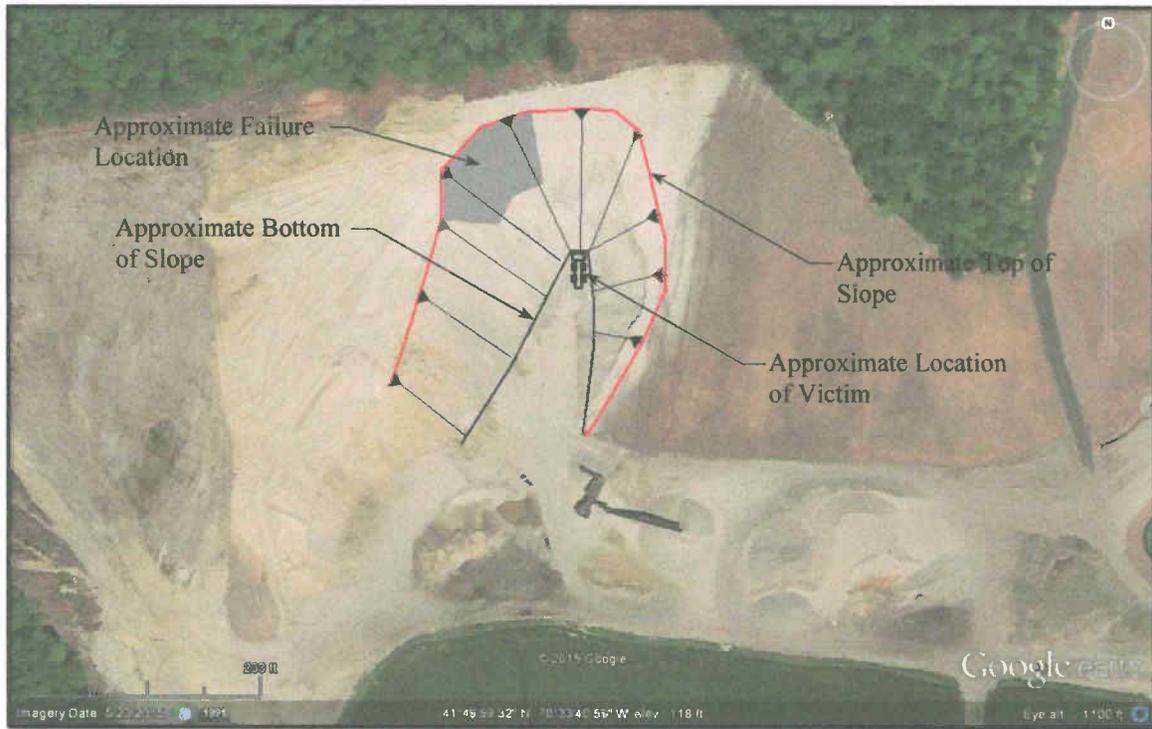
**Figure 1 - Plan view sketch of Pit 46 mining area (a portion of Phase 4)**

The work area included an excavation into the sand bank, the portable screening plant and stacker conveyor area, and the stockpile and loadout areas. The excavation into the sand bank was v-shaped with an entrance about 120 feet wide near the toe of the reclaimed slope and narrowing to the north. At about 120 feet into the v-shaped excavation, the pit was about 35 feet wide. The v-shaped excavation was approximately 170 feet deep from the entrance. About a month prior to the accident, the excavation was about 130 feet deep from the entrance.

At the time of the accident, the victim was operating a front-end loader on the pit bottom, excavating material from the base of the sand bank. The front-end loader was facing north and was reportedly backing up when the failure occurred. The failure occurred near the top of the slope in the northwest corner of the excavation (see Figure 1). The failed material slid in a southeasterly direction and covered the loader. Sand and gravel broke through the windshield and engulfed the victim.

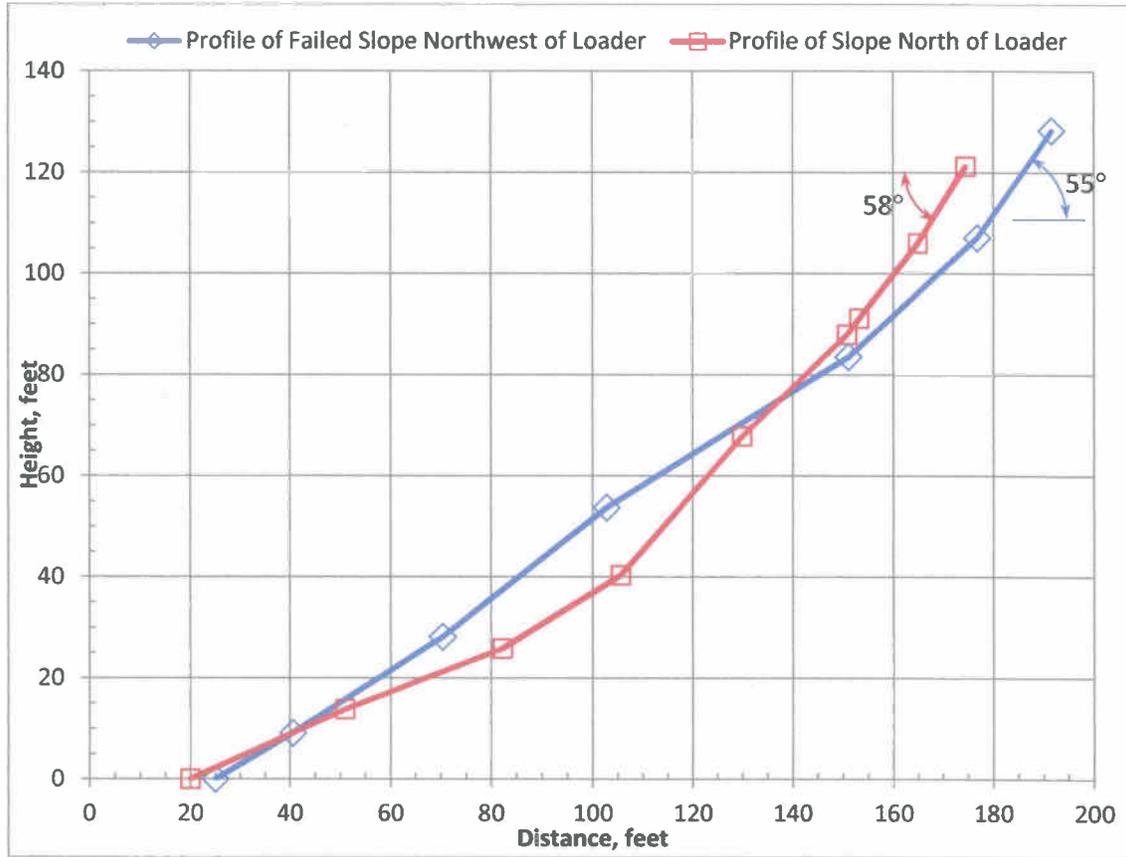
Figure 2 - Approximate profiles of sand bank slopes adjacent to the front-end loader

At the north end of the excavation, the slope was about 120 feet high and had an overall inclination of about 41 degrees from horizontal. However, the upper 80 feet was steeper than 44 degrees and the top 15 feet of the slope had an inclination of about 58 degrees from horizontal (see Figure 2).

Post-failure measurements determined that the slope in the northwest corner was about 128 feet high and had an overall inclination of about 40 degrees from horizontal. The top 45 feet of the failed slope had an average inclination of about 48 degrees and the top 21 feet had an inclination of about 55 degrees from horizontal.

At its natural moisture, this material has an apparent cohesion, which is moisture sensitive. As the material is exposed to the air and sun it loses some of its natural moisture, loses its cohesive strength and sloughs off. The material being mined was mostly sand with an angle of repose of about 33 degrees. However, the slope in natural material above the loose material was steeper than 33 degrees. The average inclination of the slope in natural material was 48 degrees or more and the slopes near the top of the bank were measured to be up to 58 degrees from horizontal.

The operator was relying upon the process of natural and excavation induced failures to feed material to the pit bottom. However, prolonged excavation at the toe of the sand bank created an oversteepened slope above the front-end loader. The height of the oversteepened slope above the pit bottom was also excessive and unsafe to work below. The great height of the sand bank contributed to the instability, and worsened the hazard by increasing the potential volume of material that could fail and the energy it had in falling. Rainfall likely contributed to the instability and triggered the failure event by increasing the weight of the material. The additional moisture infiltrating the natural material may have also contributed by reducing the apparent cohesion. The excavation into the toe of the slope was also a triggering event for the failure.

**Corrective Action:** Management established and implemented new policies and procedures to reclaim the existing phase 4 excavation (accident area). In addition, new policies and procedures were made to address future excavations at the mine. These new policies and procedures utilize bulldozers to push material down the slope toward the face of the excavation while maintaining a uniform slope gradient of 2.5:1 to 3:1. Future excavations will have a minimum working width of 300 feet, sloped on all three sides. The slope gradients will be monitored on a daily basis. Material pushed down the slope will be windrowed or stockpiled and will be loaded and transported to the screening plant. All mobile equipment operators were trained in these new policies and procedures.
