REPORT OF INVESTIGATION

**Surface Nonmetal Plant
Kaolin Clay**

**Fatal Other Accident
July 15, 2015**

**CVB Industrial Contracting, Inc.
Contractor ID No. 5BR
At
Main Processing Plant
Thiele Kaolin Company
Sandersville, Washington County, Georgia
Mine ID No. 09-00337**

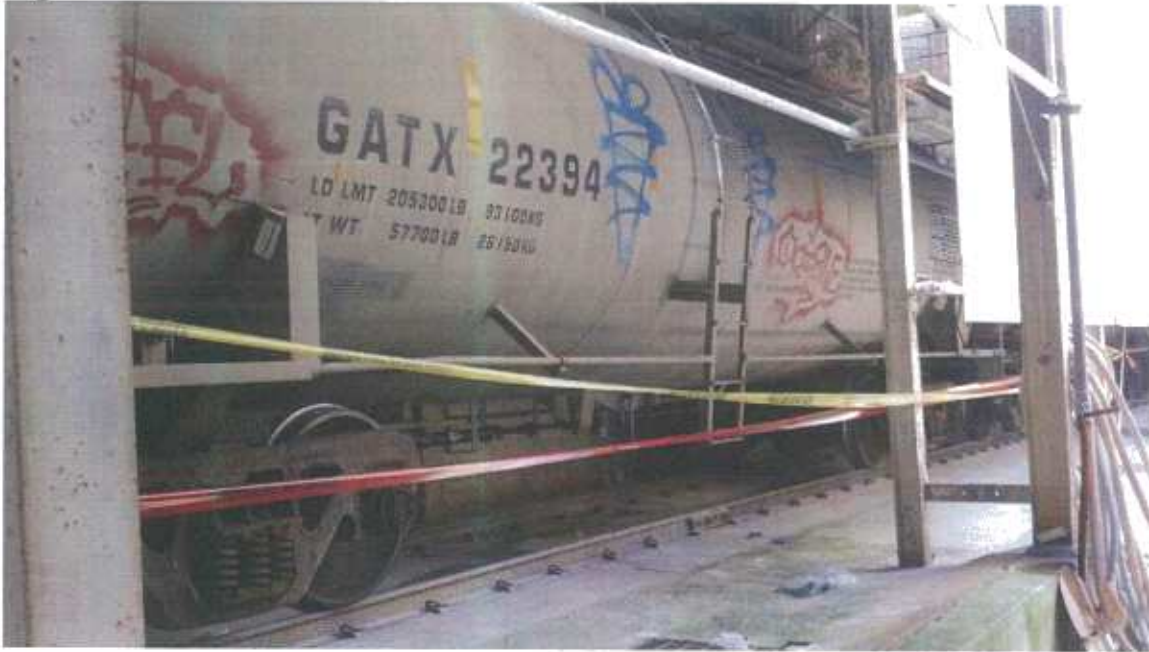
Figure A1. Victim's Railcar

The victim was preparing to wash residual slurry product out of Railcar GATX 22394, his first railcar of the day. The victim entered the railcar through the manway and climbed approximately 10 feet down an access ladder. The victim

was later found unresponsive at the bottom of the car (Appendix A, Figures A1-A4). As shown in Figures A3 and A4, the victim's railcar did not contain much residual product upon its return to Thiele.

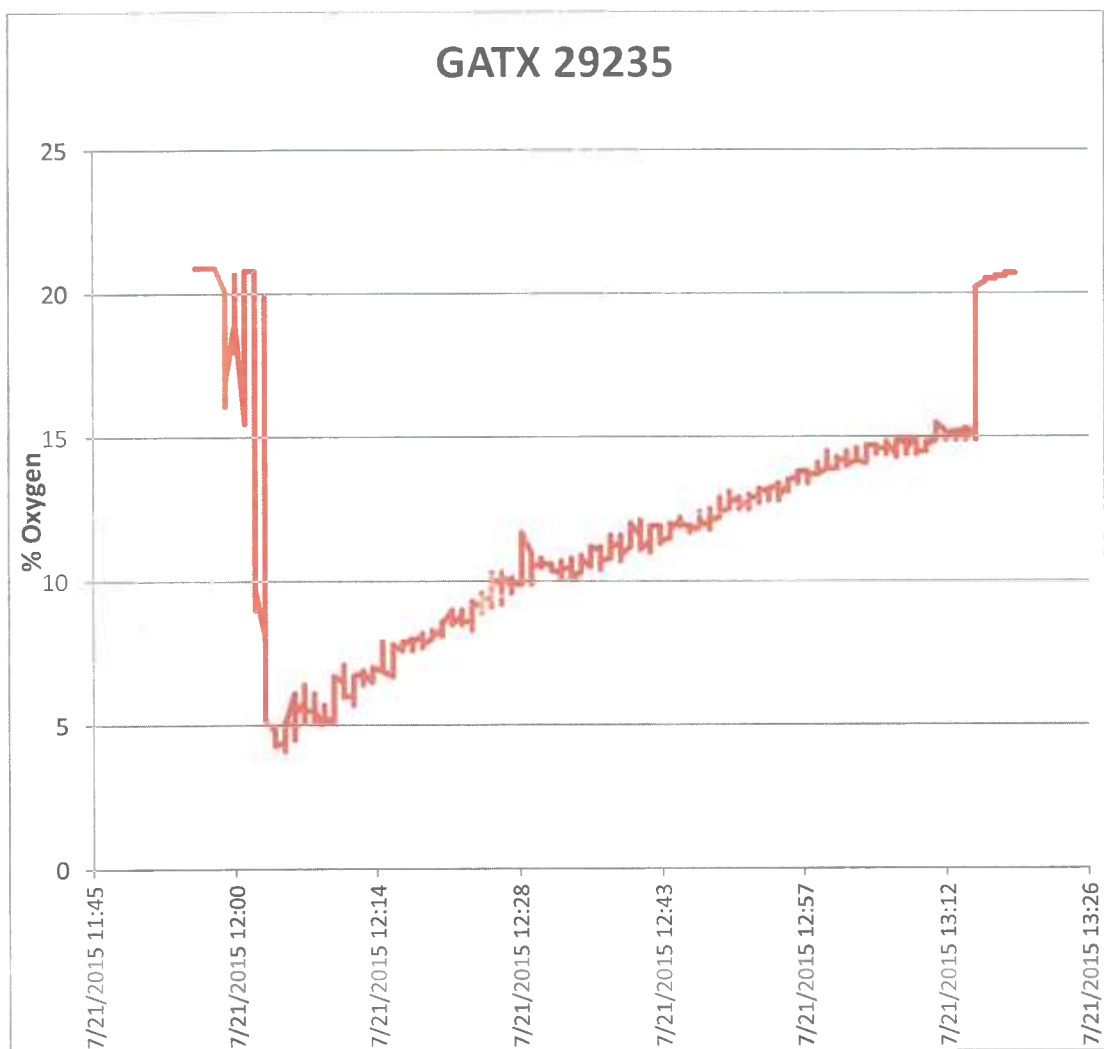
Figure B1. Railcar GATX 29235 Atmosphere with iBRID SN 001 - 7/21/15

On July 21, MSHA detected an oxygen-deficient environment inside of railcar GATX 29235 immediately upon opening the manway using an iBRID and a Thiele RKI GX-2009 monitor. The oxygen concentration ranged from 4-5% after the sampling line was dropped into the bottom of the car around 12:03 p.m. The sample line remained inside of the railcar until approximately 13:15 p.m., at which time the oxygen concentration was approximately 15% (Appendix B, Figure B1). Gas chromatography analysis of two air samples collected from the railcar confirmed a low oxygen and high nitrogen atmosphere inside the railcar. The first bag sample was collected at 12:35 p.m. and had an oxygen concentration of 14.8% and a nitrogen concentration of 84.2% (Table 4). The average WBGT was 92.3°F inside of railcar GATX 29235. Note: The average temperature on July 21, 2015, was 87°F. The average temperature on July 15, 2015, was 83.1°F.

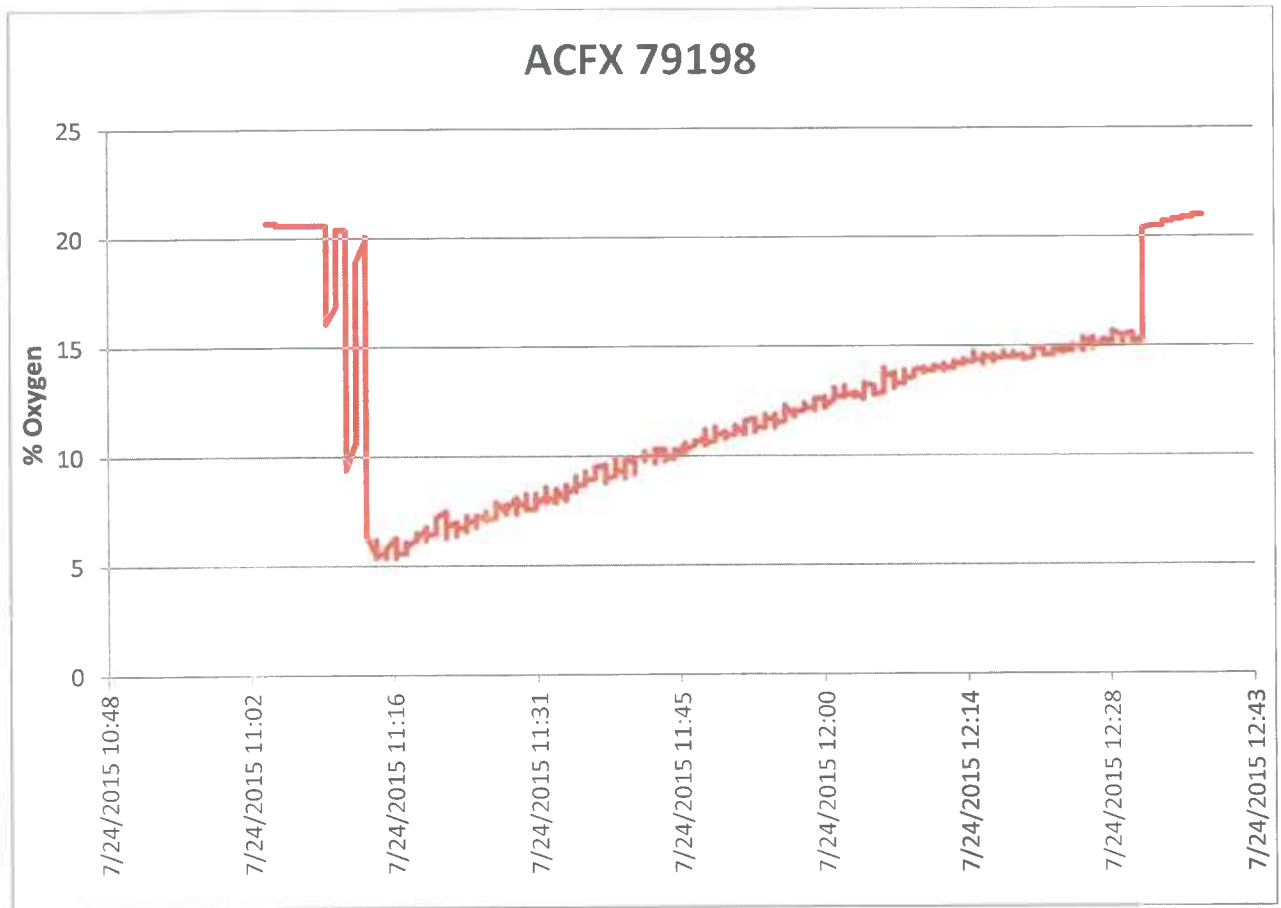
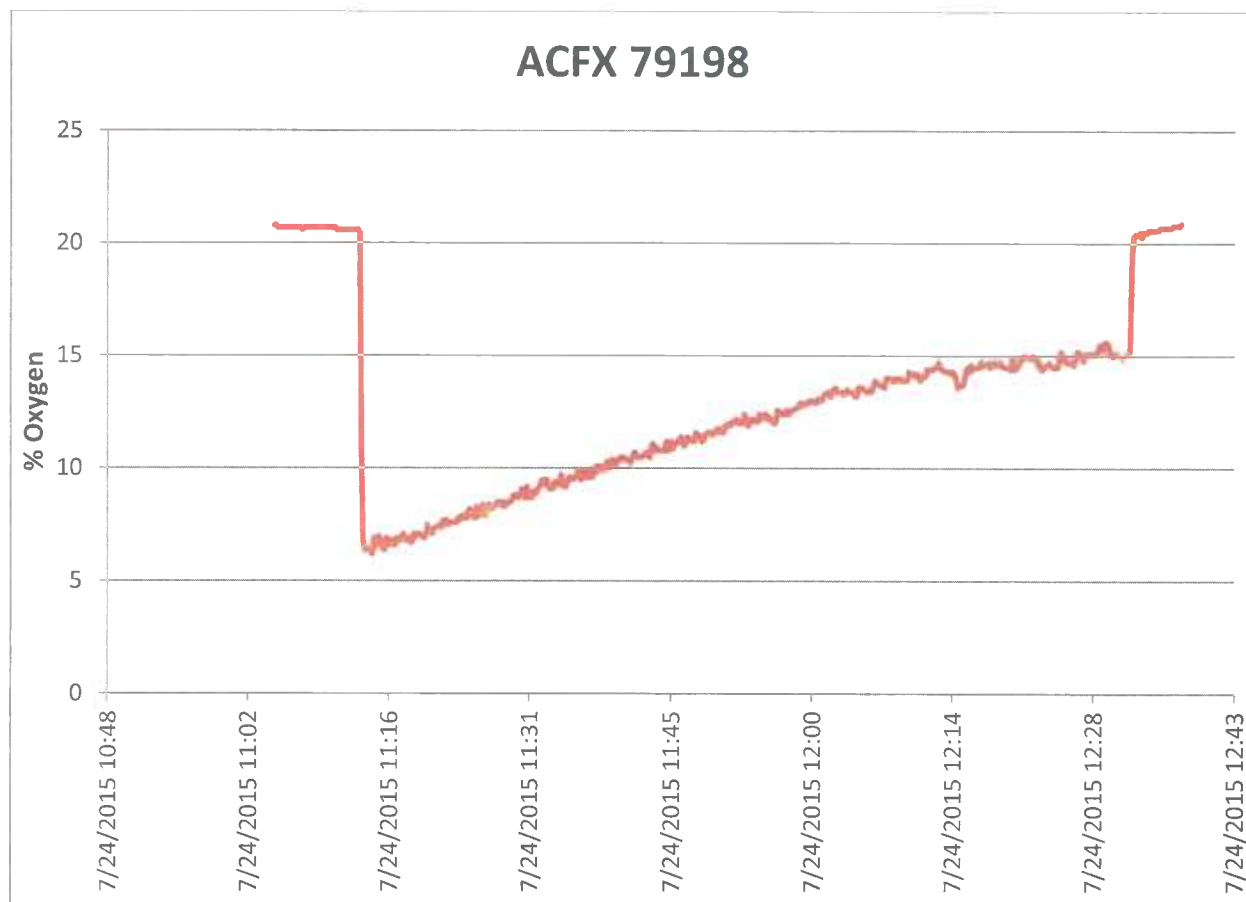
On July 24, monitoring was conducted inside railcar ACFX 79198. Immediately upon opening the manway, an oxygen-deficient environment was detected on two different iBRIDs and a Thiele RKI GX-2009 monitor. The oxygen concentration in the car ranged from 6-7% at 11:14 a.m. to 15% at 12:32 p.m.

(Appendix B, Figures B2 and B3). Gas chromatography analysis of four air samples collected from the railcar confirmed a low oxygen, high nitrogen atmosphere inside of the railcar. The first bag sample was collected at 11:22 a.m. and had an oxygen concentration of 7.8% and a nitrogen concentration of 91.2% (Table 4).

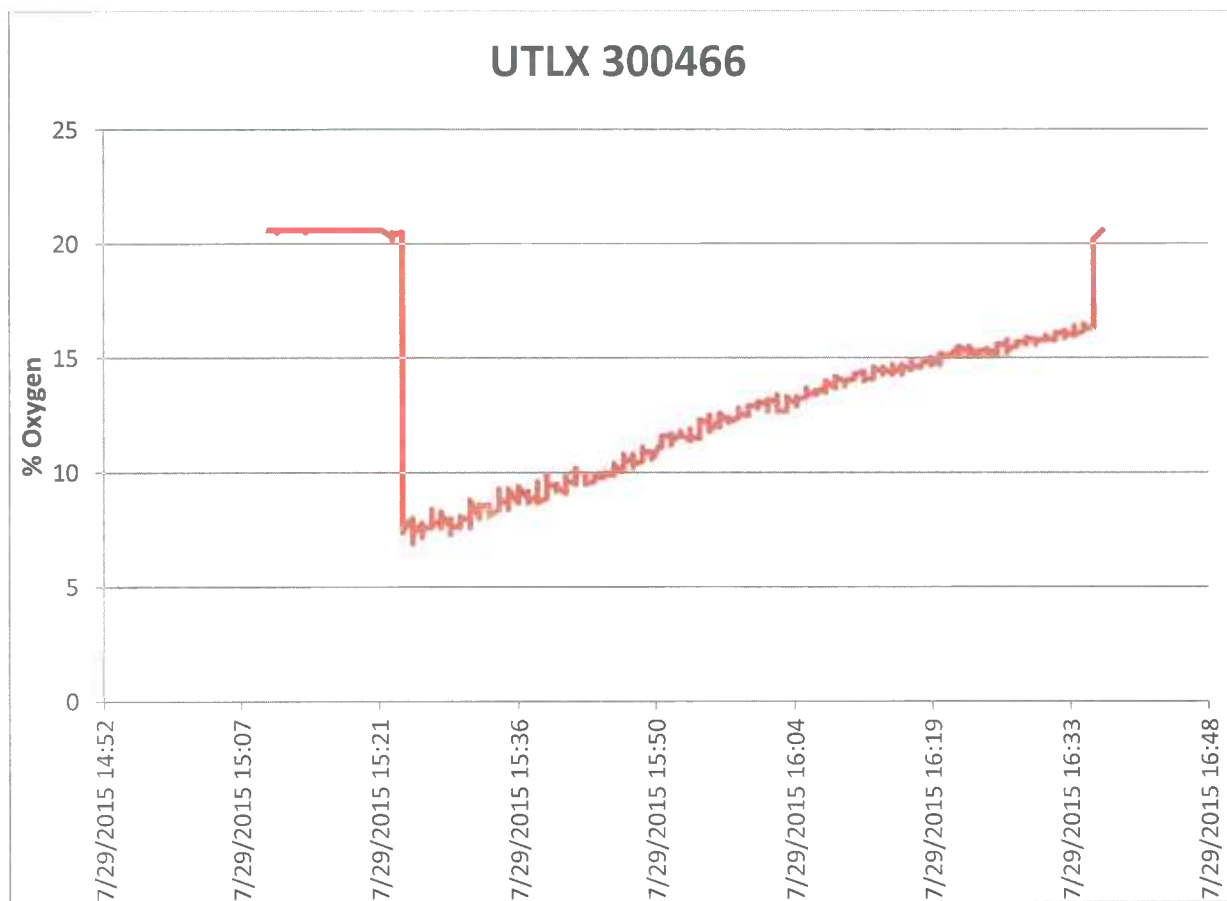
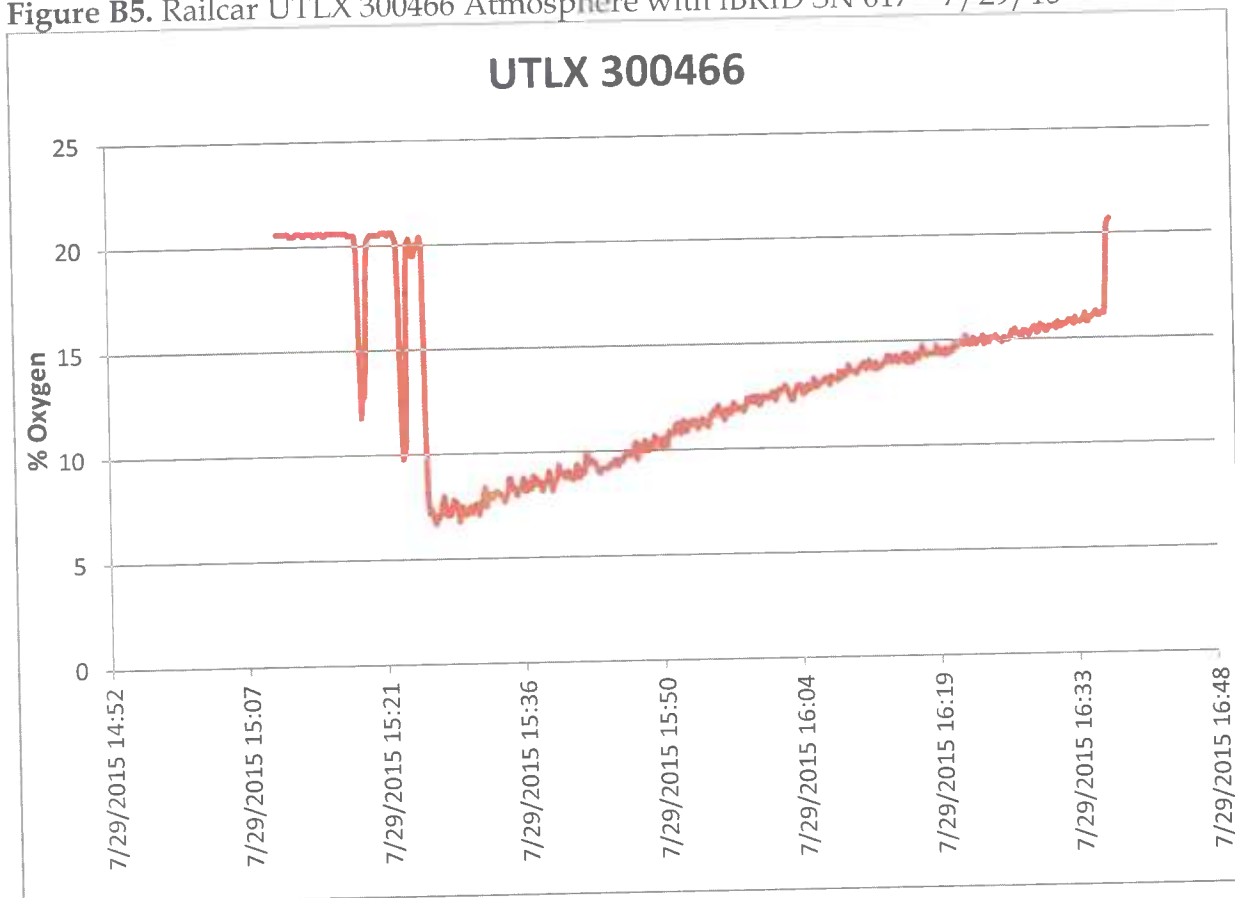
On July 29, atmospheric monitoring was conducted inside railcar UTLX 300466. Immediately upon opening the manway, an oxygen-deficient environment was detected on two iBRID monitors and on a Thiele MSA Altair multi-gas monitor. The oxygen concentration in the car ranged from 7-8% at 15:24 to 16-17% at 16:36 on two different iBRID monitors (Appendix B, Figures B4 and B5). Gas chromatography analysis of six air samples collected from the railcar confirmed a low oxygen, high nitrogen atmosphere inside of the railcar. An air sample was collected in a bottle at the manway when it was opened at 15:22. The sample had an oxygen concentration of 10.9% and a nitrogen concentration of 88.0%. The first bag sample was collected inside of the car at 15:42 and had an oxygen concentration of 9.8% and a nitrogen concentration of 89.1% (Table 4).

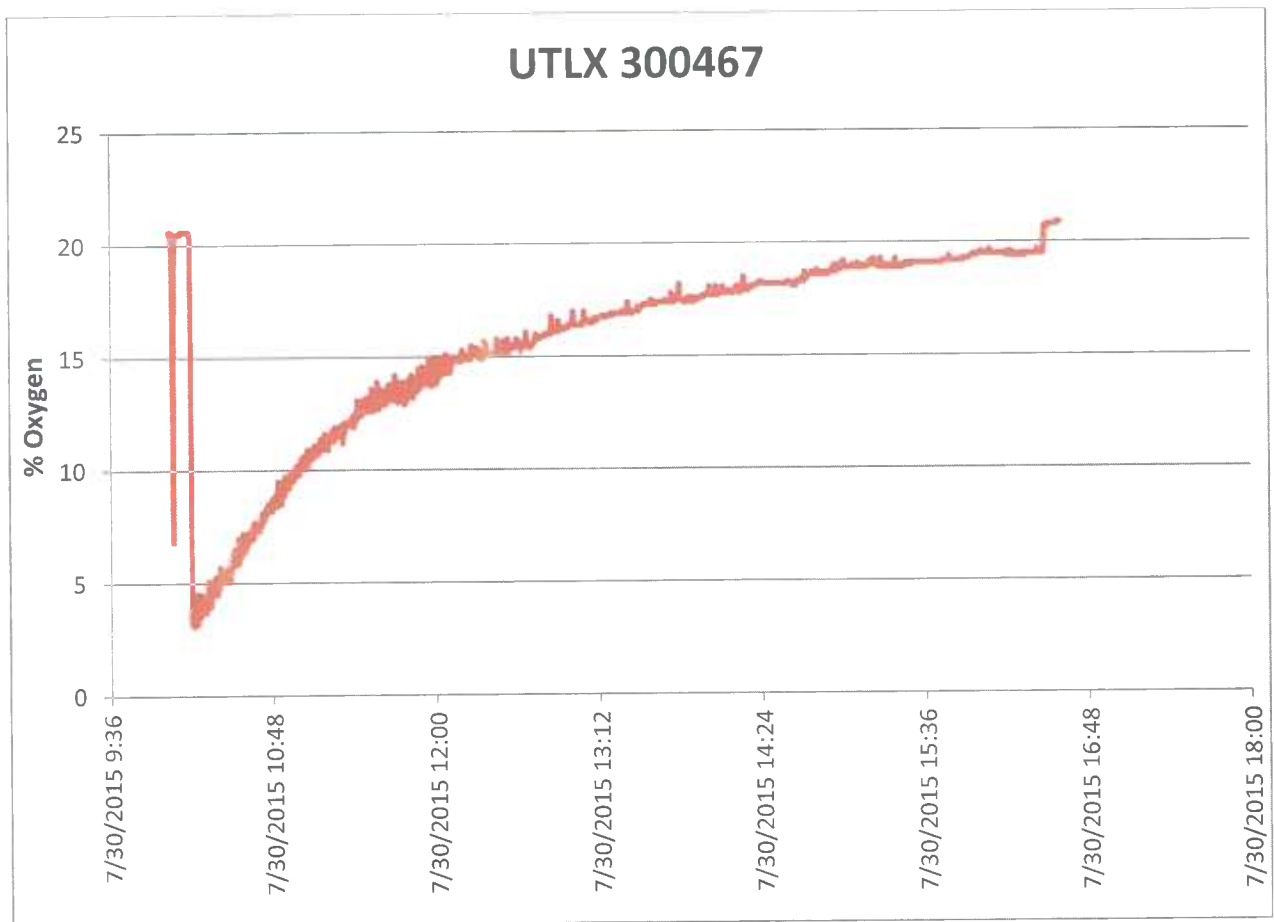
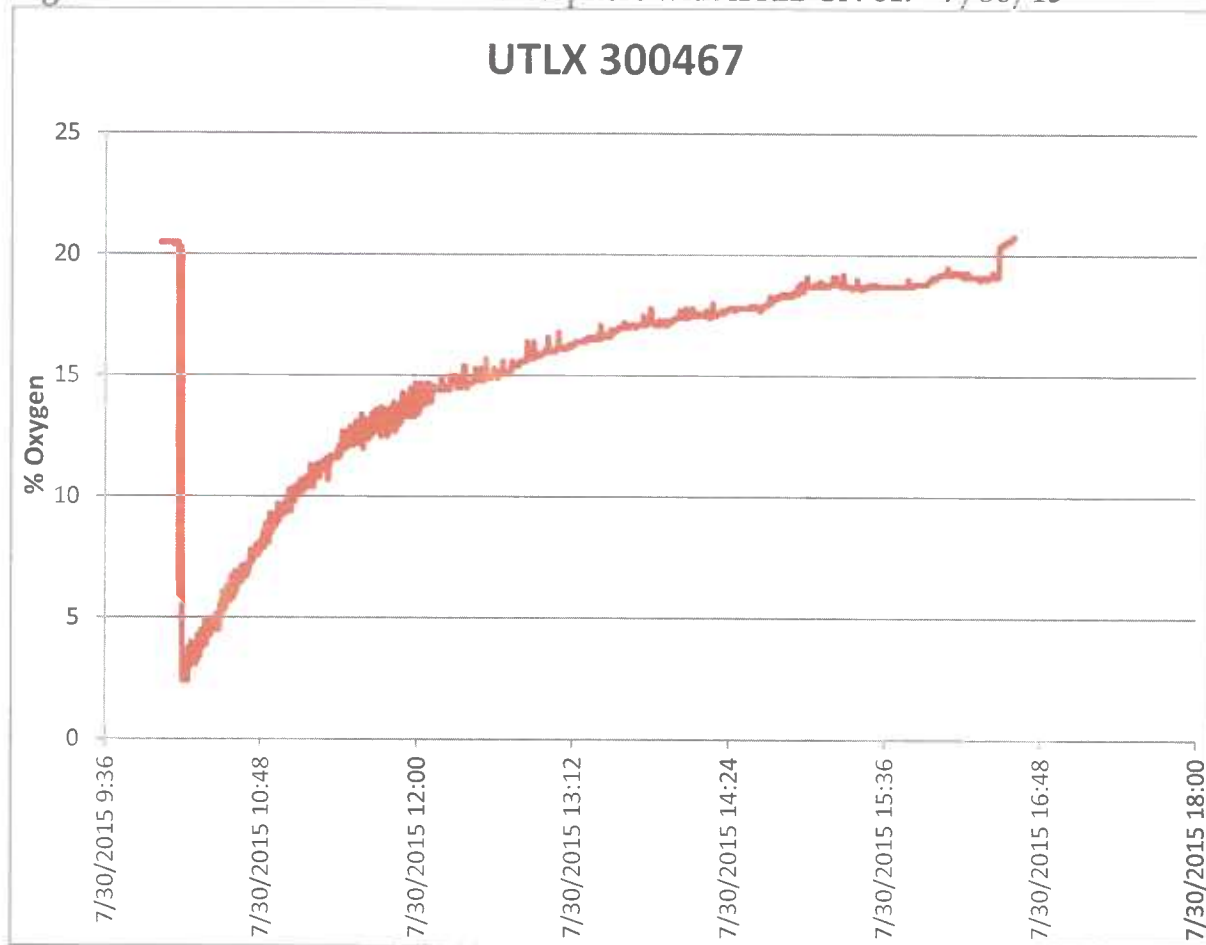
On July 30, atmospheric monitoring was conducted inside railcar UTLX 300467. Immediately upon opening the manway cover, an oxygen-deficient environment was detected on an iBRID monitor and a Thiele MSA Altair monitor. The oxygen concentration ranged from 3% at 10:11 a.m. to 20% at 16:28 (Appendix B, Figures B6 and B7). Gas chromatography analysis of nine air samples collected from the railcar confirmed a low oxygen, high nitrogen atmosphere inside the railcar. An air sample was collected in a bottle at the manway when it was opened at 10:10 a.m. The sample had an oxygen concentration of 3.3% and a nitrogen concentration of 95.6%. The first bag sample was collected inside of the car at 10:25 a.m. and had an oxygen concentration of 4.6% and a nitrogen concentration of 94.5%.

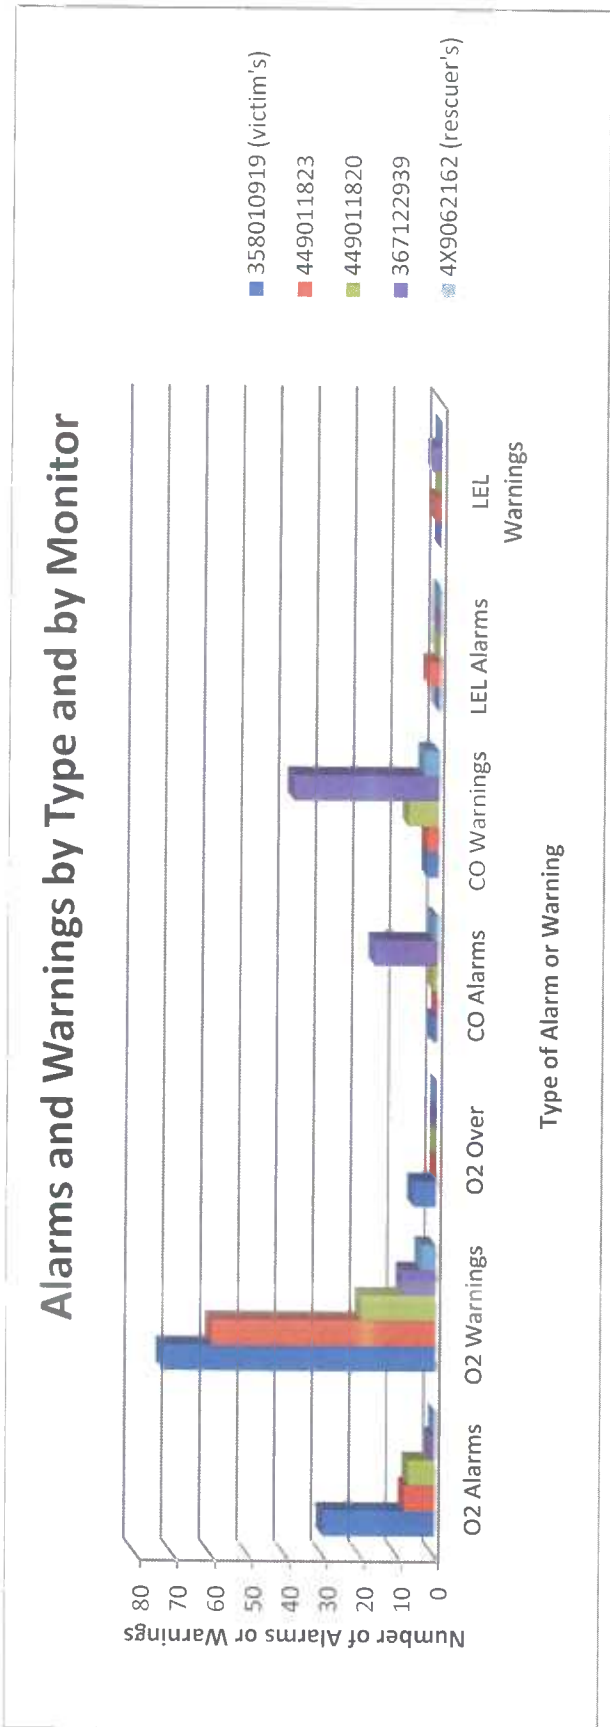
Figure C1. Total Number of Alarms and Warnings by Monitor Serial Number and Sensor Type

monitor had the highest number of alarms and warnings. Oxygen warnings (<19.5%) were the most prevalent. A significant number of oxygen alarms (>23.5%) were also observed which indicates that the monitor was improperly zeroed in contaminated air that contained less than 20.9% oxygen.

The total number of alarm and warning events recorded on each monitor is shown in Figure C1. The highest number of alarms and warnings were recorded on the victim's monitor. The victim's monitor recorded 71 low oxygen warnings and 28 low oxygen alarms from 8/15/13 to 7/21/15. Additionally, five high oxygen alarms above 23.5% were recorded. The victim's monitor was not turned on the day of the accident. The monitor was last operated on 7/6/15, at which time an oxygen sensor failure occurred. There was no log found in the monitor's history indicating that the oxygen sensor had been replaced following this event.
