REPORT OF INVESTIGATION

Surface Nonmetal Mine  
(Sand and Gravel)

Machinery Accident  
July 10, 2015

Hanson Aggregates Midwest, LLC  
Dry Fork Sand & Gravel  
Cleves, Hamilton County, Ohio  
Mine I.D. No. 33-04460

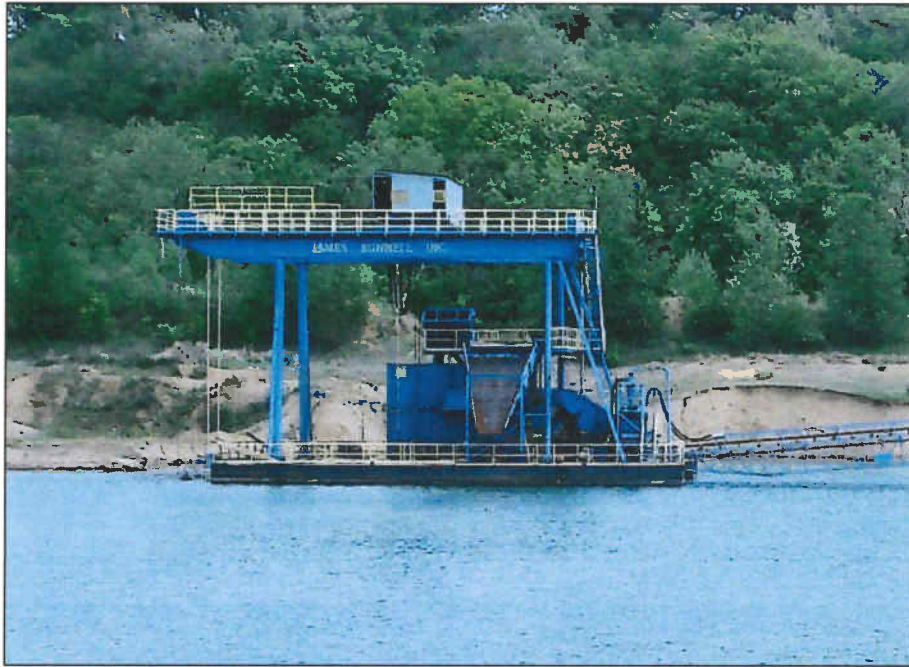
The Rohr Model RS 6.0 200 Bfg floating sand dredge was built in 1993. It is used to mine sand and gravel from a flooded artificial pit. It is equipped with an electrohydraulic clamshell bucket operated by a gantry crane that lifts material from the pit floor and dumps it onto a grizzly screen to separate out rocks, then the material is screened for size (fines return to the lake) and sent to shore via a floating conveyor system. Figure 1 shows the dredge approximately two months before the accident.

Operations of the dredge are controlled from the raised, enclosed, operator's compartment. It is visible in Figure 1 on top of the two conex (blue shipping containers). Once in position, the dredge can be run manually or in a fully automated mode controlled by the onboard Programmable Logic Controller (PLC). The lower conex was used for equipment storage and also contained a hydraulic power unit. The upper conex contained four cabinets of electronic

**Figure 1 - Dredge prior to the accident in Spring 2015.  
(Photo provided by the Ohio Department of Natural Resources)**

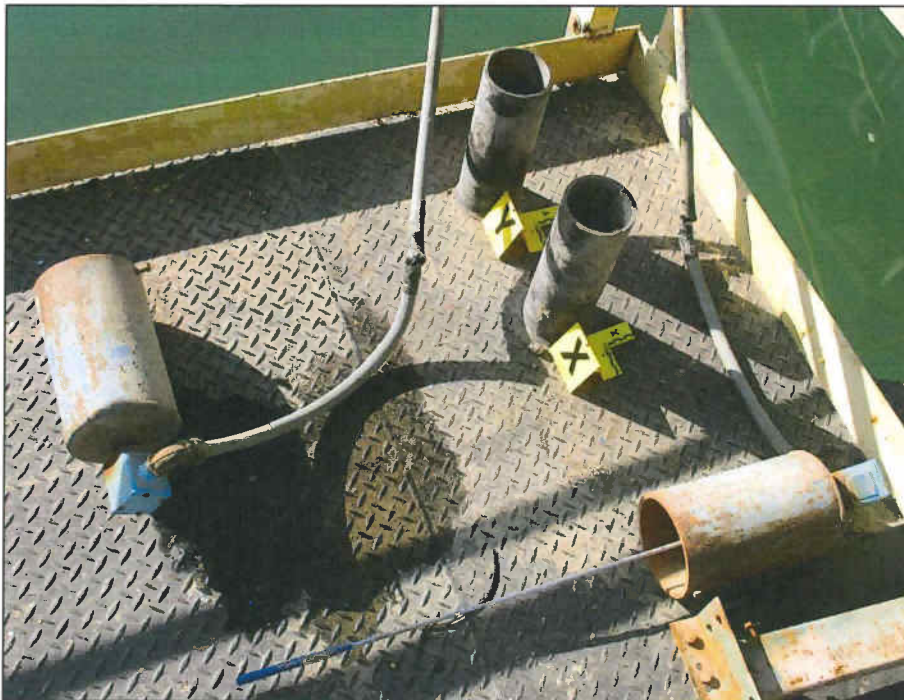
There are five sensors (Warrick Controls, Model 3E1A) located on the dredge to monitor water levels. The manual refers to these as overload sensors. There is one sensor located at each of the back corners of the dredge, three sensors on the front of the dredge, one sensor to the right of the conveyor and two sensors to the left. Each sensor is mounted on a section of pipe attached to the deck that extends through the bottom of the dredge so that it can measure freeboard. Three of the sensors had a 36 3/8 inch rod attached to a pipe about 10 inches above the deck of the dredge. The dredge operators would start measuring water levels when the dredge freeboard dropped to about 26 inches. A fourth sensor had a shorter 31 3/4 inch rod attached; it would only measure freeboard of 21 inches or less. Additionally, this rod was wrapped for about 5 inches with electrical tape. The fifth sensor was missing its rod. The readings from both the fourth and fifth sensors would have been impaired. It is unknown how the readings from these overload sensors was processed by the PLC. There is an overload light in the operator's compartment and it was known by the crew that if the sensors were triggered, power to the dredge would be interrupted. The overload sensors were mounted to pipe sections mounted to the deck with a bolt that acted as a set screw to hold the sensors in place. Figure 2 shows the two overload sensors located to the left side of the conveyor, including their mounting pipes.

From witness statements, the overload switches were removed from their mountings and laid on deck to avoid shutting down electrical power to the dredge when the freeboard was reduced while flooding the compartments. When water started coming over the deck, the overload switches likely tripped the main winch (hoist) circuit breaker. This breaker was located in the

**Figure 2 - Overload sensors and mounting pipes. Note the missing rod on one sensor and the electrical tape on the other sensor. The fastening bolt is visible at the base of the left hand mounting pipe section.**

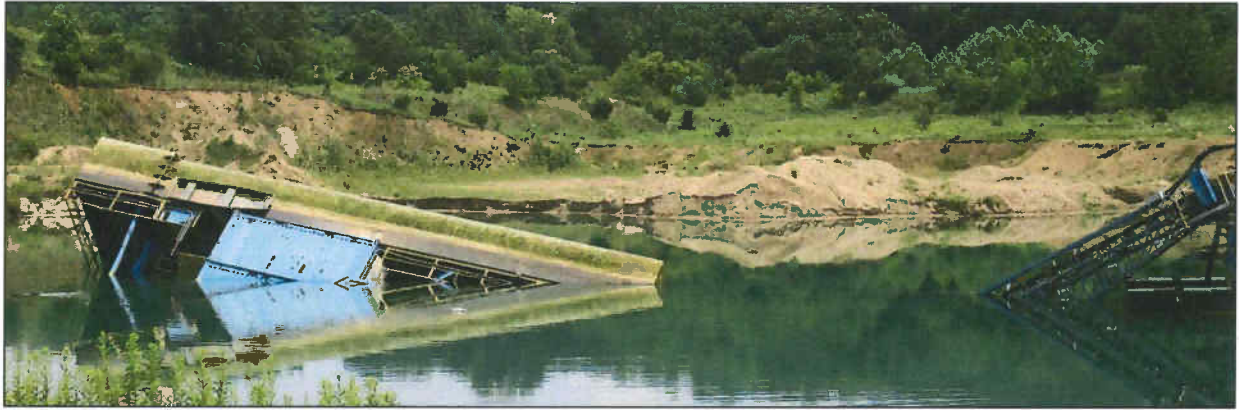
After the accident, the dredge was on its side in the lake with the rear left corner still above water. Figure 3 shows the dredge on July 11, 2015, one day after the accident. Note that the dredge settled further into the water that night.

**Figure 3 - Dredge in the water at the beginning of the investigation.**

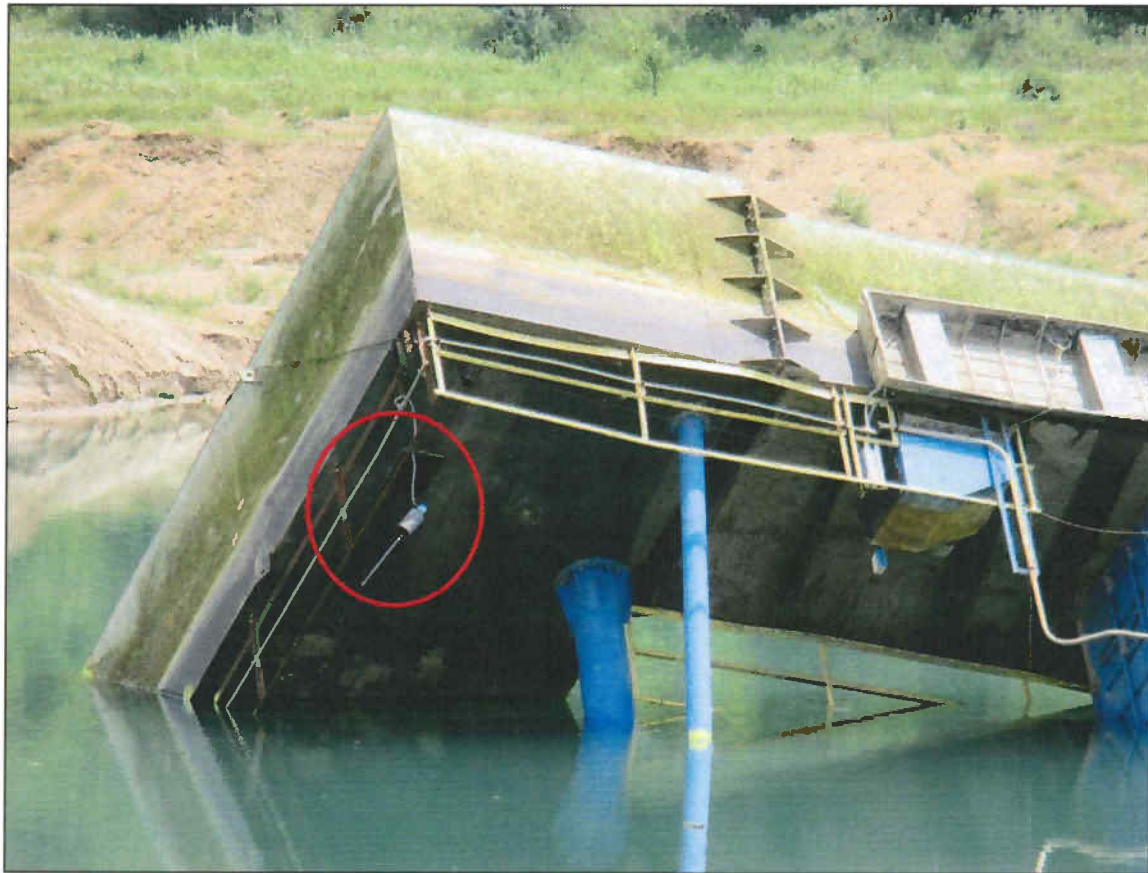
According to divers who examined the wreckage, the conveyor system was still attached to the dredge. The cable to the bucket was also attached to the dredge and was under tension. The trolley house fell off the dredge during the accident and was recovered separately. Figure 4 is a closer picture showing one of the missing hatch covers and a hanging overload sensor.

**Figure 4 - Dredge in water. Note missing hatch cover and hanging overload sensor.**
