MAI-2015-13

REPORT OF INVESTIGATION

Fatal Falling Material Accident
August 3, 2015

Pinky's Aggregates Inc.
Pinky's Aggregates Inc.
New Town, Rolette County, North Dakota
Mine ID No. 32-00909

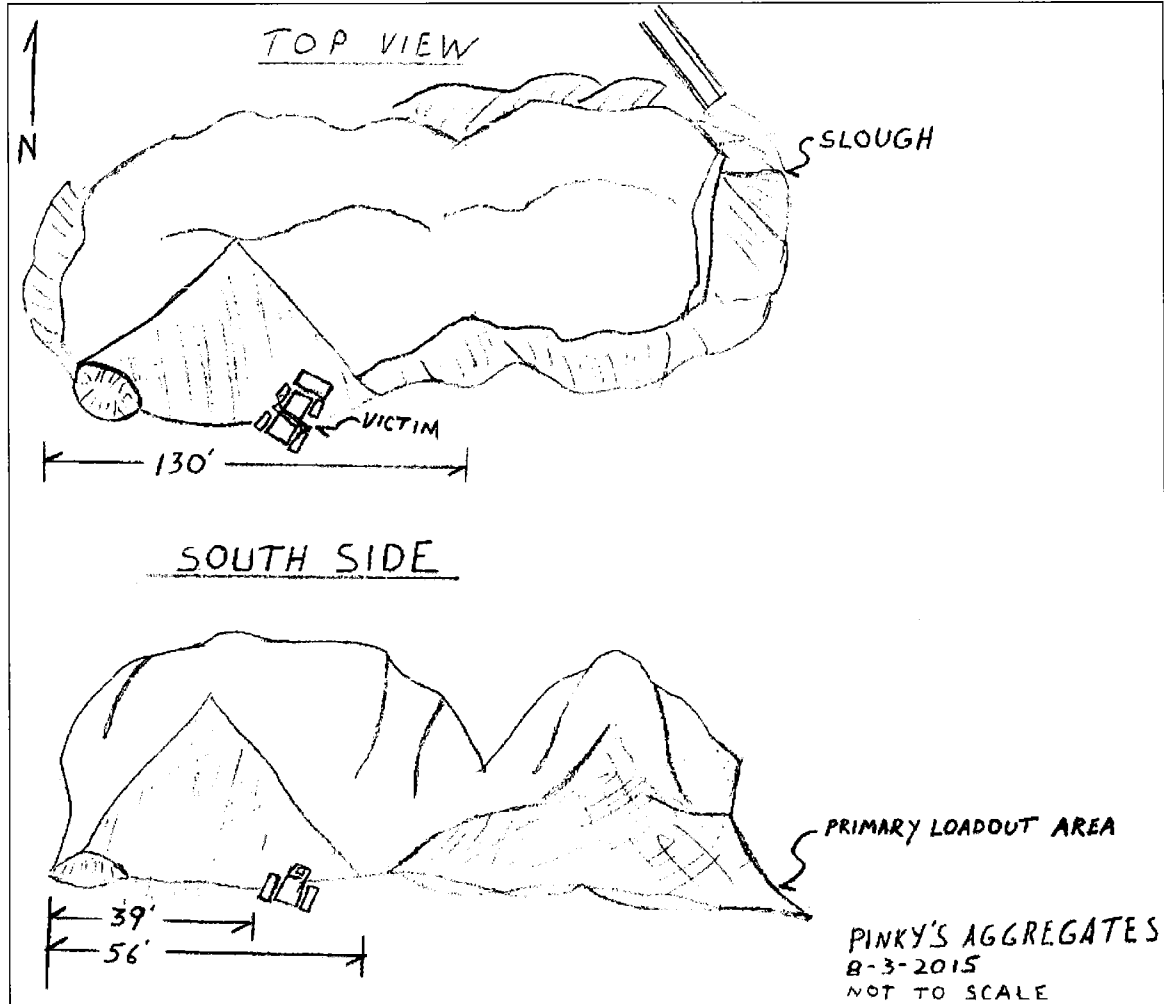
Figure 1 - Schematic of the Stockpile and Victim's Location

The accident occurred on the south face of the stockpile which was measured to be 39 feet high. The slope failure extended the full height of the pile and was 90 feet wide at the bottom, displacing an estimated 400 cubic yards of material. The slope failure occurred directly adjacent to the loader, and the fallen material partially covered the front and left side of the loader resulting in six feet of material at the front of the loader and four feet at the side of the loader where the victim was located. An estimated 15 cubic yards of fallen material adjacent to the victim had been removed during the rescue efforts.

At the time of the accident, the front end loader was located at the toe of the stockpile and oriented at a 60 degree angle to the working face. The bucket was in the lowered position and engaged into the pile. The transmission was in park and the left side cab door was open.

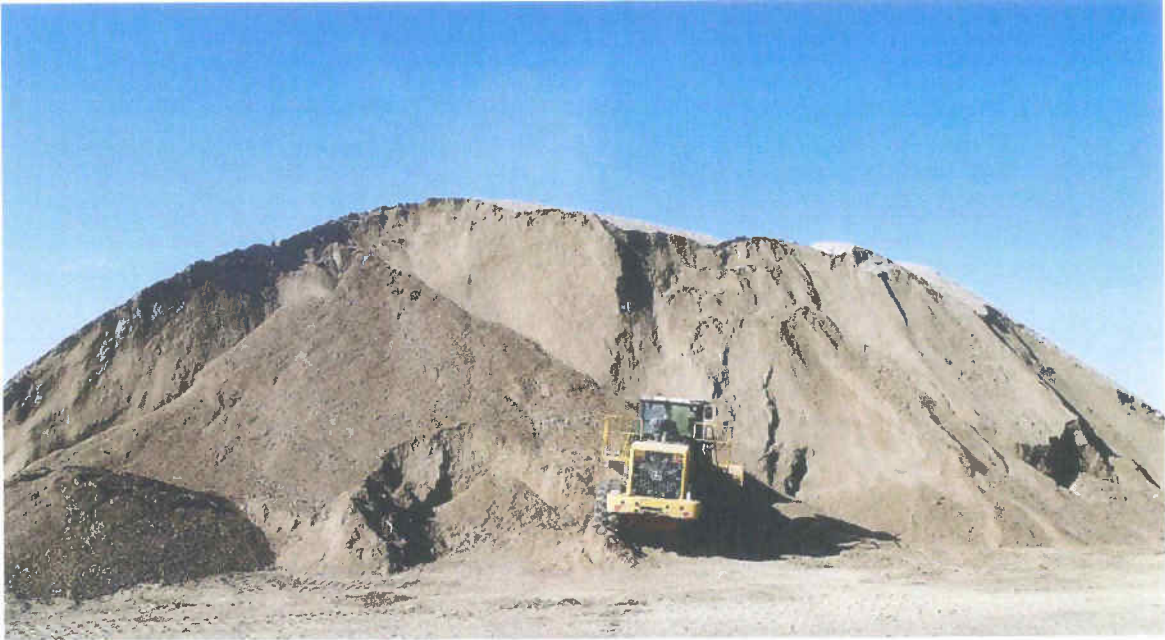
Figure 2 - Stockpile and Slide

Large cracks on the surface of the stockpile, areas of material separation and previous sloughing of material were evident on all sides of the stockpile.

Root Cause: Management failed to correct the hazardous stockpile ground conditions. The stockpile was constructed 39 feet high, and the slope was greater than the angle of repose despite not having equipment able to safely trim the pile to the angle of repose. The stockpile ground conditions created a fall of material hazard from a lack of trimming or maintenance.

Corrective action: The stockpile was trimmed to the angle of repose. Management retrained miners in identifying and controlling areas of the stockpile where hazardous slips can occur. Additionally, a Standard Operating Procedure was adopted that load out is only allowed when equipment is on site that is able to trim the 35 foot high stockpile to the angle of repose.
