REPORT OF INVESTIGATION

**Underground Metal Mine
(Gold)**

**Fatal Machinery Accident
August 3, 2015**

**Small Mine Development L.L.C.
Elko, Elko County, Nevada
Mine ID No. 26-02299**

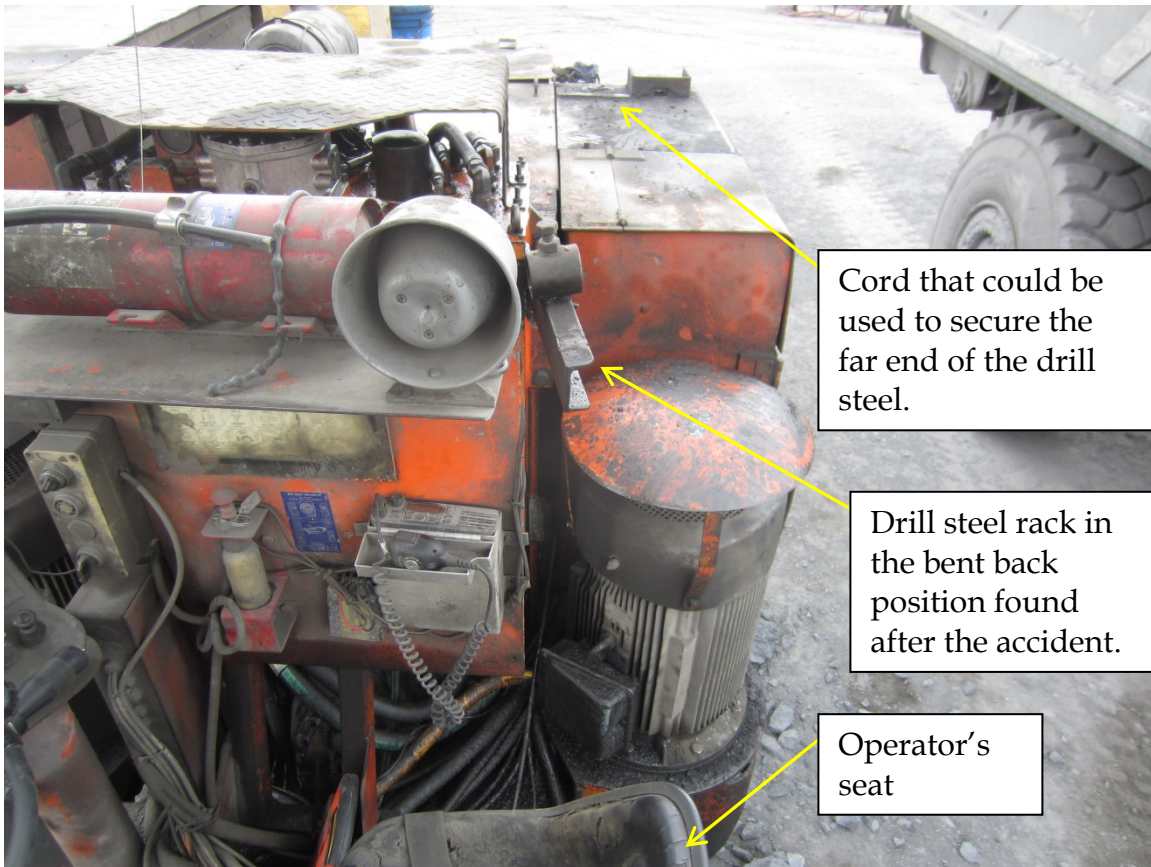
Photo 1 – Drill Steel Rack

DRILL STEEL CARRIER RACK: The drill steel rack shown in photo 1 was added to the engine half of the articulated machine after it left the factory. One end of the drill steel carrier rack consisted of a bracket made from a 14 inch long, 4 inch wide steel channel located 3½ feet away from the center of the operator's seat toward the engine end of the machine. This bracket was welded to the side of the hydraulic tank, near the top. Both the bracket and the operator's seat were on the left side of the machine. Two 2¾ inch outside diameter steel tubes were welded on top of the bracket, one 6 inches out and the other 12 inches out from the edge of the hydraulic tank. A set screw bolt in each tube could be threaded down to lock the drill steel in place. The outer tube being used at the time of the accident broke off and was still attached to the drill steel after the accident. The entire bracket was also bent back 90 degrees as a result of the impact. A cord on an engine cover handle 8½ feet from the center of the seat toward the engine end of the machine could be used to secure the other end of the drill steel. The cord was found to be intact and undamaged, other than fraying from wear, after the accident. One end of a 13½ foot long drill steel would extend approximately 2 ½ feet beyond the engine end of the machine when installed in the carrier rack and was at approximately the same elevation as the operator's head when seated in the operator's compartment. The other end of a 13½ foot long drill steel would extend to within approximately 3 feet of the center of the operator's seat.

Root Cause: Management's policies and procedures were inadequate and failed to ensure that persons loaded and transported materials in a safe manner. The drill steel was transported on top of the jumbo drill and was allowed to extend 2.5 feet beyond the leading edge of the drill. Additionally, the drill steel was not secured in a manner that prevented the drill steel from sliding side to side. This caused the drill steel to strike the rib and then strike the miner.

Corrective Action: Management conducted training for all persons regarding the safe loading and transporting of materials.
