**REPORT OF INVESTIGATION**

**Fatal Machinery Accident  
December 15, 2015**

**Ligori Auto Wrecking  
Contractor I.D. No. ZZZ**

**Continental Cement Company, LLC.  
Davenport Plant  
Buffalo, Scott County, Iowa  
Mine I.D. No. 13-00125**

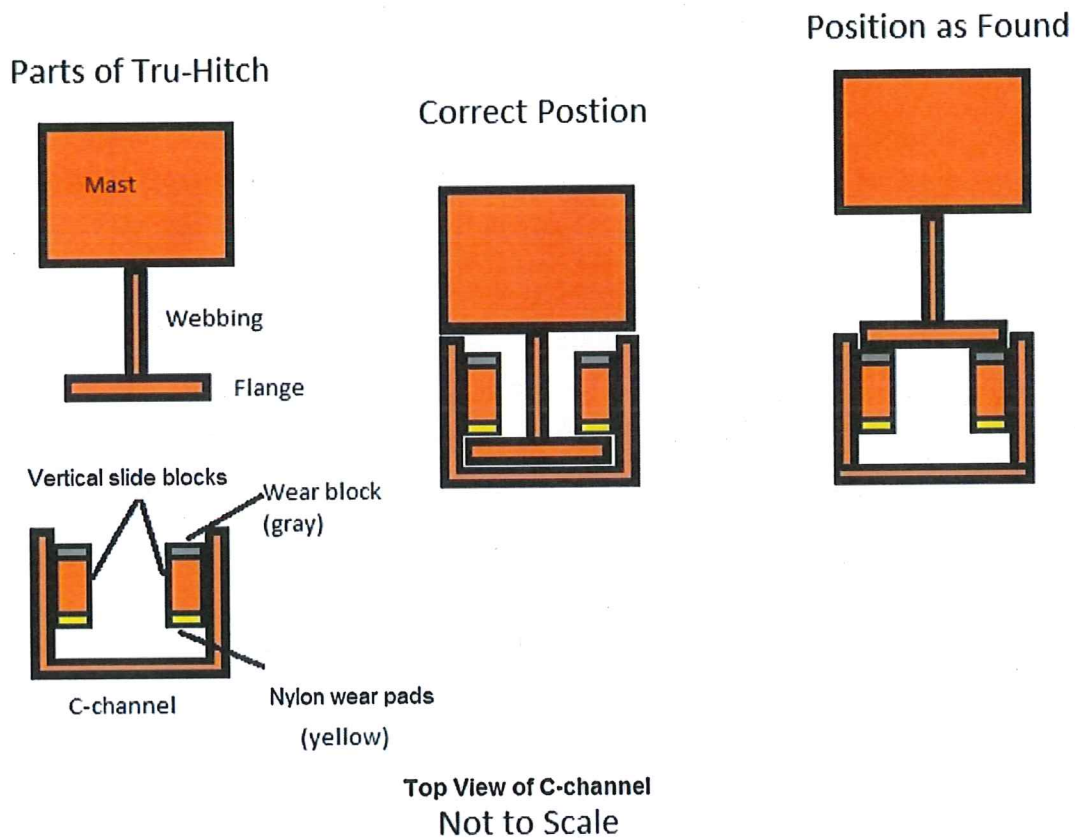
The stationary sections of the Tru-Hitch consist of triangular shaped plates that are welded to the fifth wheel frame, with a set of plates on both sides. These plates along with the fifth wheel frame form a C-channel. This C-channel contains blocks through which the I-beam webbing of the vertical slide section of the mast raises/lowers. (See figure below)

The vertical slide blocks prevent the mast from rotating about the frame once the mast is in position (see Correct Position in figure above). With the mast's I-beam flange behind the blocks, it is impossible for the mast to be outside the C-channel but for a structural failure or an error in procedural deployment.

During functionality testing, as the Tru-Hitch unit was lowered into the towing position, the nylon wear pads, attached to the rear of the vertical slide blocks, were sheared off. The investigators found that the bottom bolts on both of the vertical slide blocks on the driver's side C-channel were sheared off as well, but they were unable to determine if the damage to the bottom bolts occurred during the functionality testing or if they were damaged previously. The top bolts remained intact in the holes. Because the nylon wear pads were not attached to the vertical slide blocks, this was the only functionality test the investigation team was able to perform. The functionality test of the Tru-Hitch presented no mechanical or hydraulic defects and no unexpected movements were observed.

After the accident occurred, and prior to functional testing, the mast was found outside the C-channel and vertical slide blocks. Since the investigation did not discover any equipment defects or structural damage, and the mast was outside the vertical slide blocks, it was determined that the accident occurred as a result of improper deployment of the equipment. Ligori deployed the boom first, which caused an uneven weight distribution at the end of the mast, causing the mast and boom assembly to tip off and over its pivot point position, striking the victim with a boom arm.
