MNMF Fatal 2015-01

- Machinery
- January 8, 2015 (California)
- Sand and Gravel
- Contract Sales Manager
- 63 years old
- 11 years of experience

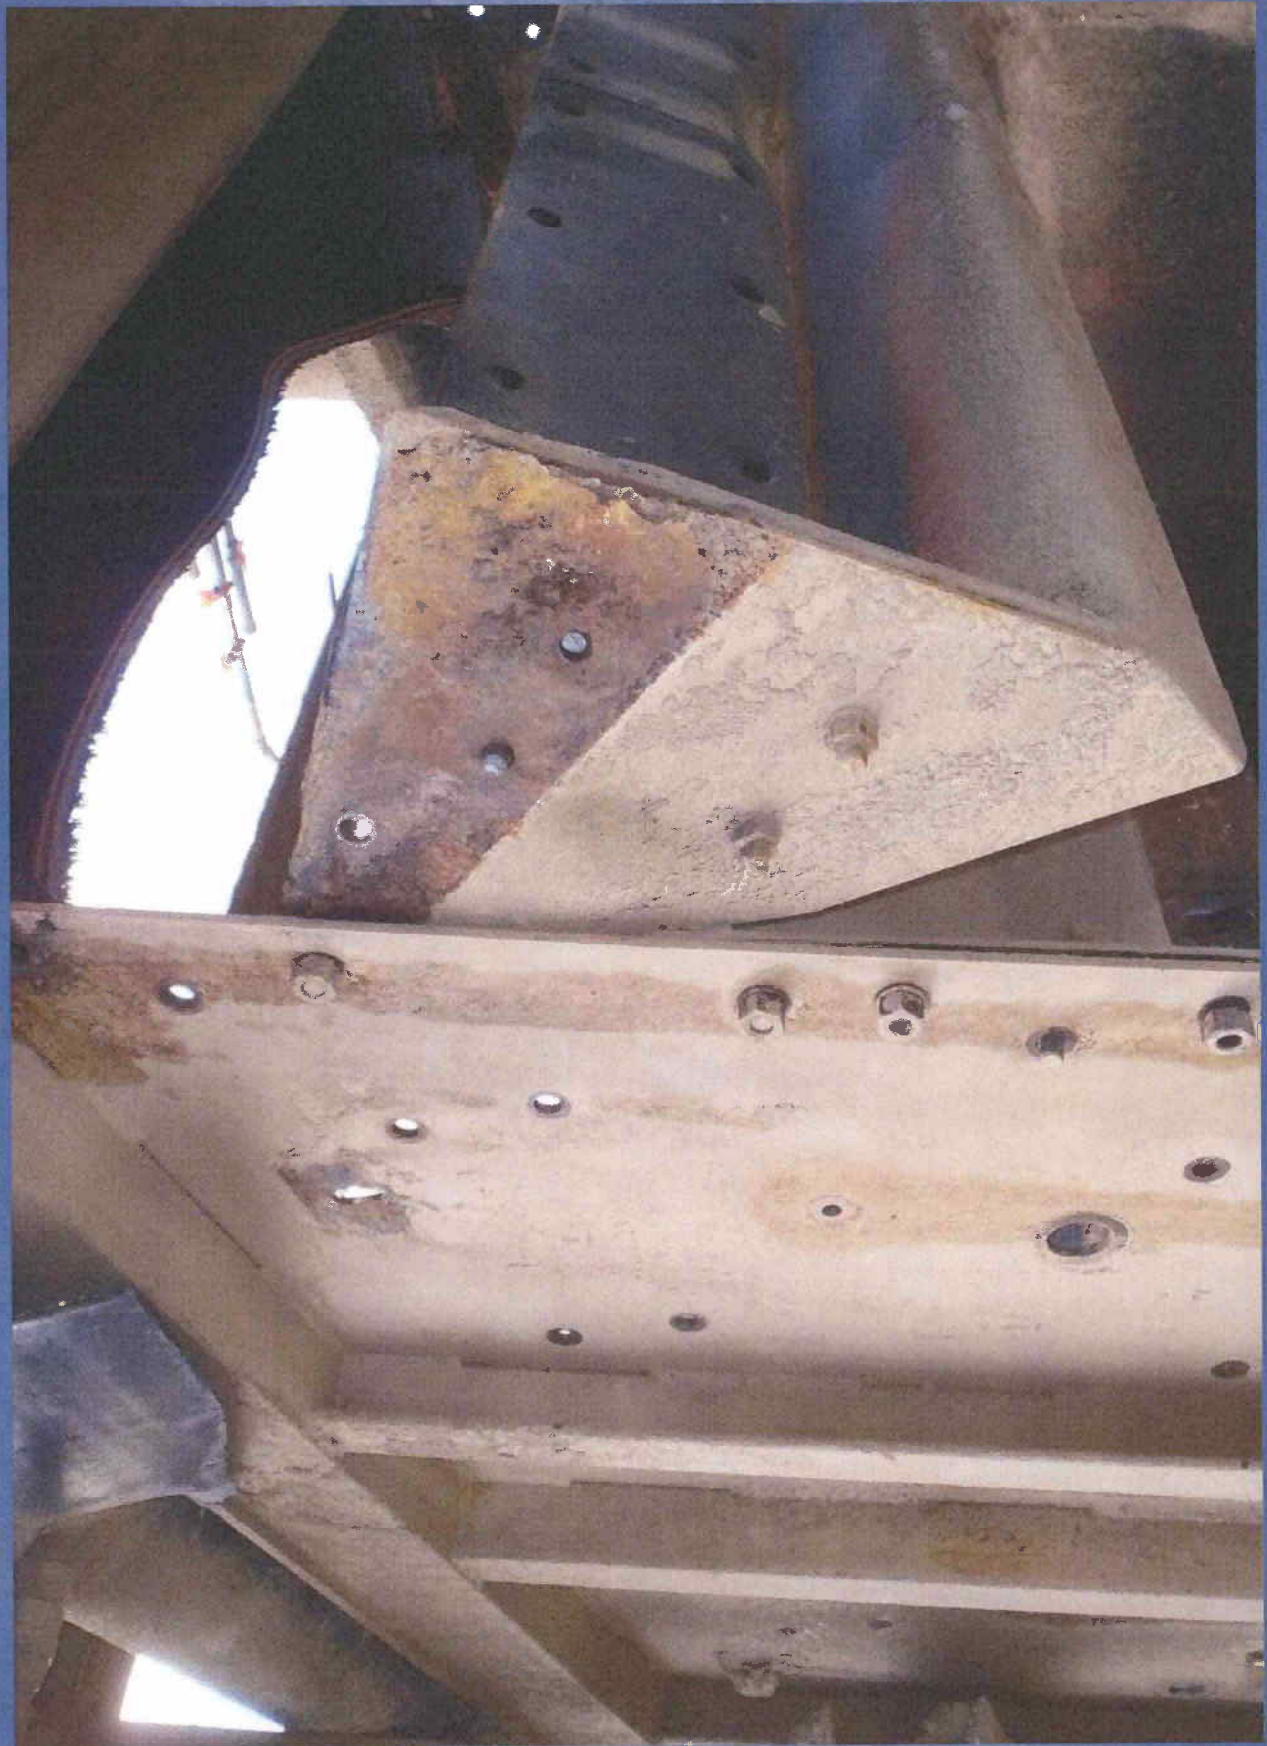
On January 8, 2015, Alan Tindall, Contract Sales Manager, age 63, was killed at this mine while working with mine personnel to install new screen panels in a tower screen. A loosened feeder box pivoted down, pinning Tindall between the box and the splash curtain support bracket on the screen.

On January 7, 2015, the day before the accident, mine personnel cut four of the six retaining nuts and bolts holding the feeder box in place with a torch and the two remaining bolts were loosened to allow the old screens to slide out. This left the feeder box unsecured while the new screen panels were installed.

The accident occurred due to management's failure to establish policies and procedures for persons to safely remove the old screens and install new screens on the screen tower. The feeder box was not secured in place or blocked against hazardous motion because four of the six retaining nuts and bolts were cut off. After the nuts and bolts were cut off, the feeder box was never resecured and the four nuts and bolts were not replaced. The feeder box hung by the loosened bottom two nuts and bolts.

Management also failed to ensure that an examination was conducted of the repairs on the screen. The repairs had been in progress for two days. The unsecured feeder box should have been recognized as a hazard by a work place examiner looking for hazardous conditions. The cut off nuts and bolts allowed the feeder box to move unexpectedly and pin the victim.

Root Cause: Management failed to establish policies and procedures for persons to safely replace the old screens and install new screens on Tower B. The feeder box was not secured in place nor blocked against hazardous motion after four of the six retaining nuts and bolts were torched off. The feeder box was never secured and the four bolts and nuts were not replaced to keep it secured. The feeder box hung by the remaining bottom two nuts and bolts, which were loosened.

Corrective Action: Management has developed a new standard operating procedure for retrofitting screen decks. The miners were trained in these new procedures.
