MNM Fatal 2015-4

- Machinery
- January 26, 2015 (Florida)
- Phosphate Rock Mining
- Heavy Equipment Operator
- 57 years old
- 35 years of experience

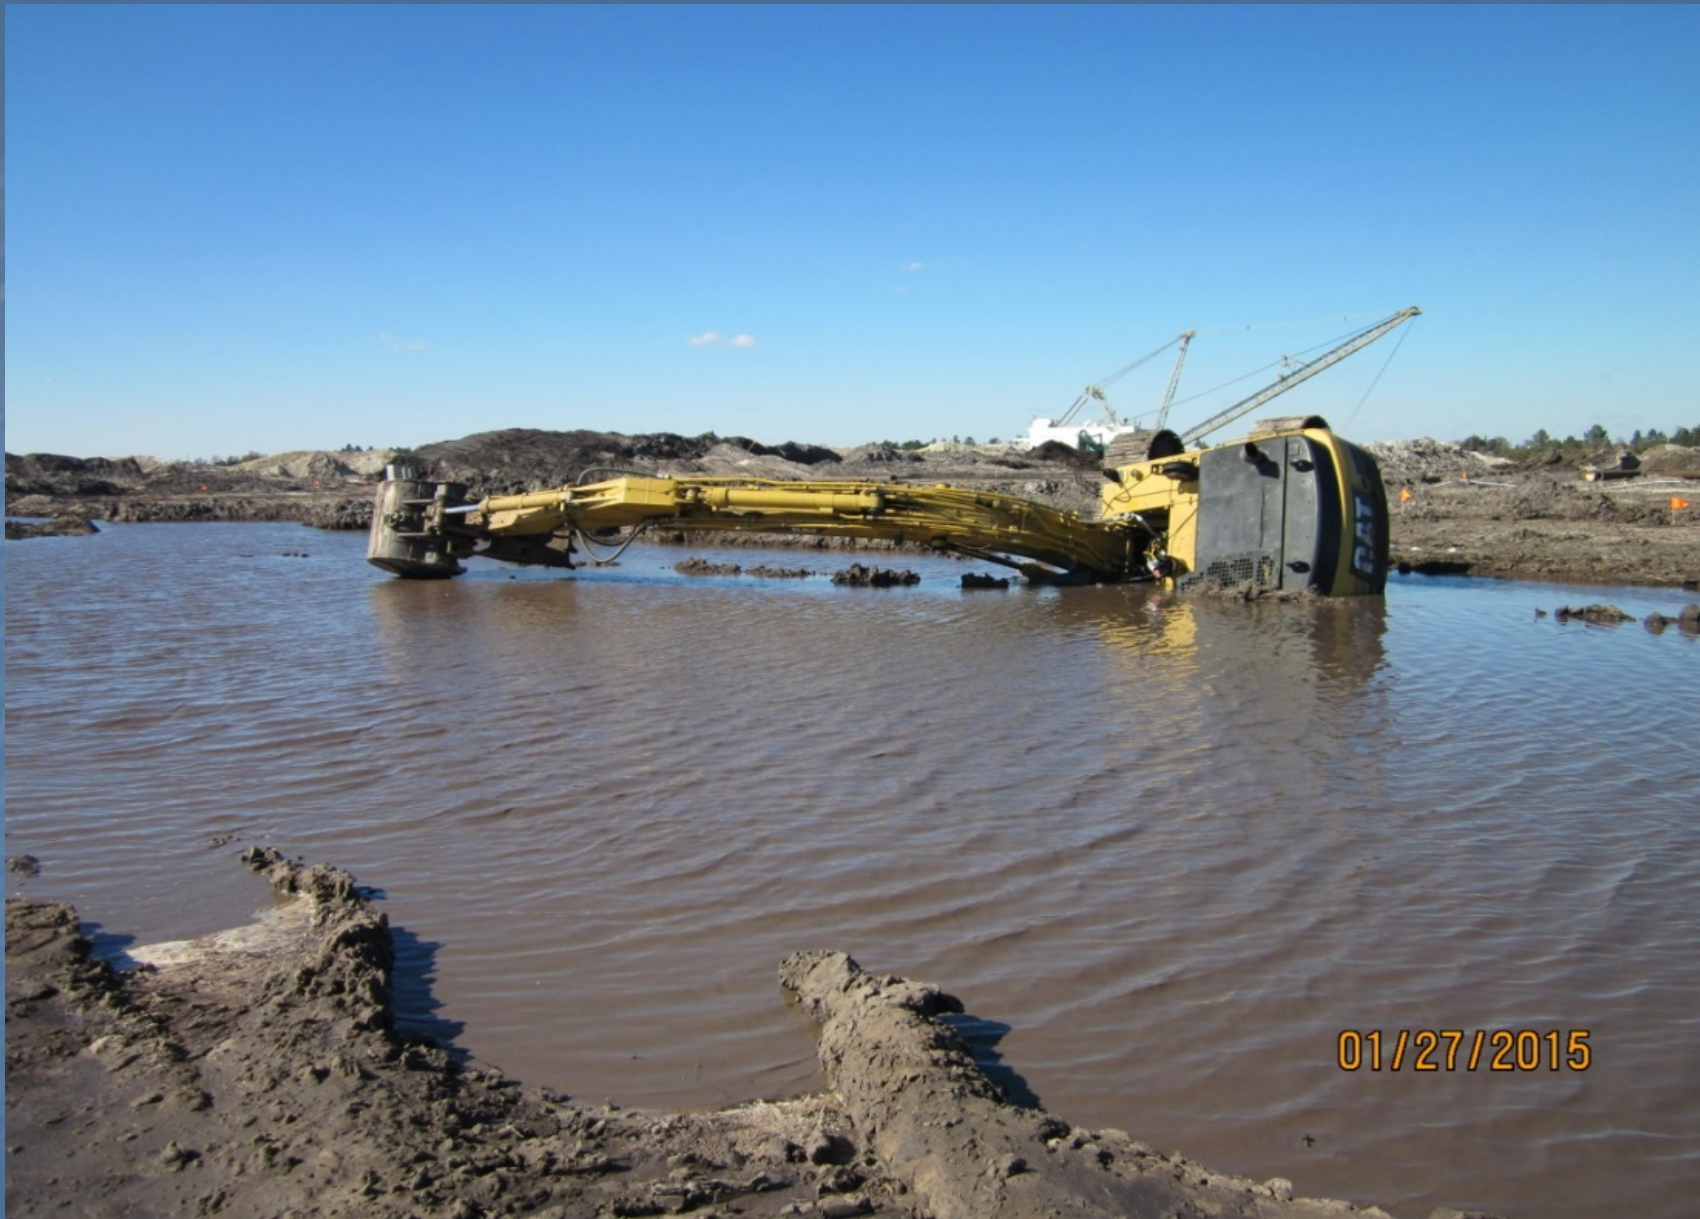
01/27/2015

William K. Stormant, Heavy Equipment Operator, age 57, was seriously injured on January 26, 2015. Stormant was operating an excavator near a water-filled ditch when the excavator tipped on its side and entered the murky water, trapping him inside the nearly submerged cab. Rescuers removed Stormant from the water-filled cab. Stormant was transported to a hospital where he died later that day.

The accident occurred due to management's failure to ensure that procedures were established to ensure miners could safely prepare a work area in advance of a dragline. Management failed to ensure competent persons were properly conducting workplace examinations. The water-filled ditch was not identified as a hazard after the heavy rainfall and management failed to barricade or place warning signs to warn employees of hazards, such as the water-filled ditch, that were not immediately obvious to miners.

- **Root Cause:** Management failed to establish policies and procedures to ensure competent persons were properly conducting workplace examinations so miners could safely prepare a work area in advance of a dragline. Stormant was operating an excavator near a water-filled ditch that was not identified as a hazard after the heavy rainfall three days prior to the accident.
- **Corrective Action:** Management established policies and procedures to ensure that competent persons conduct workplace examinations before persons on the dragline support crew conduct any work. Training on the new policies and procedures was provided for all competent persons to conduct workplace examinations and to take corrective actions if needed.

- **Root Cause:** Management failed to establish policies and procedures to ensure that barricades or warning signs were placed to warn employees of hazards, such as the water-filled ditch, that are not immediately obvious to miners.
- **Corrective Action:** Management established policies and procedures to ensure that barricades or warning signs are placed to warn employees of hazards, such as the water-filled ditch, that are not immediately obvious to miners. All miners were trained regarding these policies and procedures.
