MNM Fatal 2015-09

- Falling Material
- June 30, 2015 (Massachusetts)
- Construction Sand and Gravel
- Equipment Operator
- 65 years old
- 19 years of experience

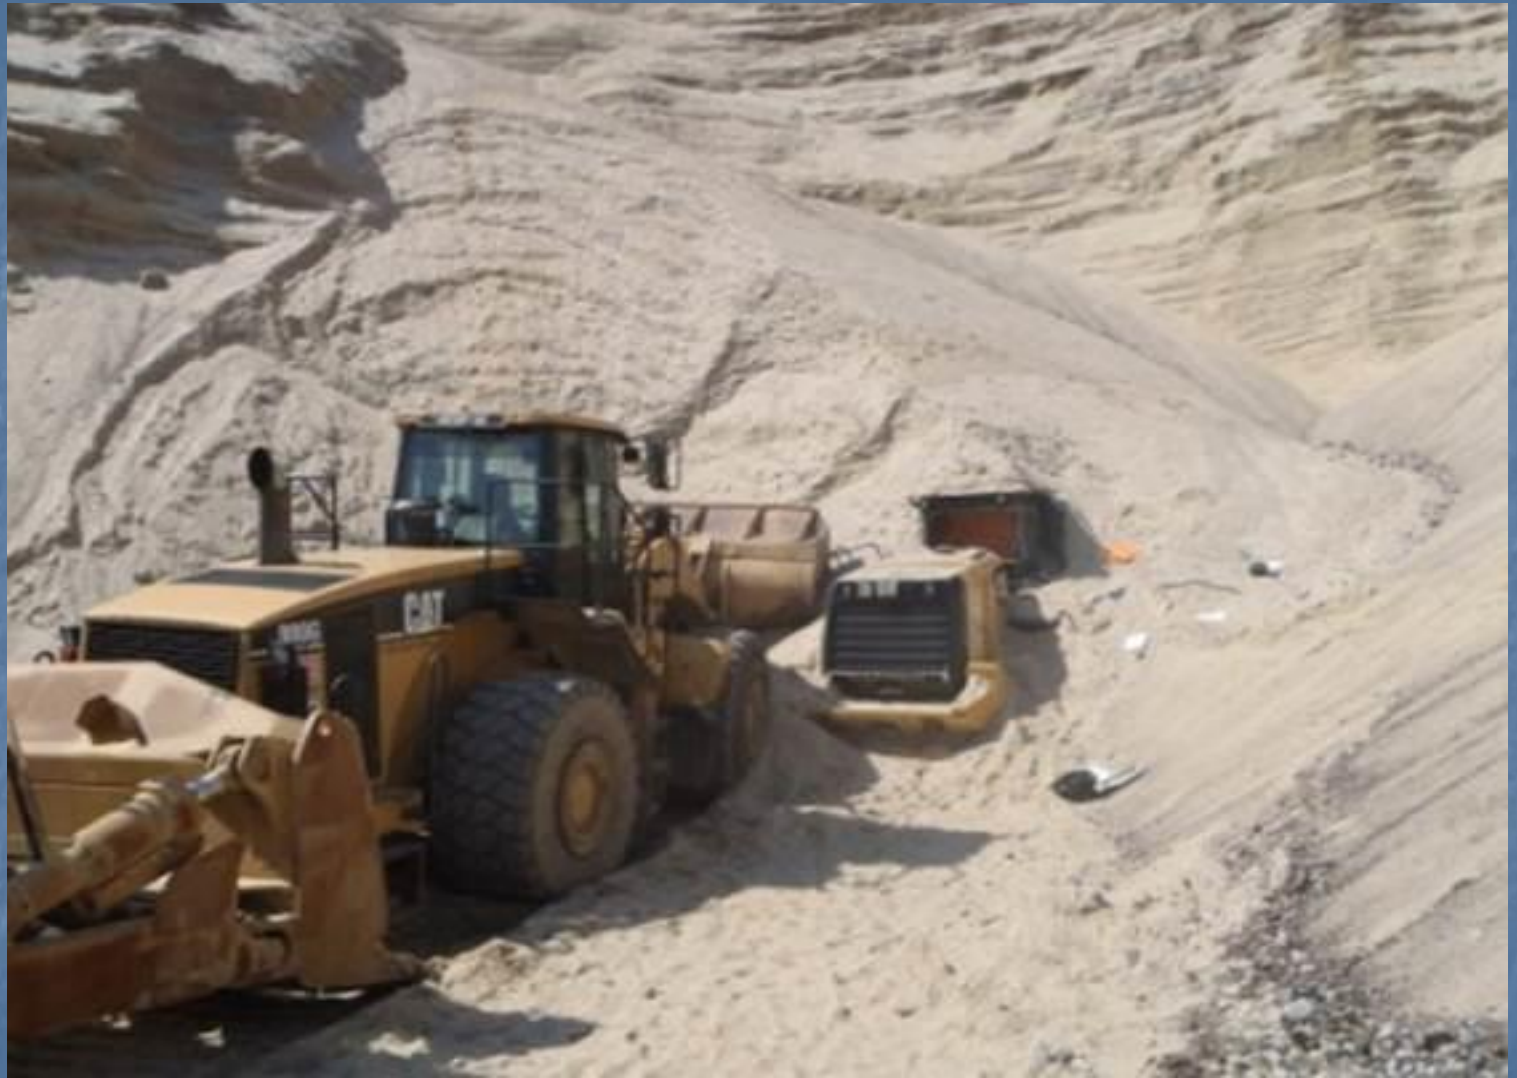
On June 30, 2015, Charles E. Pace, equipment operator, age 65, was killed while operating a front-end loader at the base of a sand bank. Pace was trapped in the operator's cab when a portion of the bank collapsed and engulfed the front-end loader.

The accident occurred due to mine management's failure to utilize previously established mining methods to maintain wall, bank, and slope stability in the area. The victim was extracting material from the base of a 128 feet high bank that was not sloped to a safe angle. In addition, management failed to adequately examine the mining area prior to commencing work and periodically throughout the shift as changing ground conditions warranted.

- **Root Cause:** Management failed to utilize previously established mining methods to maintain wall, bank, and slope stability in the area. The mine operator had used bulldozers in the past to push the bank material down to a flatter slope; however, this mining practice had not been employed during this phase of mining. The victim was extracting material from the base of a 128 feet high bank that was not sloped to a safe angle.

- **Root Cause:** Management failed to adequately examine the mining area prior to commencing work and periodically throughout the shift as changing ground conditions warranted.

- **Corrective Action:** Management established and implemented new policies and procedures to reclaim the existing phase 4 excavation (accident area). In addition, new policies and procedures were made to address future excavations at the mine. These new policies and procedures utilize bulldozers to push material down the slope toward the face of the excavation while maintaining a uniform slope gradient of 2.5:1 to 3:1. Future excavations will have a minimum working width of 300 feet, sloped on all three sides. The slope gradients will be monitored on a daily basis. Material pushed down the slope will be windrowed or stockpiled and will be loaded and transported to the screening plant. All mobile equipment operators were trained in these new policies and procedures.

- **Corrective Action:** Management established and implemented an examination plan for the mining area and designated an exam coordinator, responsible for ensuring adequate examinations and monitoring slope gradients. Examinations of the face of the slope and side slopes will be conducted each day prior to the start of excavation and as weather conditions dictate, particularly during and after precipitation events. The slope surfaces will be evaluated for bulging, cuts, seepage, and cracking. Any adverse conditions found will be corrected prior to the commencement of mining in the area. Mining will also cease at any time during the shift when adverse conditions are encountered until they can be evaluated and addressed. All mobile equipment operators were trained by the exam coordinator in the new examination plan relative to identifying adverse ground conditions, changing slope conditions, and remedial actions.
