MNM Fatal 2015-12

- Machinery
- July 10, 2015 (Ohio)
- Construction Sand and Gravel
- Superintendent
- 50 years old
- 26 years of experience

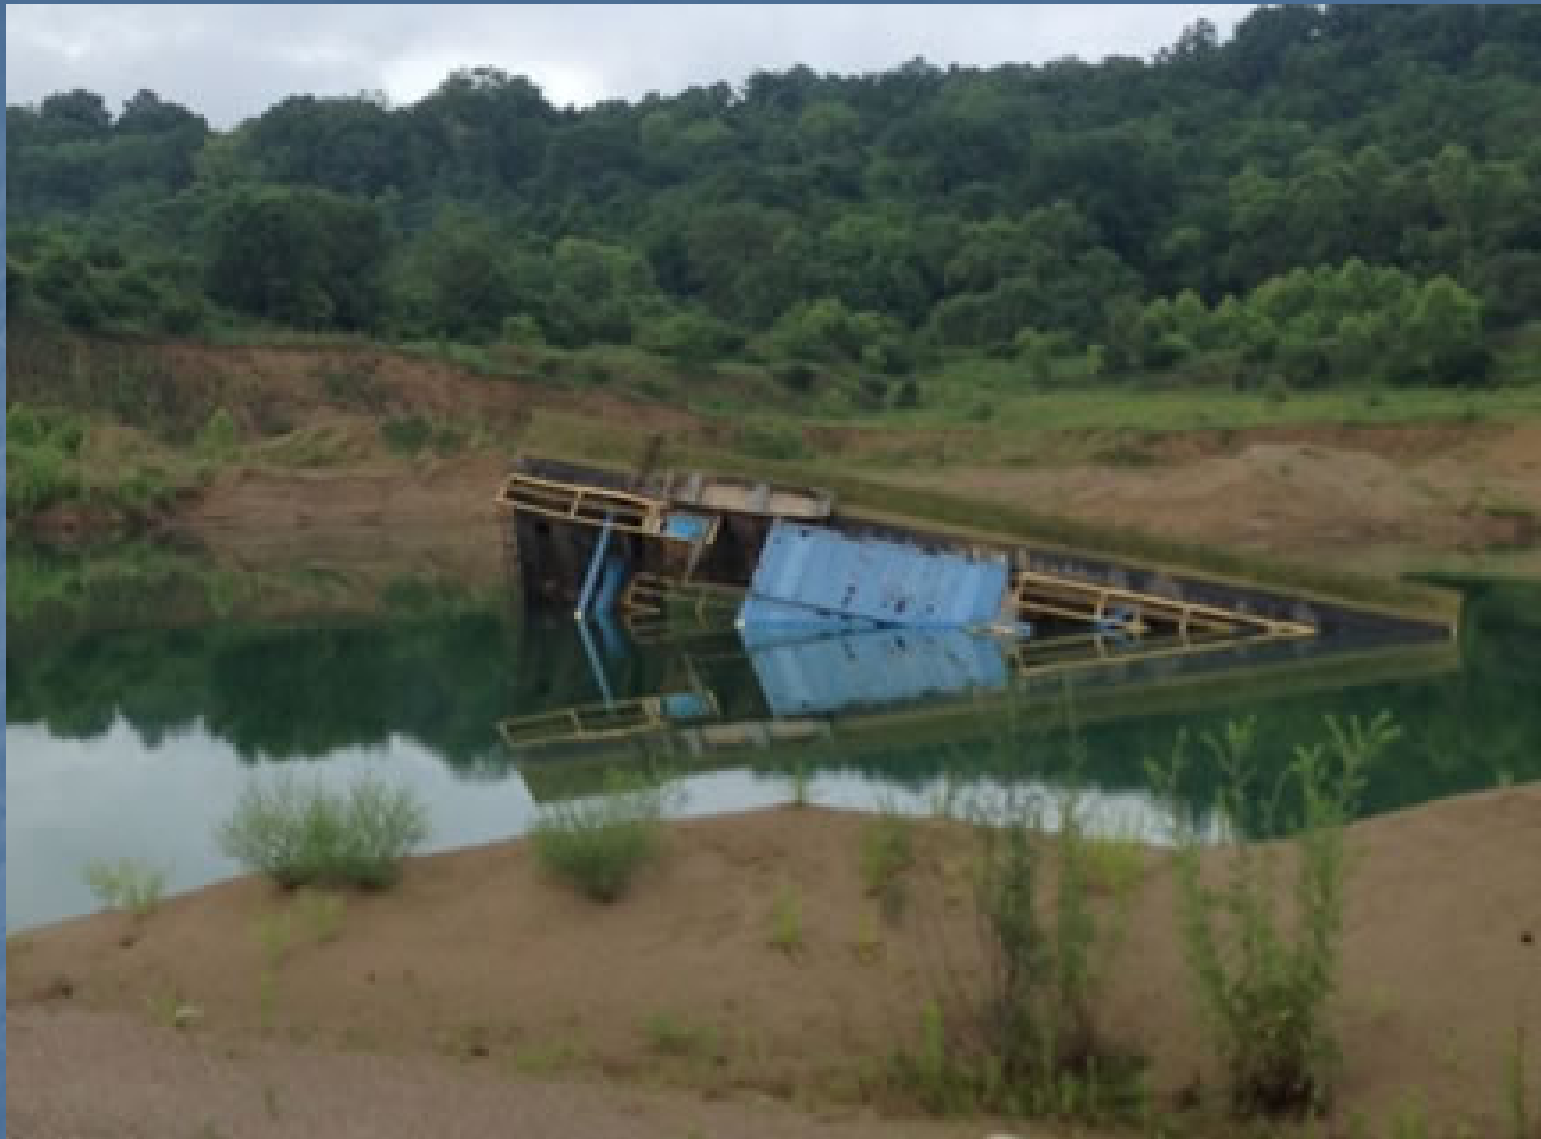
On July 10, 2015, William J. Roell, Superintendent, age 50, was killed while operating a dredge at this sand and gravel operation. Roell and another miner were attempting to dislodge the clamshell bucket from the bottom of a lake when the dredge capsized. The miner was injured when he was thrown from the dredge as it capsized, but was able to swim to shore. Divers recovered Roell from the motor control center (MCC) room in the submerged dredge eight days later.

The accident occurred due to management's failure to consult with the manufacturer or follow its recommended safe procedures when attempting to dislodge the dredge bucket from the lake bottom. As a result, the dredge was used beyond the design capacity intended by the manufacturer. In addition, mine management participated in the removal of the dredge's pontoon overload sensors, knew about its unfastened pontoon hatches and did not correct these conditions before continuing to operate the dredge. These modifications directly impacted the stability of the dredge and contributed to the cause of the accident. Finally, mine management failed to provide task training to miners in accordance with the manufacturer's recommended safe procedures for dislodging or recovering a dredge bucket.

- **Root Cause:** Management policies and controls were inadequate. Mine management participated in the removal of the dredge's pontoon overload sensors and knew about its unfastened hatches and did not correct these conditions before continuing to operate the dredge.
- **Corrective Action:** Management is working with Rohr representatives to possibly refurbish and use the dredge. If the dredge is salvageable or a replacement dredge is to be used, the mine operator will establish and implement written safe operating procedures to ensure that all of the dredge safety devices are in place and maintained according to the manufacturer's specifications at all times while the dredge is operating. The dredge operators and crews will be trained in these safe operating procedures.

- **Root Cause:** Management policies and controls were inadequate. The dredge had been modified and used beyond the design capacity intended by the manufacturer. Mine management failed to consult with the manufacturer or follow its recommended safe procedures when attempting to dislodge the dredge bucket from the lake bottom.
- **Corrective Action:** If the dredge is salvageable or a replacement dredge is to be used, the mine operator will establish and implement written safe operating procedures to ensure that the manufacturer's recommended methods are used to dislodge or recover the dredge bucket from the lake bottom. The dredge operators and crews will be trained in these safe operating procedures.

- **Root Cause:** Mine management failed to provide task training to miners in accordance with the manufacturer's recommended safe procedures for dislodging or recovering a dredge bucket.
- **Corrective Action:** If the dredge is salvageable or a replacement dredge is to be used, the mine operator will train the dredge operators and crews in the manufacturer's safe procedures for dislodging or recovering the dredge bucket from the lake bottom.
