MAI-2016-6

REPORT OF INVESTIGATION

**Fatal Fall of Person
May 10, 2016**

**Ash Grove Cement Company
Midlothian, Texas
Mine ID No. 41-00026**

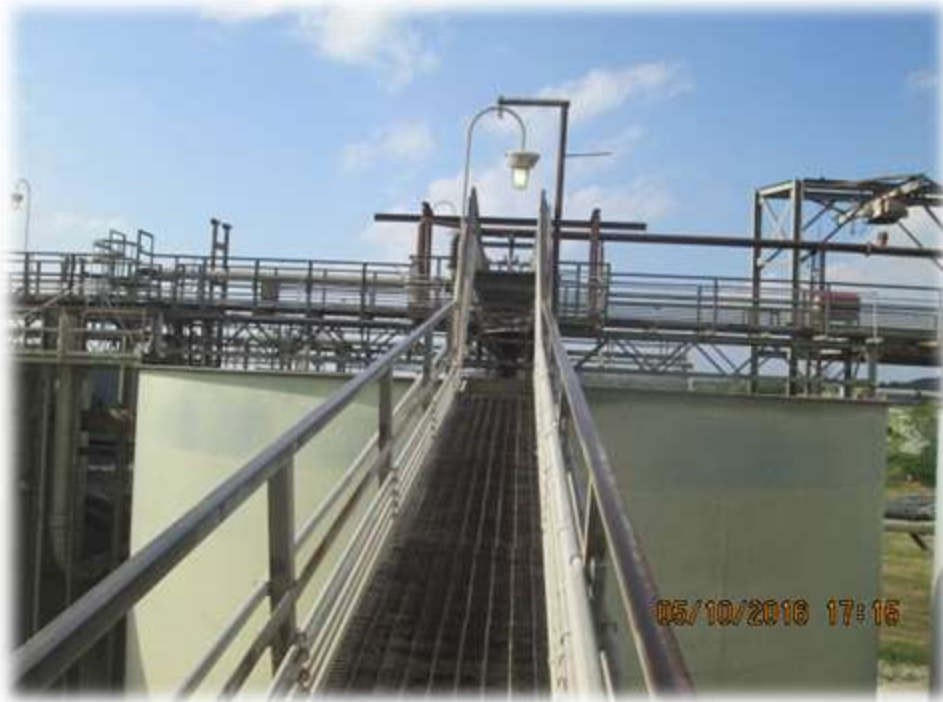
Attachment #1 (Approach to work site)

The accident occurred at the platform and travelway above the #2 Slurry Tank. (*Attachment 6*) The platform is accessed by climbing several flights of stairs and traversing an inclined catwalk (*Attachment 1*) that ultimately ends at the platform. This platform is the common point by which all six of the area tanks are accessed. The platform above #2 was square in shape, measuring approximately 13 feet x 13 feet, with elevated walkways intersecting all four sides. The drive unit was located near the center of the platform. The open hole, which the victim fell through, was directly behind the drive unit. (*Attachment 2*)

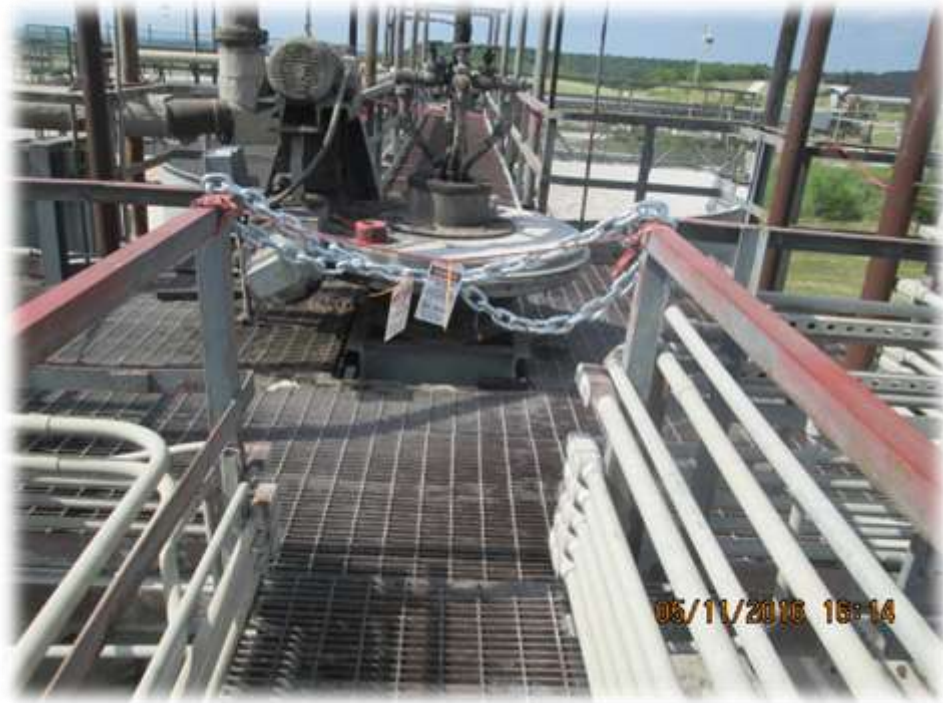
Attachment #2 (Entrance to work site)

A view of the opening in the floor was obstructed to those entering the upper level work via the catwalk. On May 2, McBride directed SCM employees to install a chain and warning tag, provided by Ash Grove, where the elevated catwalk intersected the #2 Slurry Tank platform. (*Attachment 2*) From May 2 to May 10, both Ash Grove and SCM personnel ducked under this chain to gain access to the working area. The chain, tags and direction Ash Grove provided SCM were not in compliance with requirements of 30 CFR 56.20011, Barricades and warning signs.

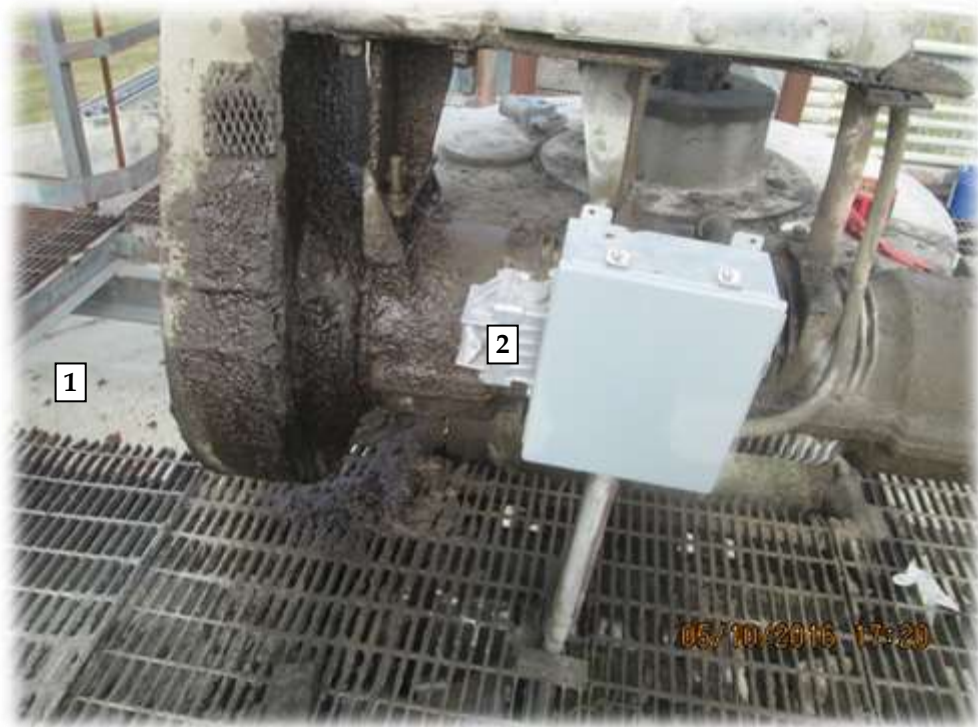
Attachment #3 (Left Side of drive unit)

1. Unprotected opening in travelway
2. Control Switch Mr. Barnes was tasked with activating

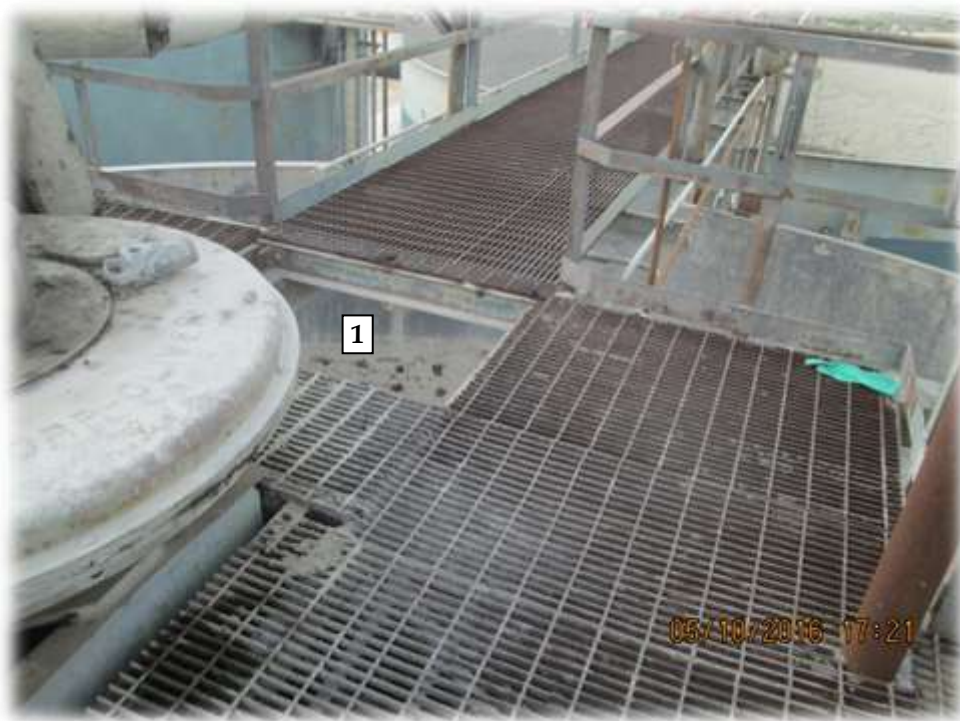
Attachment #4 (Right Side of Drive Unit)

On May 2, 2016, SCM per Ash Grove's instruction, removed a 3' x 4' section of floor grating from the platform (*Attachment 4*) above the #2 Slurry Tank to allow the crane basket to be suspended adjacent to the center column and work to be conducted on the air lines directly below the rake drive. SCM employees, equipped with fall protection, worked near this open hole and from the suspended man basket below this opening from May 2 to May 3, 2016 without incident. On May 3, 2016, SCM discussed an additional problem found with the drive unit on the rake system with Ash Grove's Maintenance Supervisor, Jason McBride. It was unclear whether SCM, Ash Grove, or the two working in unison would complete this additional work. Pending this decision, McBride directed SCM to focus their efforts and attention to repairing the tank walls. Neither Ash Grove nor SCM used the unprotected open hole, until May 10, 2016, the date of Mr. Barnes's fatal fall.

1. Unprotected opening

Corrective Action: The open hole was covered and Management established the following mandatory policies and controls:

- Hazardous Opening Protection Plan
- Hazardous Opening & Handrail Removal Permit
- Working at Heights Permit Program

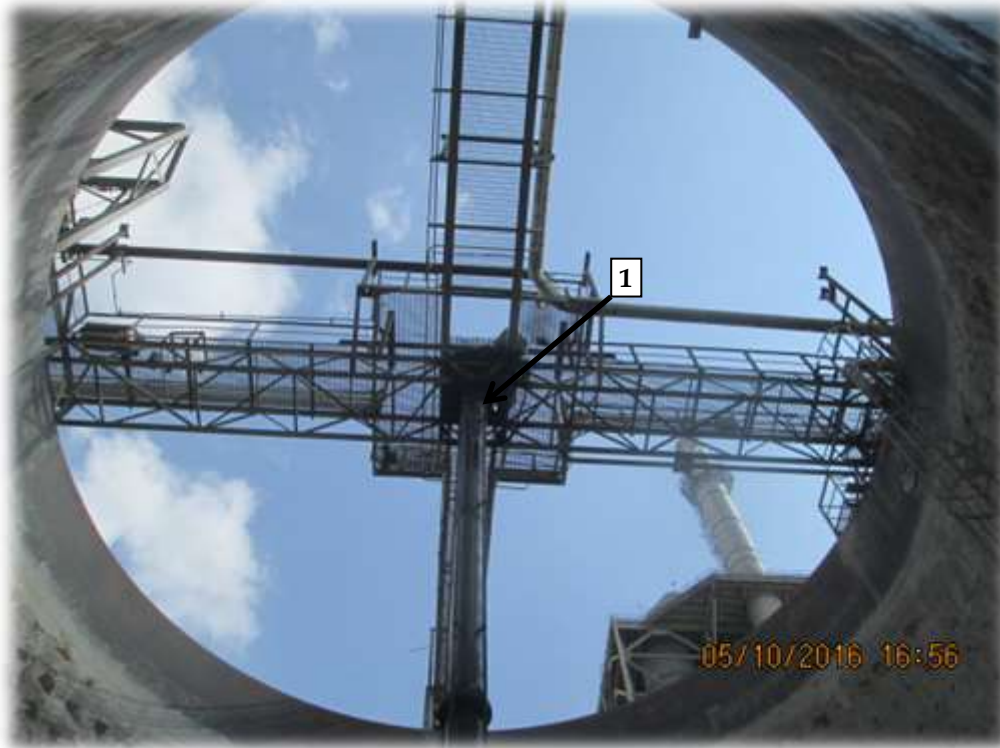
Attachment #5 (Looking up about 50' to opening)

1. Unprotected opening
