REPORT OF INVESTIGATION

**Surface Nonmetal Mine
(Limestone)**

**Fatal Powered Haulage Accident
June 27, 2016**

**Atlas Quarries
Atlas Qu Pt Crusher #1
Cord, Independence County, Arkansas
Mine ID No. 03-01720**

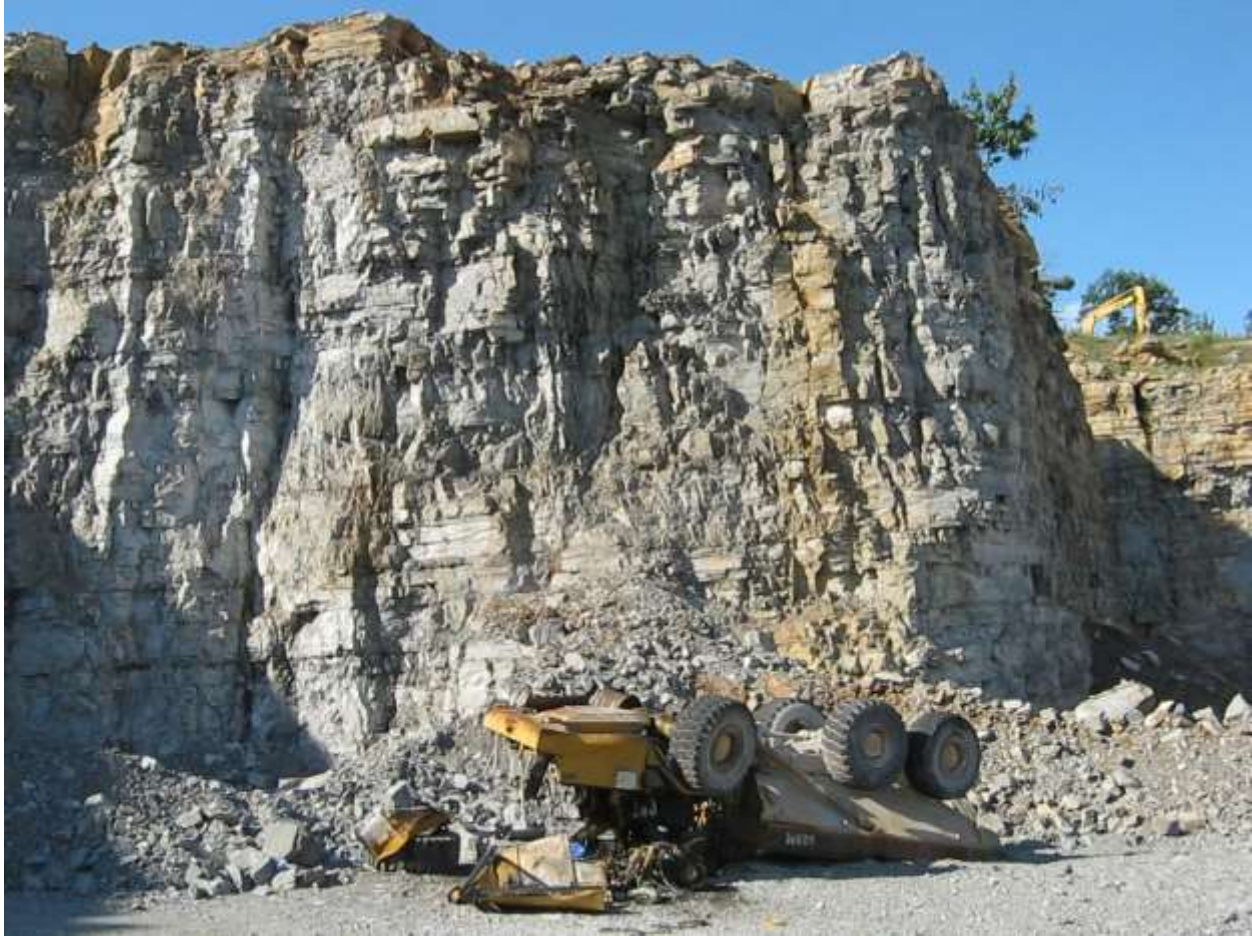
On June 27, 2016, Billy L. Cude, Superintendent (age 61), was killed when the haul truck he was operating traveled over the edge of the highwall. Cude was using the haul truck to transport material to be used in the construction of a ramp.

The accident occurred due to management's failure to provide berms, bumper blocks, safety hooks, or similar impeding devices at dumping locations where there was a hazard of over travel or overturning.

The accident occurred at the northwest bench of Atlas Qu. The ramp under construction on the bench was generally hard packed rocks and dirt with minor ruts. The ramp extended down toward the top edge of the high wall at a slope of approximately 21%.

Corrective Action: The mine operator installed berms along the edge of the highwall where the accident occurred. The mine operator conducted training on haulage procedures and related safety standards with all miners. The training included inspection of dump sites, location and construction of berms as well as other dump site restraints.
