REPORT OF INVESTIGATION

**Surface Nonmetal Mine
Crushed and Broken Limestone**

**Fatal Fall of Highwall Accident
July 25, 2016**

**Vulcan Construction Materials, LLC
Savannah Quarry
Savannah, Hardin County, Tennessee
Mine I.D. No. 40-00108**

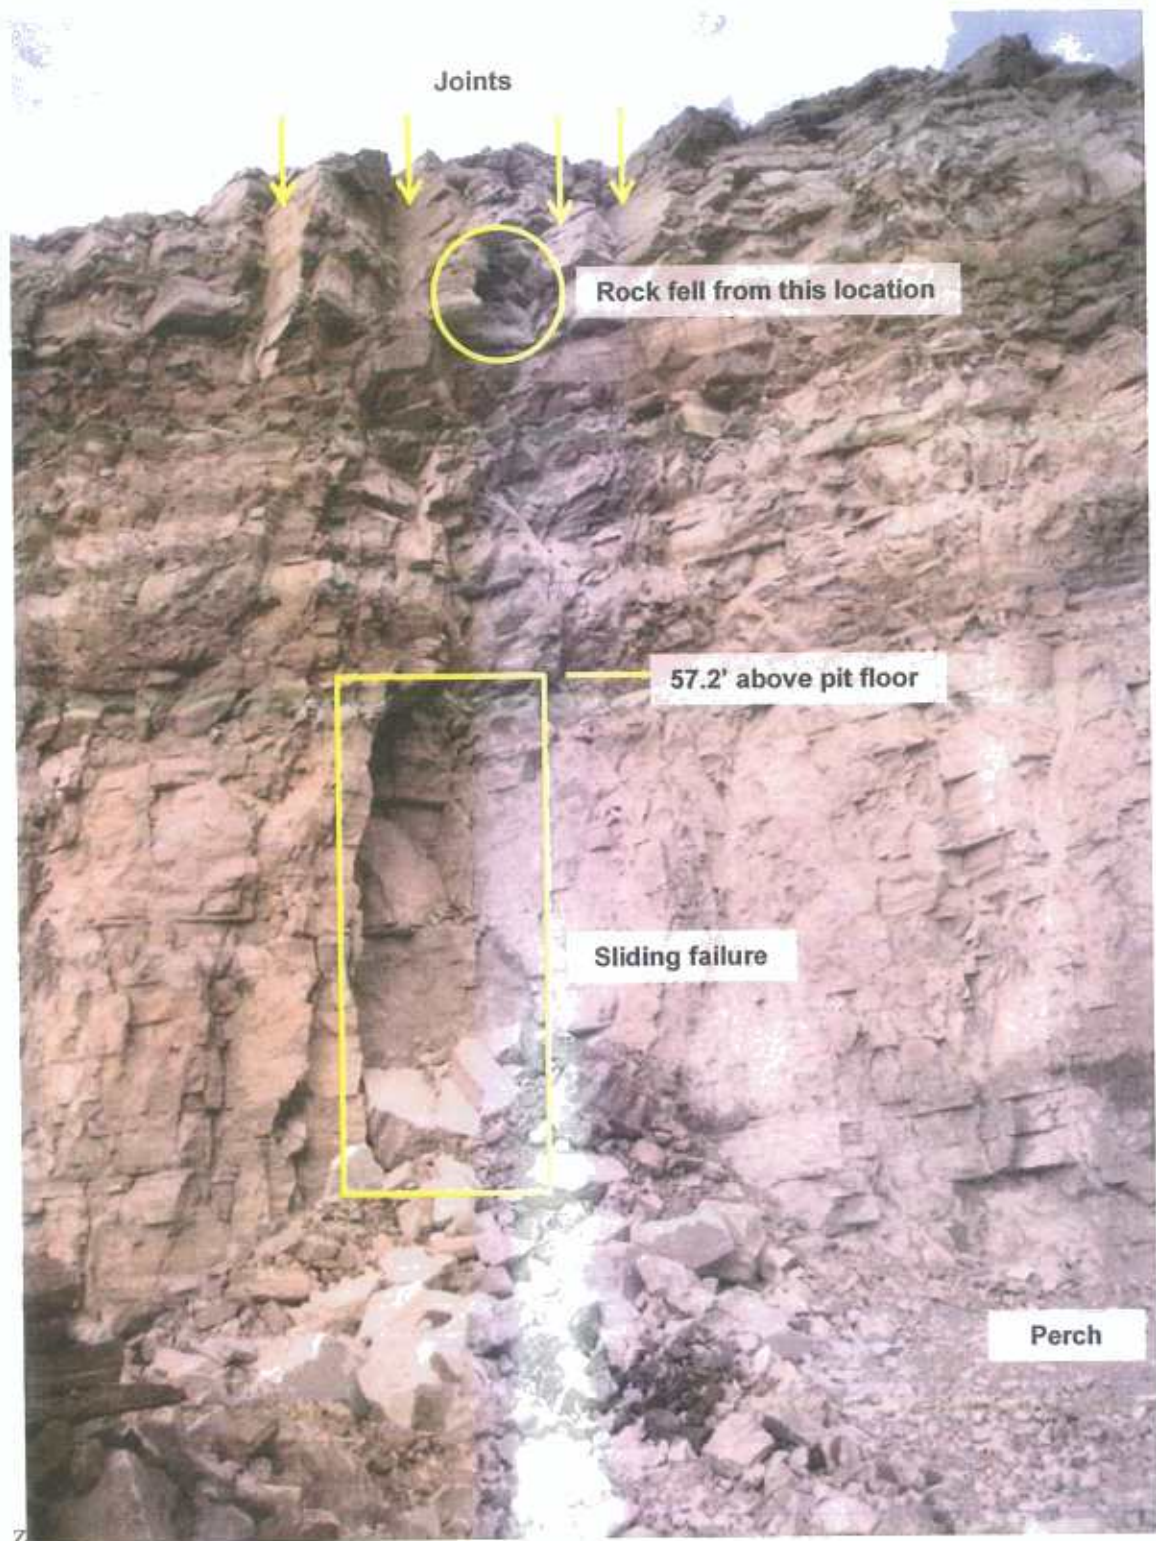
The formations in the quarry are highly jointed. This creates a rugged highwall face, as shown in APPENDIX B, Photos 1, 2, and 3, and increases the likelihood of rockfalls. The portion of the west wall at the accident site is nearly vertical with strike in the north to south direction. The primary joint set in the accident area runs in the direction of N26°E. Measurements indicate that the dip of the joint set was 88.6°, or nearly vertical. One of the joint sets was traced to 48 feet on the top of the highwall and was visible in the north highwall 252 feet away as shown in APPENDIX B, Photo 4. In addition, there were at least four additional joints parallel to the primary joint in an area 24 feet from the highwall face. The spacing between the joints was as close as 13 feet. The joints were visible and appeared tight well behind the highwall face, but were open as the joints got closer to the face. A close-up view of a primary joint set near the highwall face is shown in APPENDIX B, Photo 5.

As shown in Appendix B, Photo 1, an area adjacent to the excavator's location previously failed at some undetermined time. Highwall material slid from a height of approximately 57 feet above the pit floor. Such failures should be cause for further investigation as they are often indicative of instability.

Photo 1
Overview of Rockfall Area

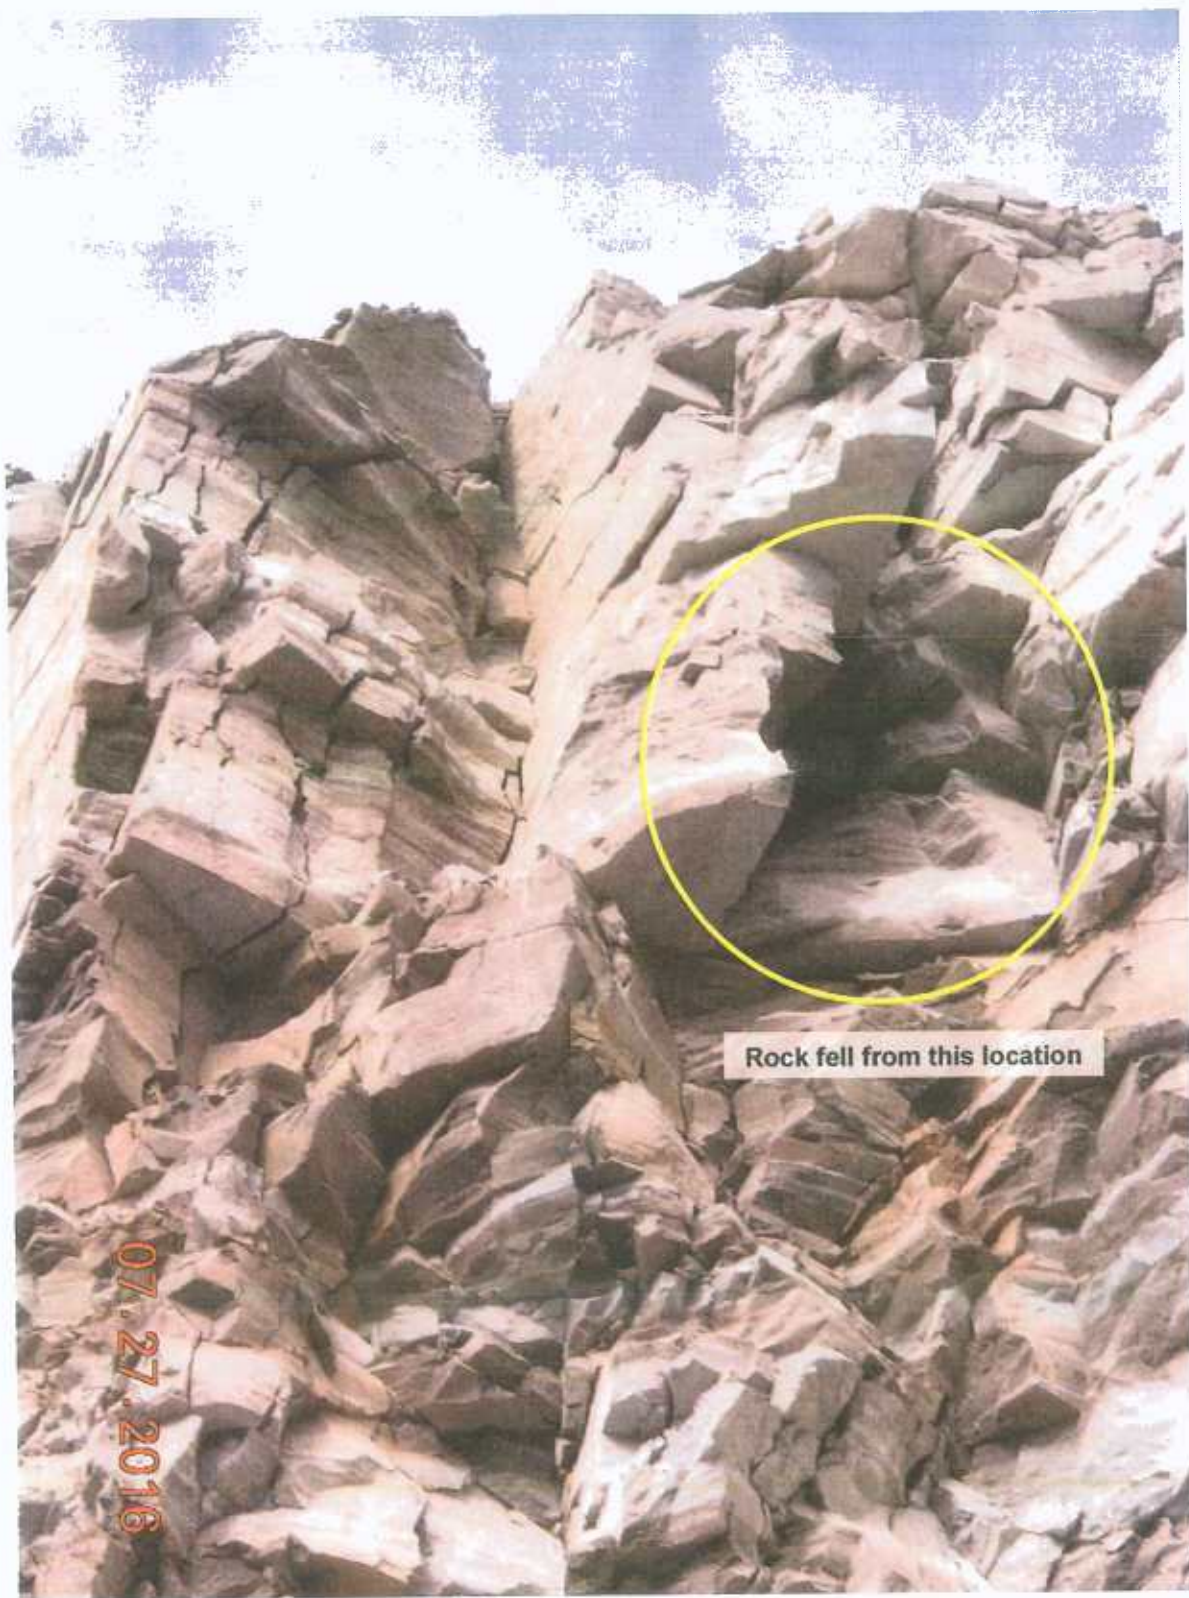
Photo 2

Close-up View of Rockfall Origination and Highwall Face

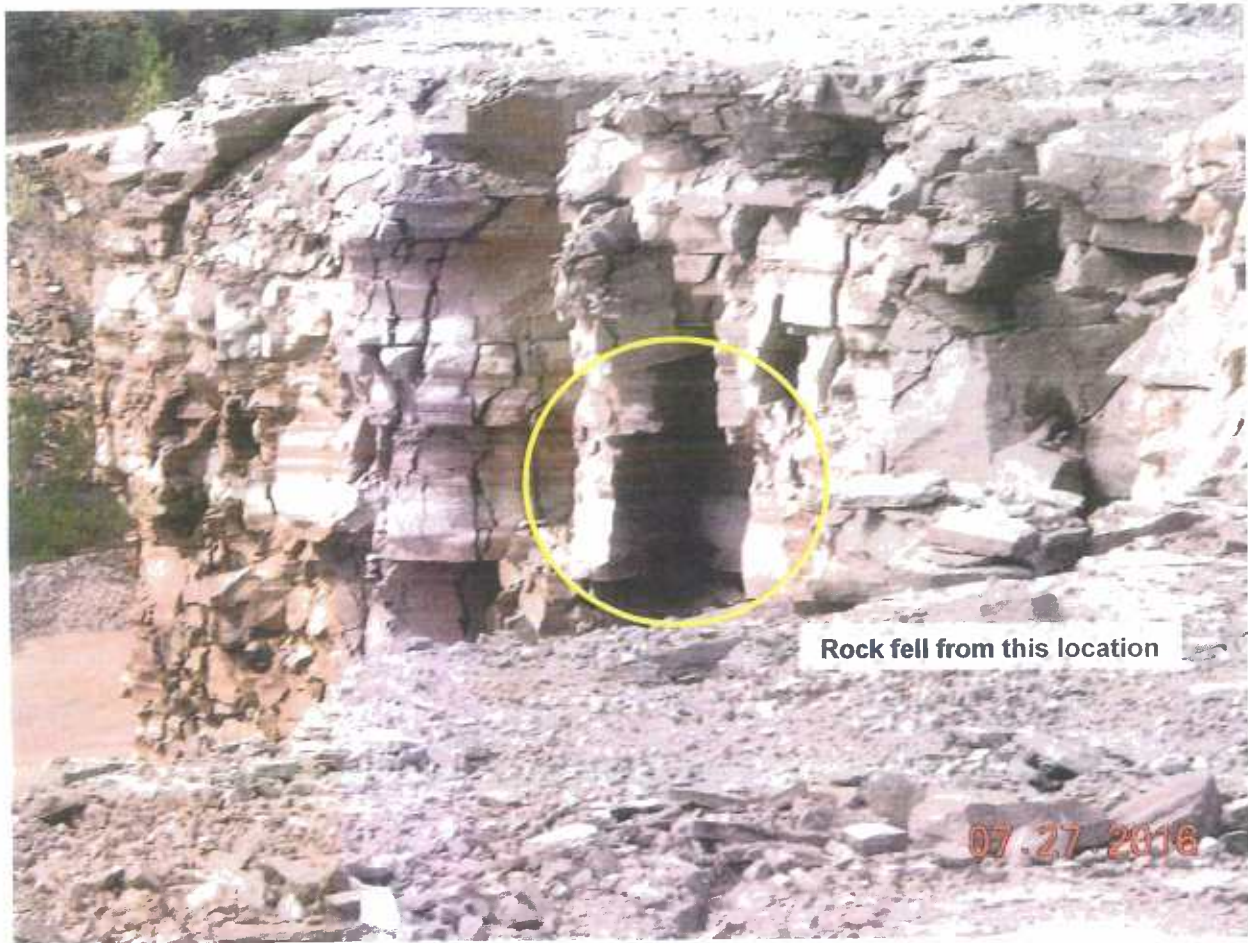
Photo 3

Top of Highwall: Side View of Rockfall Origination and Conditions

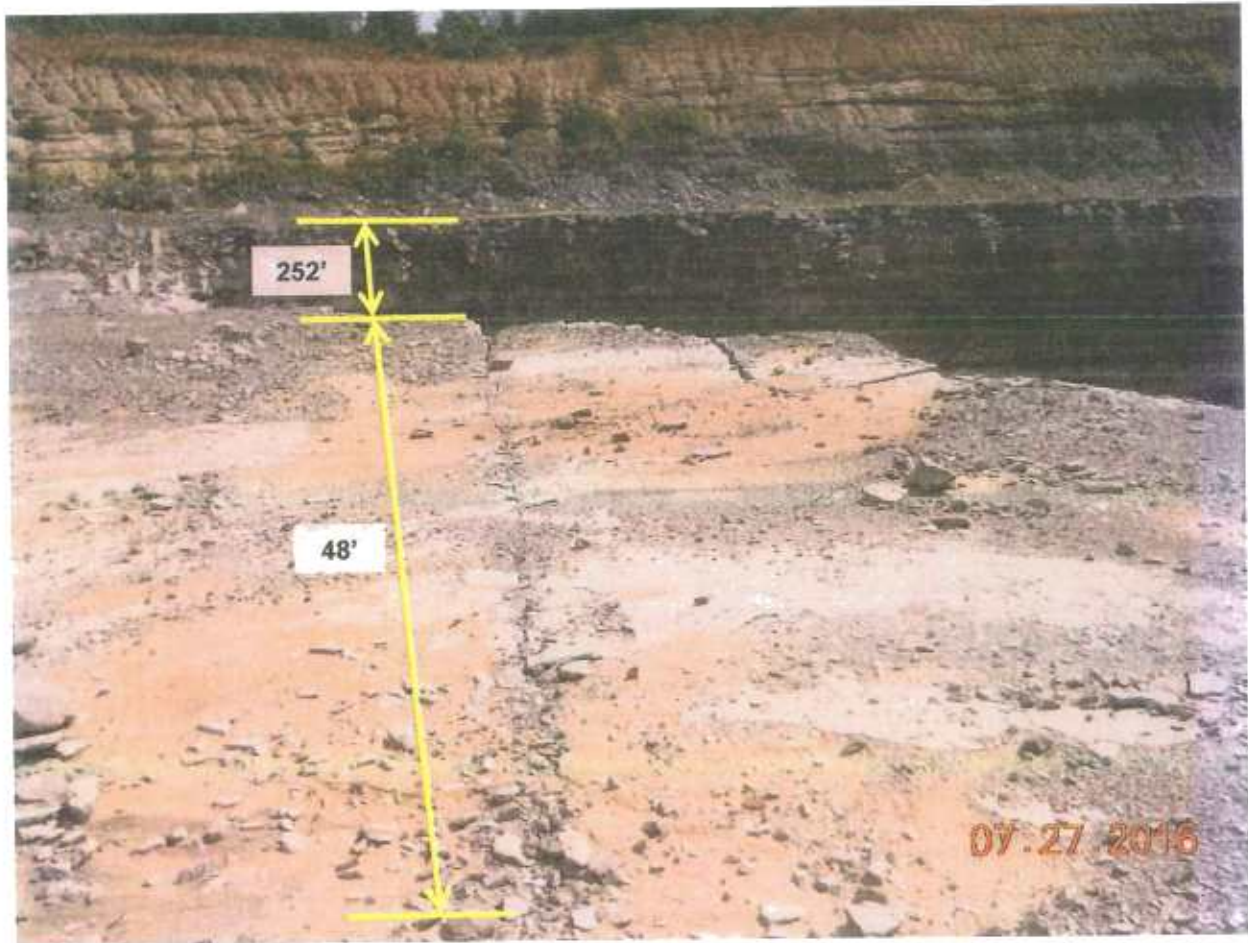
Photo 4

Top of Highwall: Primary Joint Set in N26°E Direction

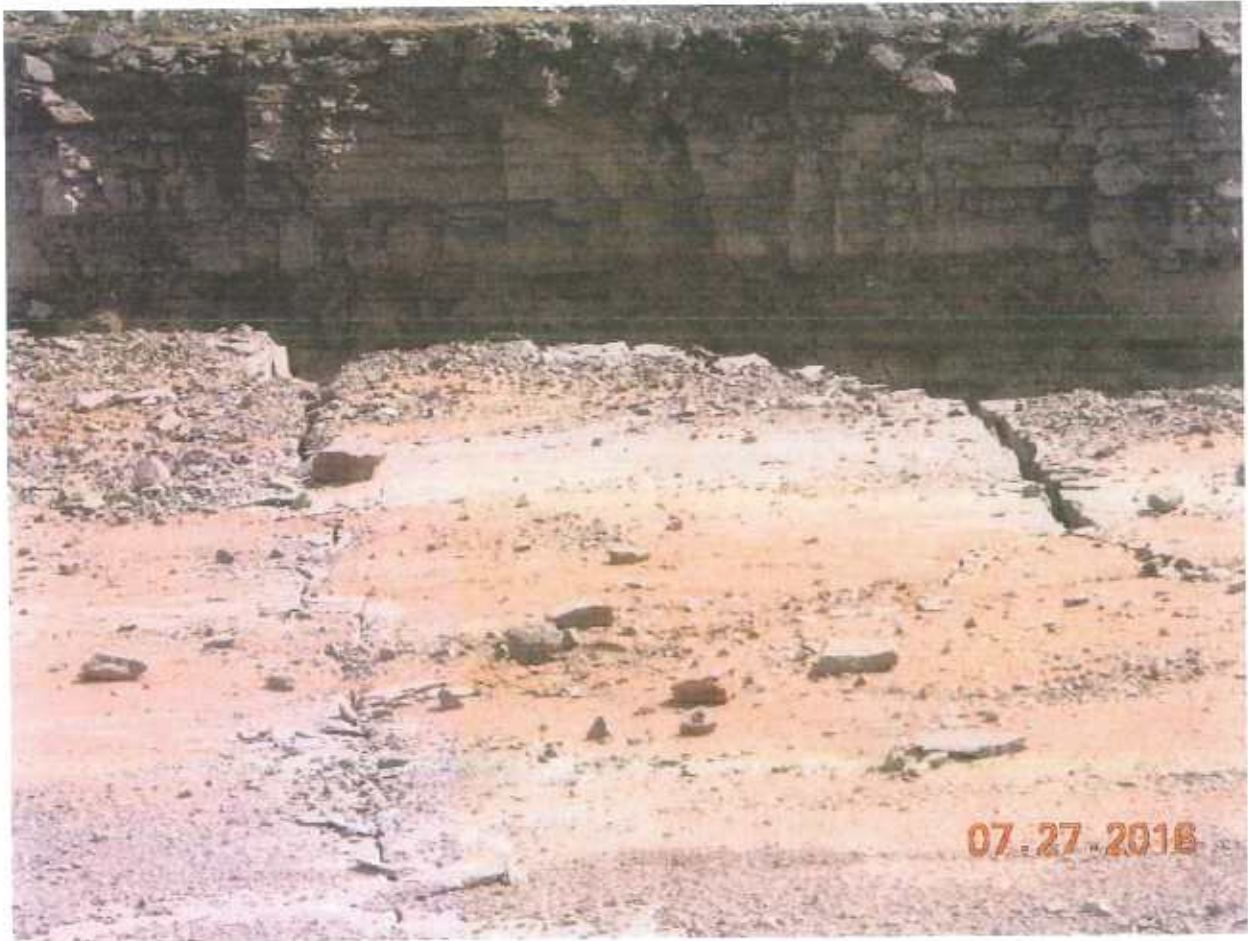
Photo 5

Top of Highwall: Close-up View of a Primary Joint Set
