REPORT OF INVESTIGATION

**Surface Nonmetal Mine
Crushed and Broken Limestone**

**Fatal Fall of Highwall Accident
July 25, 2016**

**Vulcan Construction Materials, LLC
Savannah Quarry
Savannah, Hardin County, Tennessee
Mine I.D. No. 40-00108**

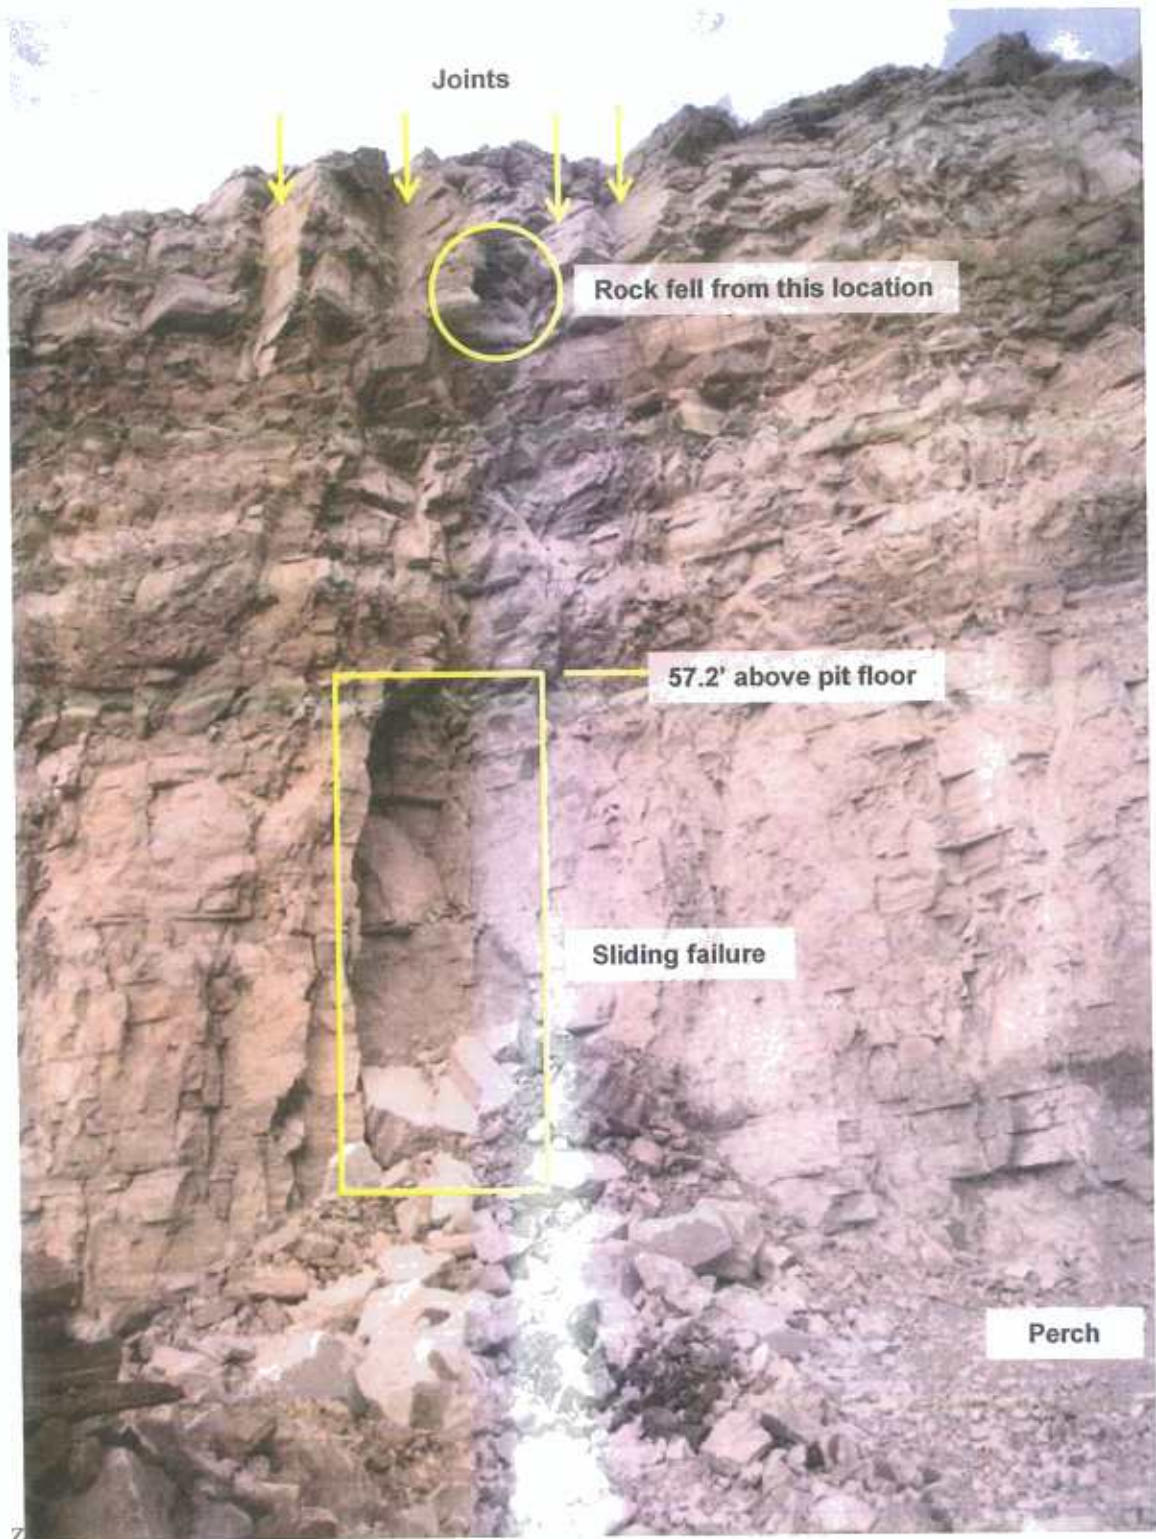
Photo 1
Overview of Rockfall Area

The formations in the quarry are highly jointed. This creates a rugged highwall face, as shown in APPENDIX B, Photos 1, 2, and 3, and increases the likelihood of rockfalls. The portion of the west wall at the accident site is nearly vertical with strike in the north to south direction. The primary joint set in the accident area runs in the direction of N26°E. Measurements indicate that the dip of the joint set was 88.6°, or nearly vertical. One of the joint sets was traced to 48 feet on the top of the highwall and was visible in the north highwall 252 feet away as shown in APPENDIX B, Photo 4. In addition, there were at least four additional joints parallel to the primary joint in an area 24 feet from the highwall face. The spacing between the joints was as close as 13 feet. The joints were visible and appeared tight well behind the highwall face, but were open as the joints got closer to the face. A close-up view of a primary joint set near the highwall face is shown in APPENDIX B, Photo 5.

As shown in Appendix B, Photo 1, an area adjacent to the excavator's location previously failed at some undetermined time. Highwall material slid from a height of approximately 57 feet above the pit floor. Such failures should be cause for further investigation as they are often indicative of instability.

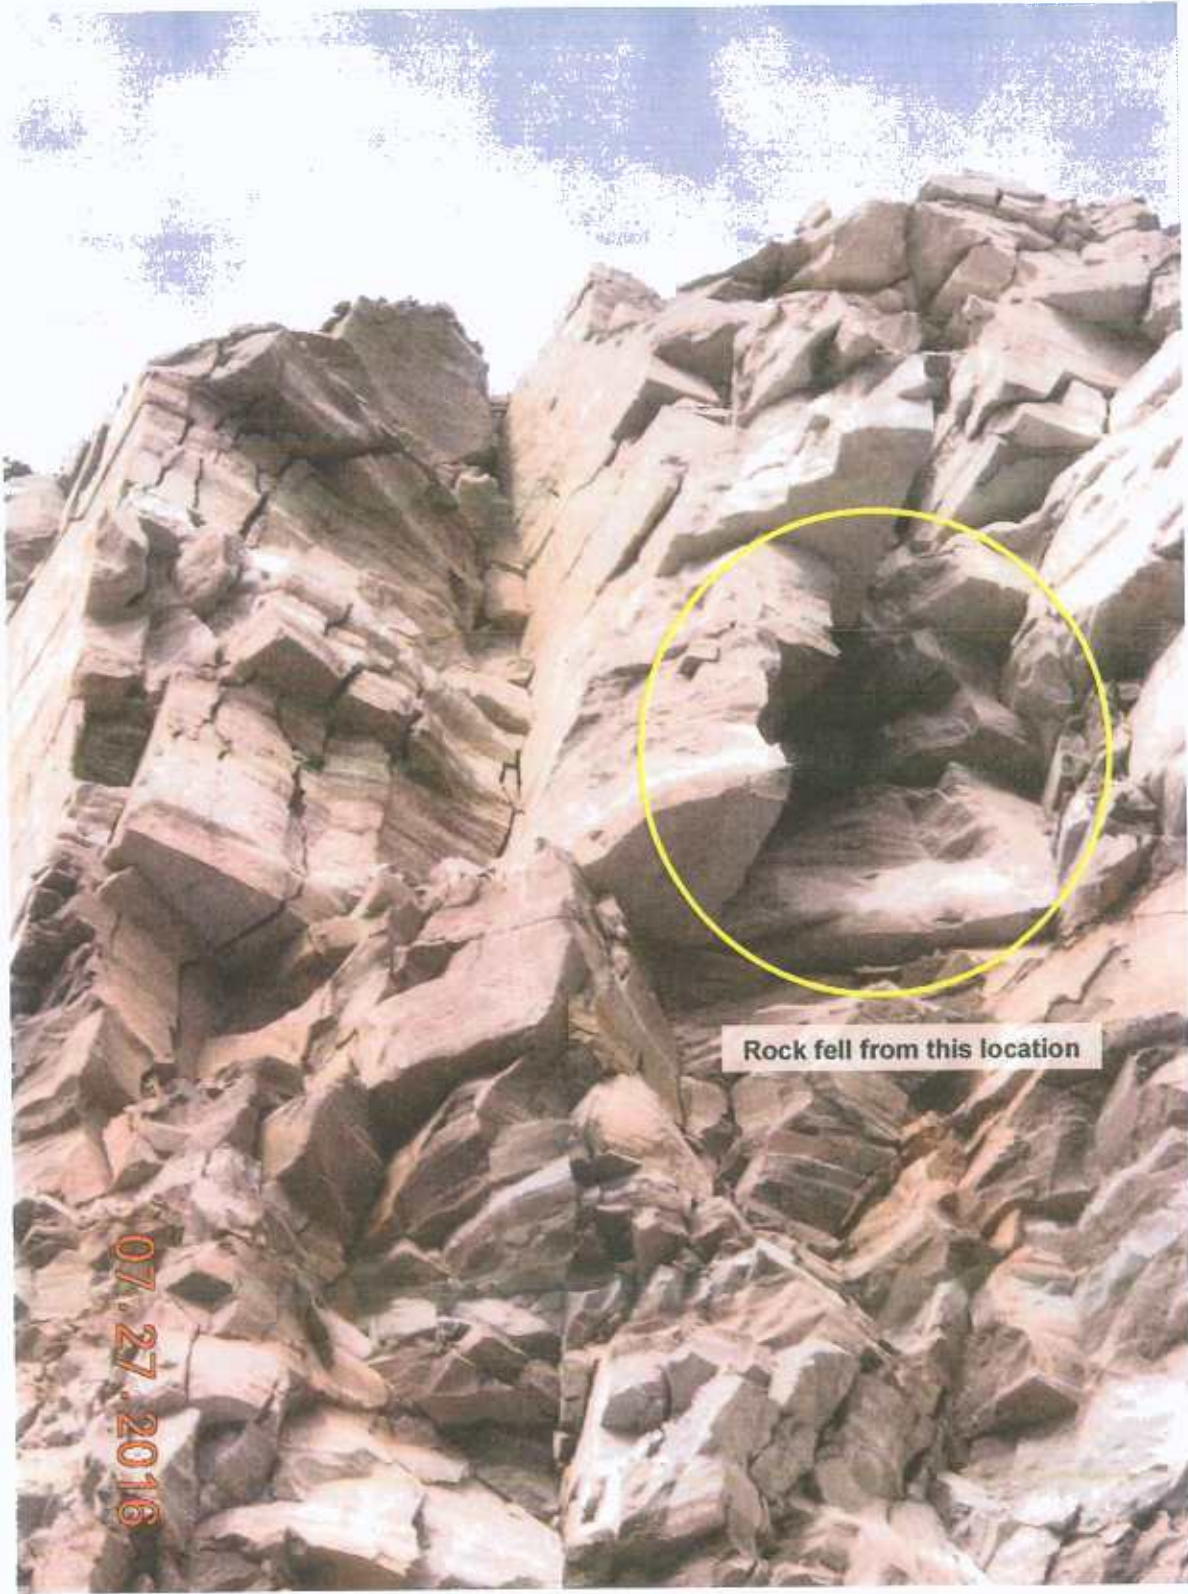
Photo 2
Close-up View of Rockfall Origination and Highwall Face

have initiated at a height between 96 and 102 feet above the pit floor, approximately 80 feet above the excavator cab, and left a V shape cavity in wall. The excavator was located near the highwall with the rear of the excavator facing away from the wall. This placed the operator's cab directly adjacent to the highwall.
