REPORT OF INVESTIGATION

**Surface Facility
Cement**

**Fatal Machinery Accident
August 9, 2016**

**Kosmos Cement Co.
Louisville, Jefferson County, Kentucky
Mine I.D. No. 15-04469**

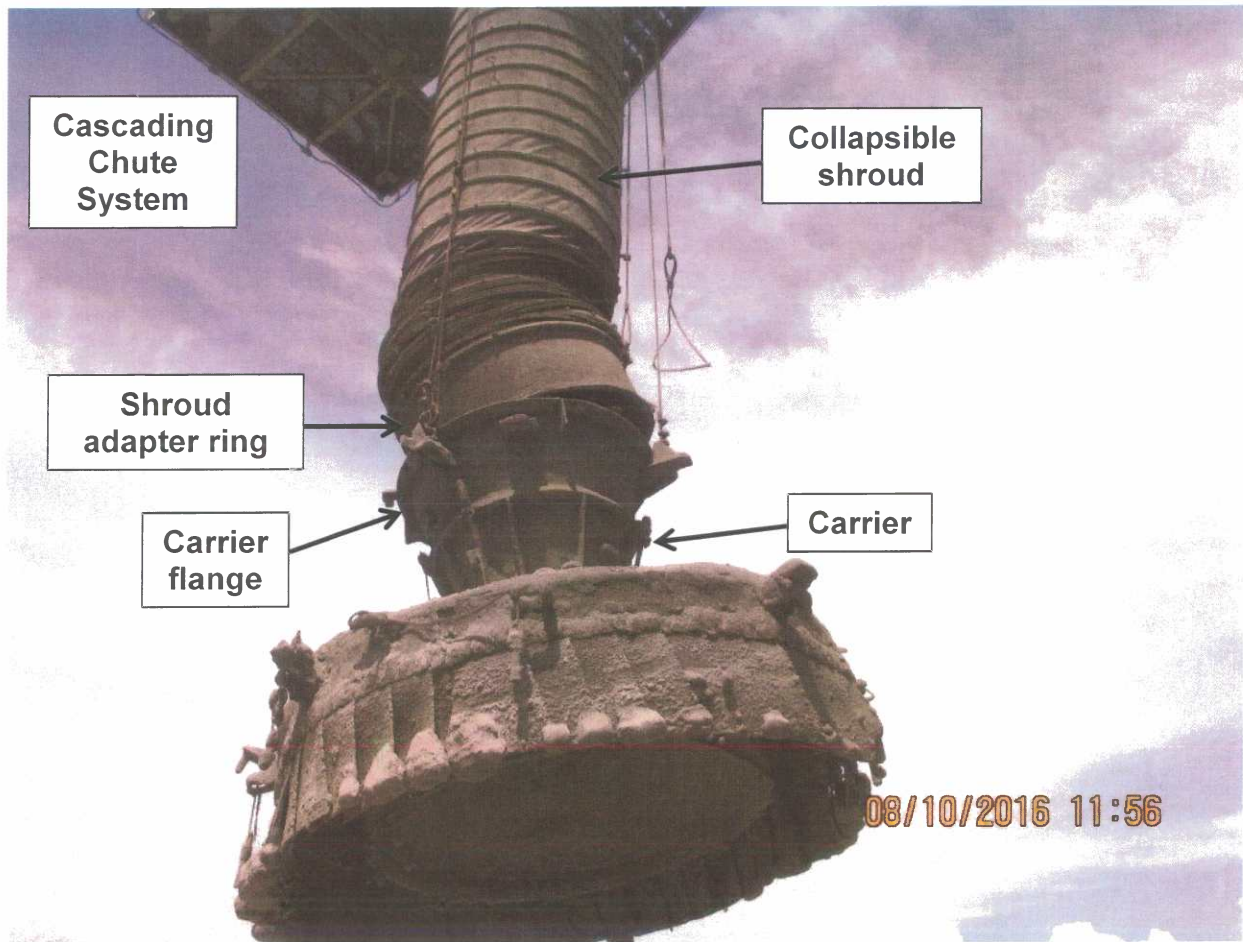
On August 9, 2016, Richard J. Snyder (age 33), was fatally injured while changing sheave wheels at a cascading barge loadout chute. The victim was positioned between slackened wire ropes and the chute when the chute dropped. This caused a loss of slack in the wire ropes, which pinned the victim against the chute.

The connection between the adapter ring and the carrier flange was examined during the investigation. Three 1/2-inch grade 8 bolts and nuts spaced approximately 120 degrees apart were found on the carrier flange. Three matching holes were identified in the adapter ring. The 1/2-inch bolted connections joining the adapter ring to the carrier flange were insufficient to support the loads imposed on them while the sheaves were being changed. The adapter ring was not manufactured by PEBCO or originally designed to provide a lifting point for the lower portion of the chute indicating that the machinery, equipment, and tools used to raise the chute were being used beyond the design capacity intended by the manufacturer. Additionally, the chute was not otherwise blocked against hazardous motion.
