**REPORT OF INVESTIGATION**

**Surface Nonmetal Mine  
Crushed, Broken Granite**

**Fatal Powered Haulage Accident  
September 8, 2016**

**Neverson Quarry  
Hanson Aggregates Southeast, LLC  
Sims, Wilson County, North Carolina  
Mine I.D. No. 31-00074**

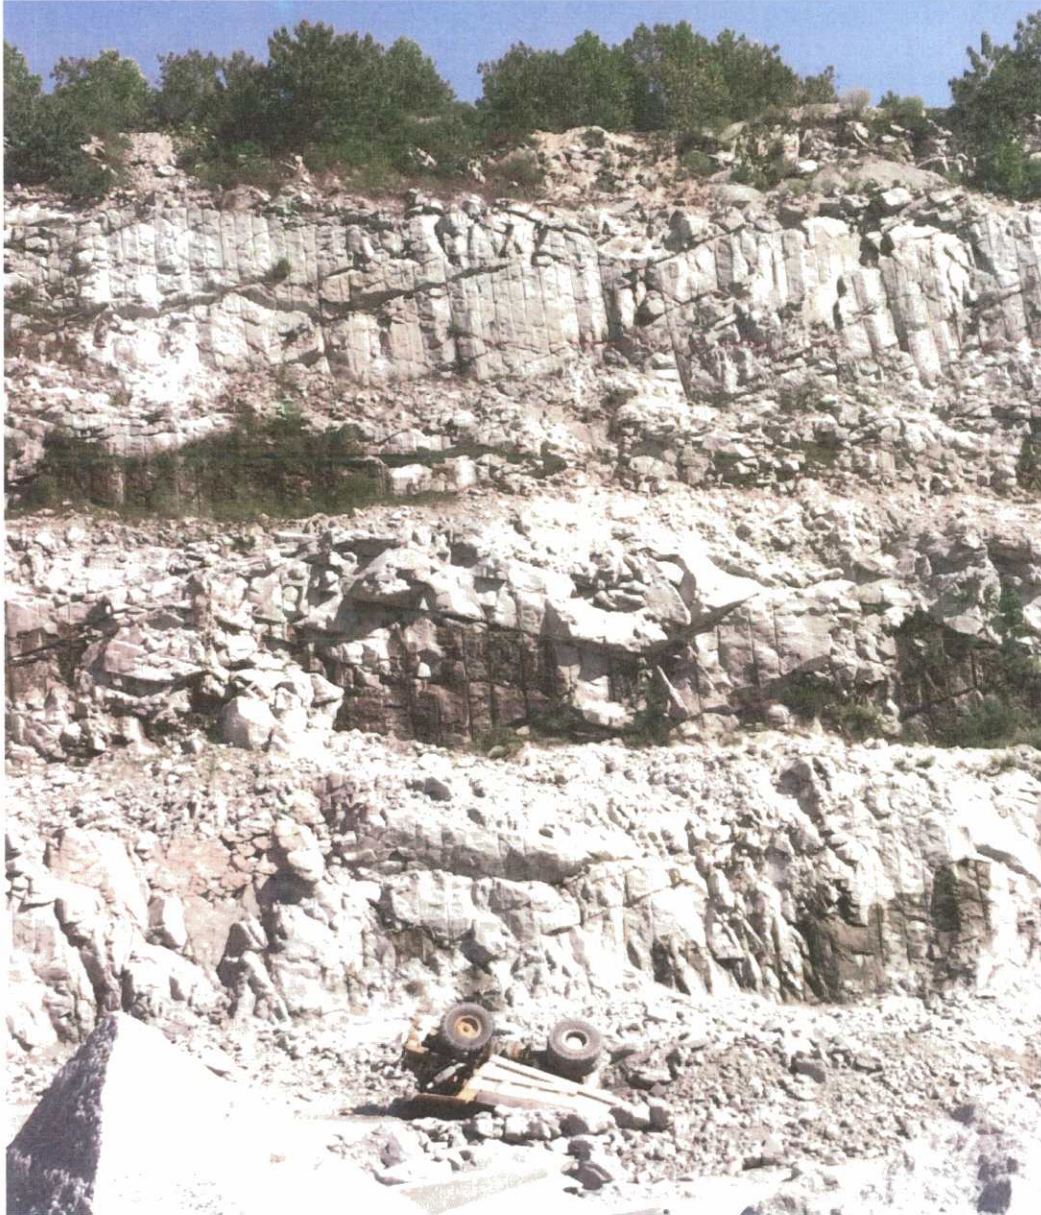
Richard Smith, a 58-year old Haul Truck Operator, was fatally injured on September 8, 2016. The victim was operating a Caterpillar 773E haul truck and was returning to the pit for loading when the truck, traveling down a 9% grade, veered from the right to the left side of the haul road and traveled over the berm at the top of the highwall. The truck landed upside down approximately 201 feet below.

Measurements made during the investigation showed that Smith's haul truck traveled 655 feet down the pit ramp on a 9% grade, veered to the left and struck the approximately 5-foot high berm. The truck traveled approximately 64 feet along the top of the berm before rolling over the highwall.
