REPORT OF INVESTIGATION

Surface Nonmetal Mine
(Crushed and Broken Limestone)

Fatal Machinery Accident
September 21, 2016

Gilliam & Mundy Drilling Co.
Buchanan, Botetourt County, Virginia
Contractor ID No. X7B
at
Holston River Quarry Inc.
Dublin, Pulaski County, Virginia
Mine ID No. 44-06134

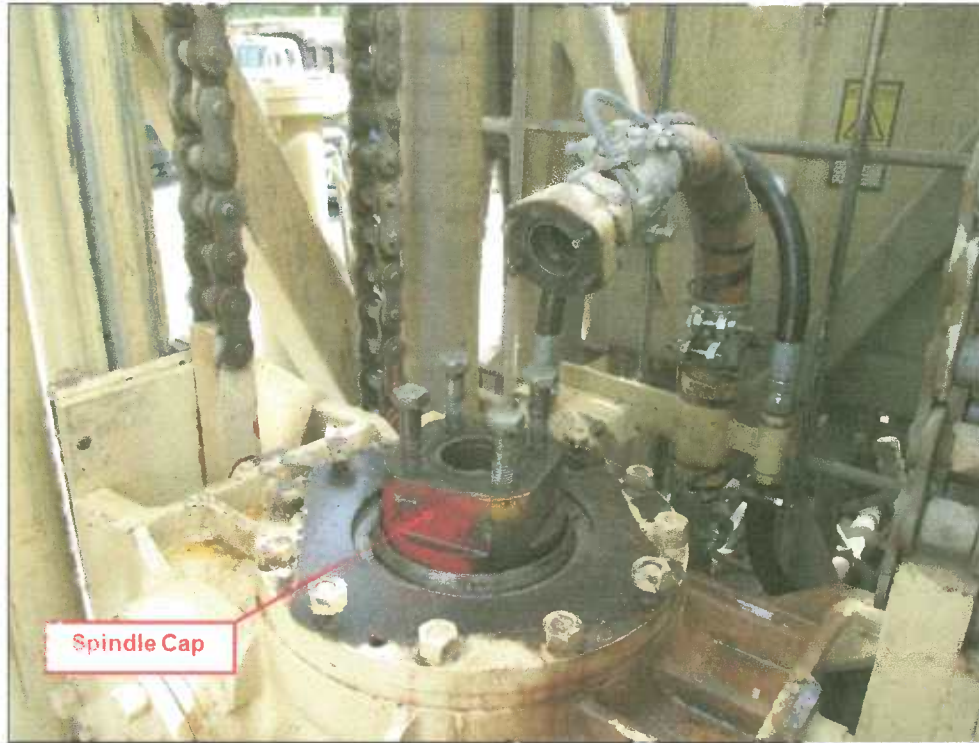
For several days prior to the accident, Layton documented in his contractor's drill log that the machine he was operating had a leaking water seal on the top drive power head spindle cap (see Figure 1). Two days before the accident, Layton drilled blast holes in the quarry and moved the drill to the equipment staging area.

Figure 1 - Top of Power Head showing Spindle Cap (close-up)

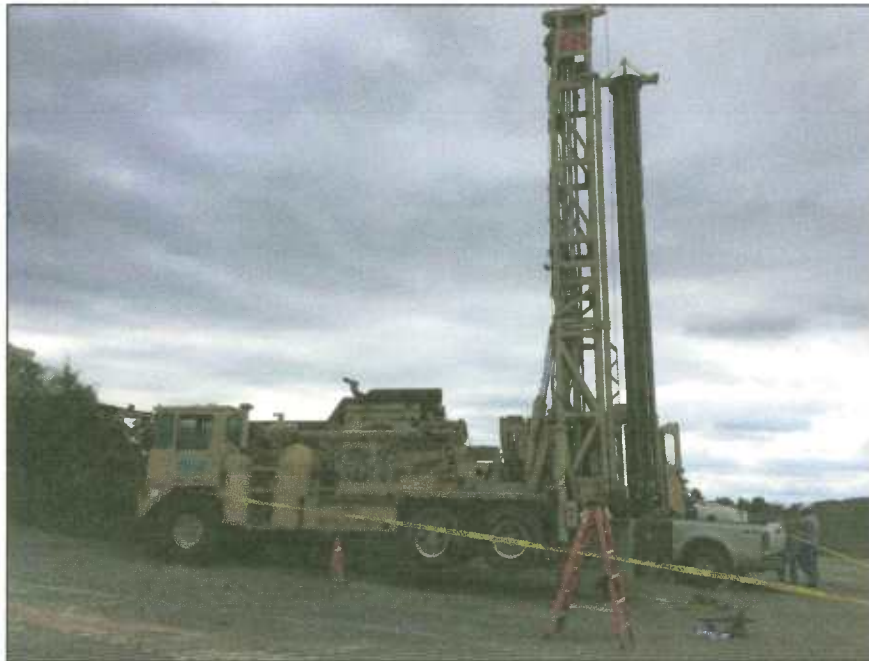
The accident occurred at an equipment staging area located near the main shop on mine property (see Figure 2). The truck-mounted rotary drill was parked approximately 120 feet from the southwest corner of the shop. The drill truck frame was raised approximately one-foot off the ground and the machine's three outriggers were deployed. Layton was working on the raised drill platform, 54 inches above ground level (See Figure 3).

Figure 2 - The Ingersoll-Rand/Atlas Copco Model T4BH Drill Rig (overview)

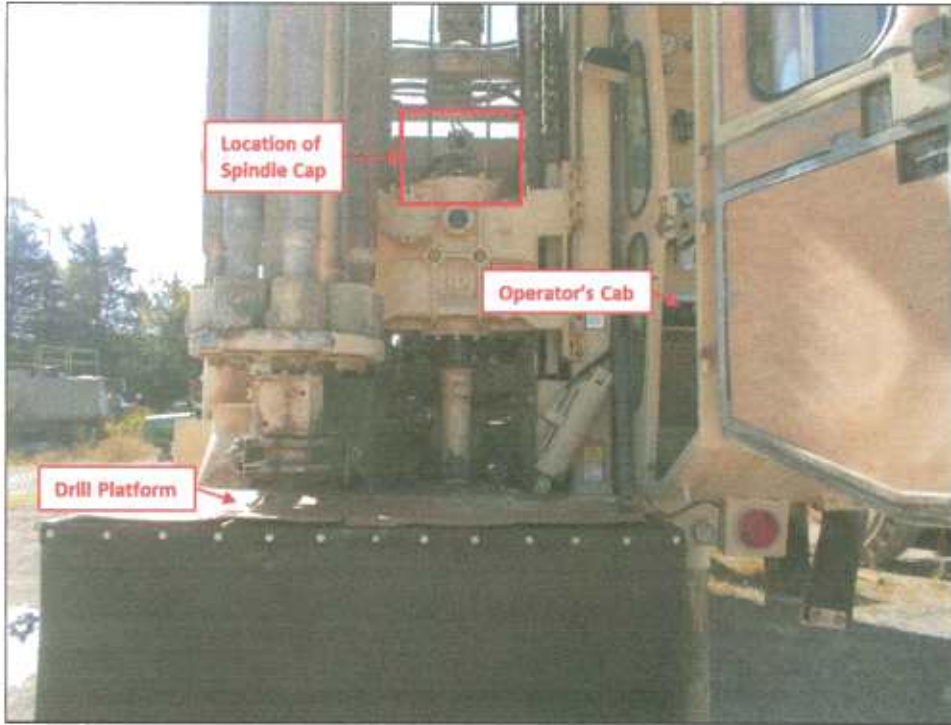
Figure 3 – Accident Site, showing Location of Spindle Cap.

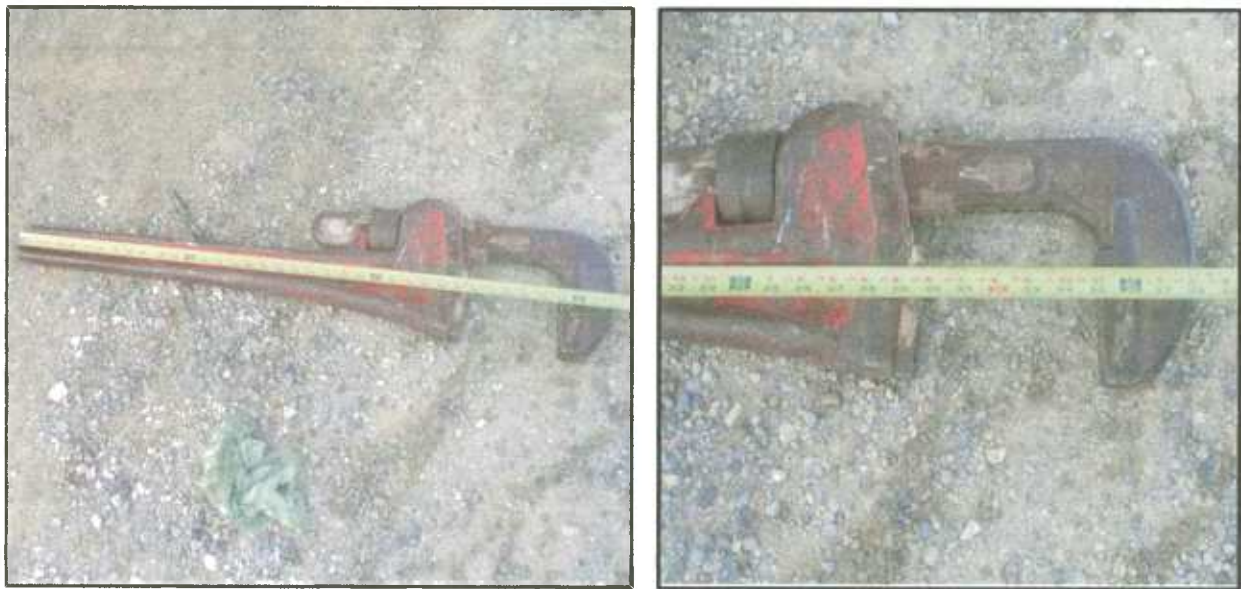
Wrench: Layton was using a Ridgid steel, heavy duty straight pipe wrench, which had been modified prior to the accident. The handle of the 60-inch wrench had been cut down to 29 ½ inches, leaving an overall length of 38 inches with an opened jaw (See Figure 4). Some of the teeth in the fixed jaw and moveable jaw were worn and flattened. The weight of the modified pipe wrench was 46.5 pounds.

Ridgid, the pipe wrench manufacturer, warns users not to use pipe wrenches on hard, square, or hexagonal material; not to apply high impact loads to the wrench handle; not to use the wrench in conjunction with power drives or any mechanical/hydraulic device; not to modify a pipe wrench; and to replace the jaws of the wrench when the teeth are worn. Investigators concluded that Layton attached the modified pipe wrench to the spindle cap and was supporting it against the drill tower structure while reaching inside of the operator's cab to operate the drill rotation hydraulics.

Figure 4 - Modified Pipe Wrench

Corrective Action: The drill was taken off site to the Noland Drilling Equipment facility and repaired. Afterward, the contractor developed a safe procedure for removing the spindle cap and it is included as Appendix D. The procedure utilizes a portable hydraulic wrench, remotely applied while the drill engine is off and locked out. All drilling personnel were trained in the new procedure.
