REPORT OF INVESTIGATION

**Underground Metal Mine
(Gold Ore)**

**Fatal Powered Haulage Accident
December 21, 2016**

**Buckhorn Mine
Crown Resources- Kettle River Operations
Kinross Gold Corp
Mine ID No. 45-03615**

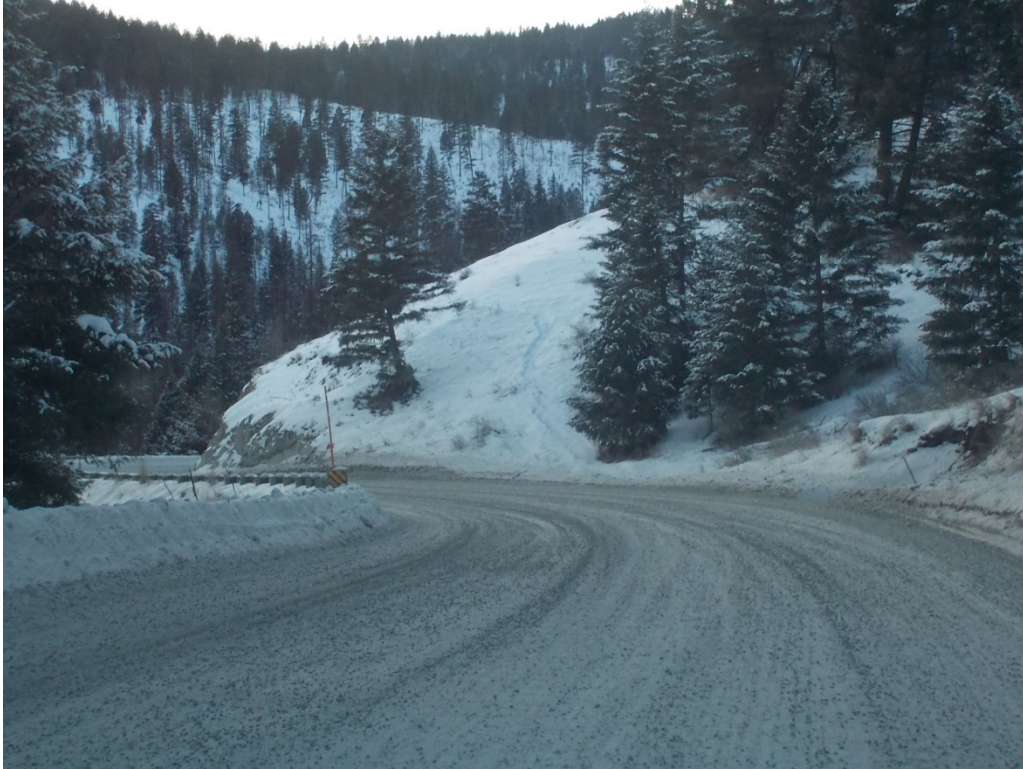
Attachment # 1 (Downhill view entering S-curve at top of 5.5 mile)

The accident occurred on the haul road near the 5.5 mile marker. On the downhill side between 6 mile marker and 5.25 mile marker, the haul road was posted as an 8% grade and consisted of several S-curves. The victim was traveling down the right side of the road (Attachment 1) when his truck struck and traveled over an embankment, and fell 20 feet to the roadway below. (Attachment 2) The graded roadway consisted of packed snow and ice with road rock and sand on the surface. There was snow accumulation on the adjacent bank.

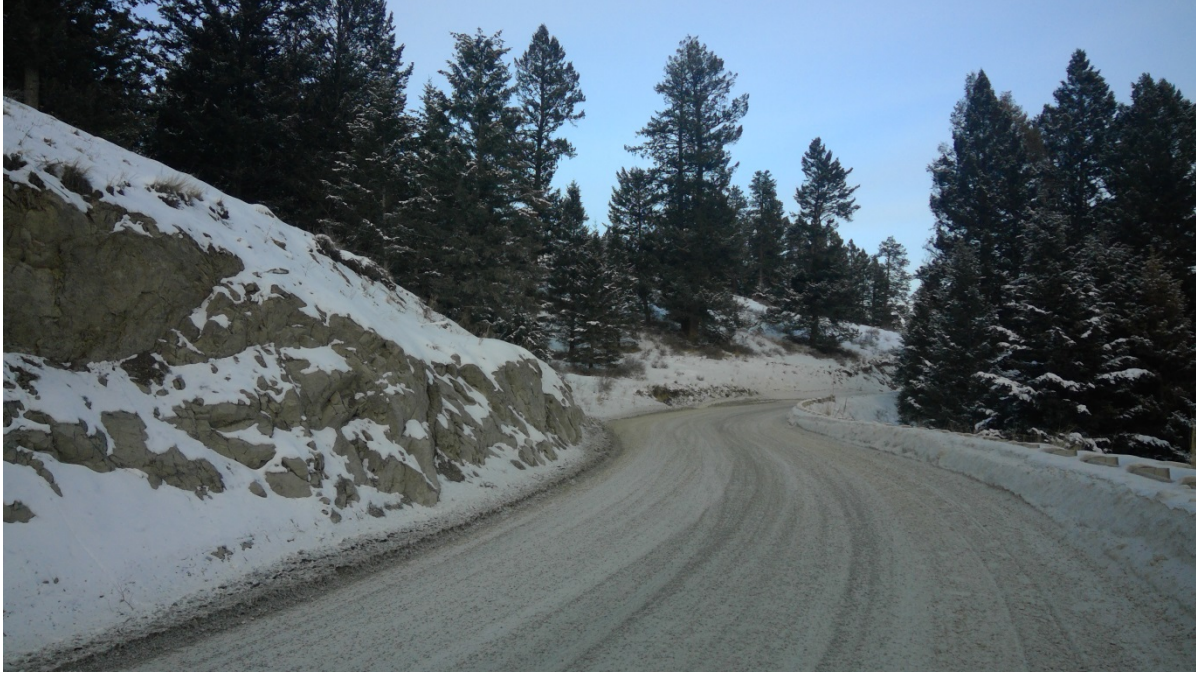
Attachment # 2 (Uphill view of cut-bank where truck traveled over)

A fatal accident occurred at this mine on 12/21/2016 when a haul truck operator lost control of the vehicle while descending a posted 8% grade on the mine haul road. The Peterbilt 378 dump truck left the right side of the road and went about 175 feet up the side of a hill where it then traveled over a drop off of about 20 feet and came to rest on the driver's side, back on the original roadway.
