MNM Fatal 2016-04

- Electrical
- April 4, 2016 (Arizona)
- Copper Ore Mine
- Hydromet EW Operator
- 25 years old
- 4 years of experience

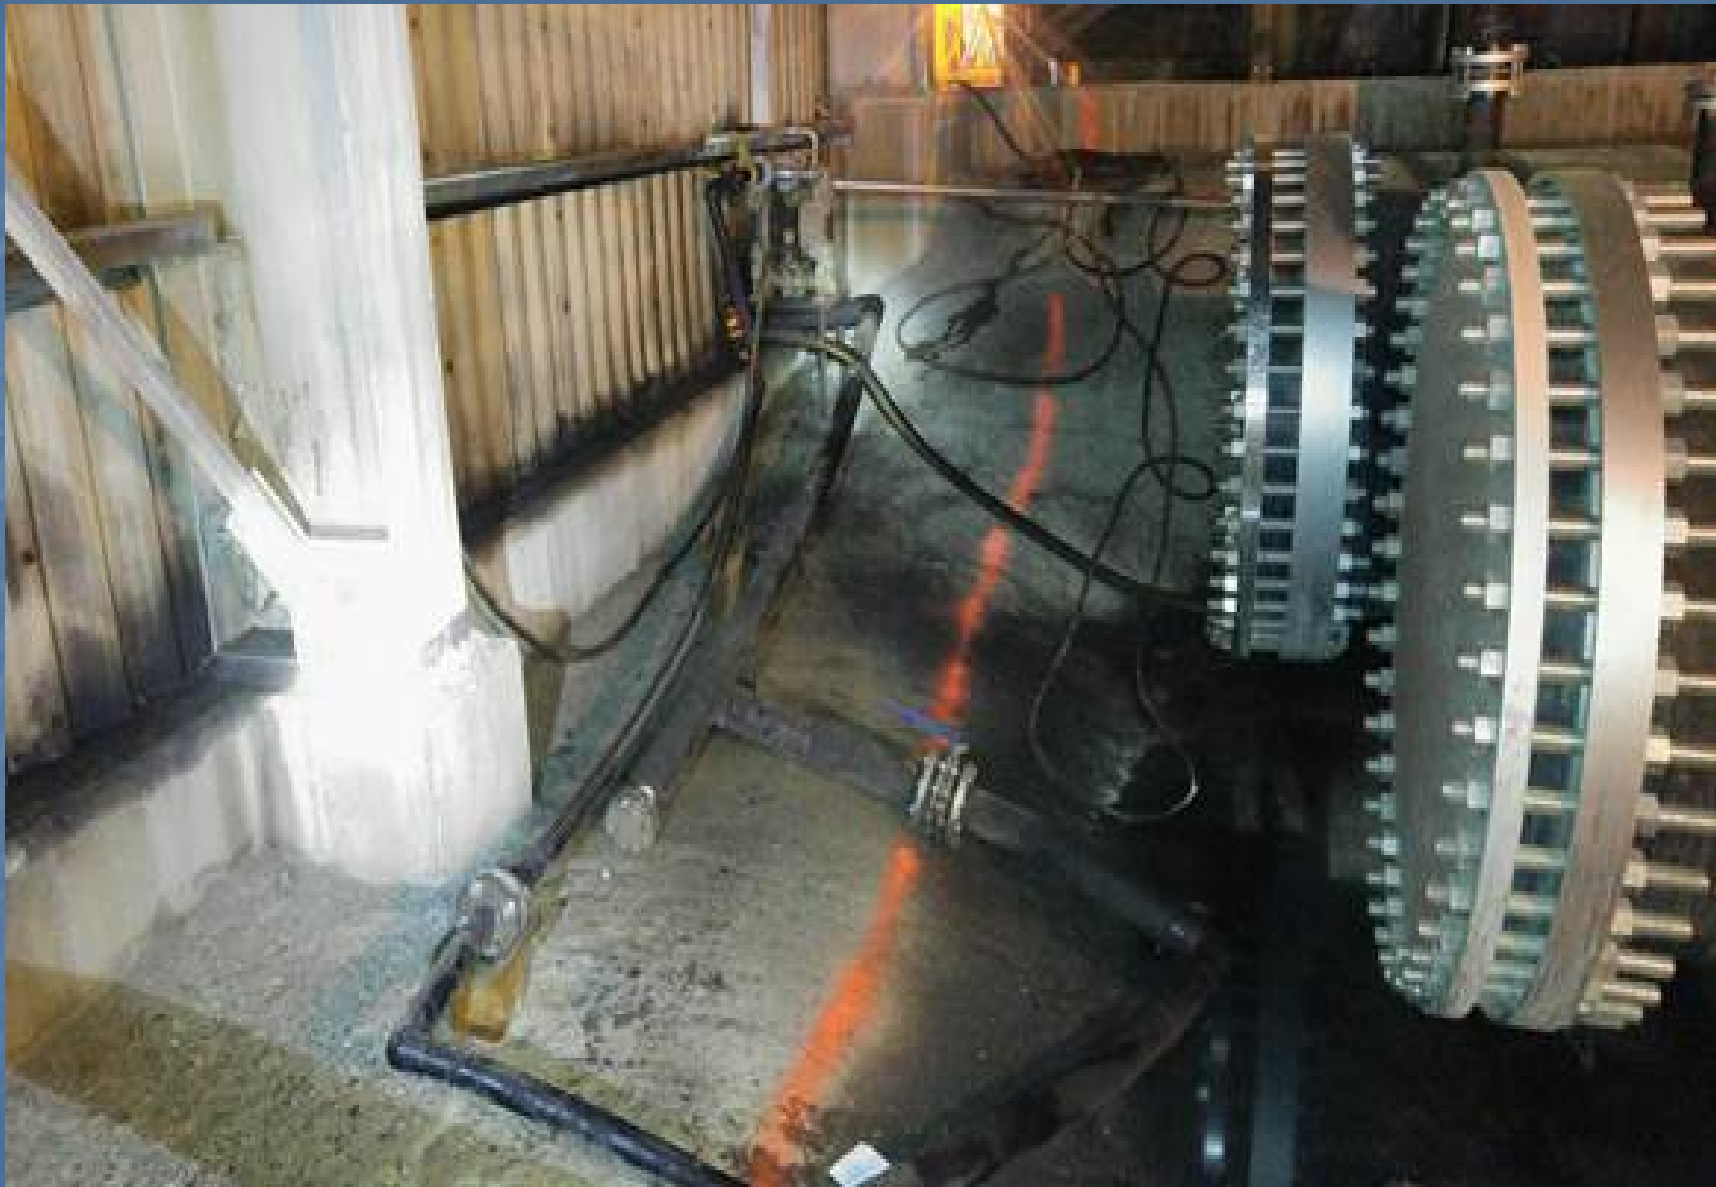
On April 9, 2016, Bryan Ortiz, Hydromet Electrowinning Operator I, age 25, was seriously injured when he was electrocuted by an energized flange on the electrolyte return line. Ortiz was instructed to prime a pump in the area and was found incapacitated kneeling in electrolyte solution with his head contacting an energized flange. Ortiz died of his injuries on April 10, 2016.

The accident occurred due to management's failure to insulate or guard energized flanges on the electrolyte return piping and failure to provide adequate personal protective equipment (PPE) for the electrical hazards that existed.

- Establish and discuss safe work procedures that include hazard analysis before beginning work. Identify and control all hazards associated with the work to be performed and use methods to properly protect persons.

- Train all persons to understand the hazards associated with working near energized electrical conductors.
- Use properly rated Personal Protective Equipment (PPE) including Arc Flash Protection such as a hood, gloves, shirt, and pants.

- Ensure that all electrical systems are safely designed and properly installed and that all metal enclosing or encasing electrical circuits are grounded or provided with equivalent protection.

- Provide equipment grounding conductors, with a sufficiently low impedance to limit the voltage to ground, for metal enclosures. Use a properly rated meter to identify any stray electrical currents which may be present.

- Lock Out, Tag Out, and Try: Place your lock and tag on the disconnecting device and test for power.
