MNM Fatal 2016-13

- Machinery
- September 21, 2016 (Virginia)
- Crushed & Broken Limestone Mine
- Drill Operator
- 52 years old
- 30 years of experience

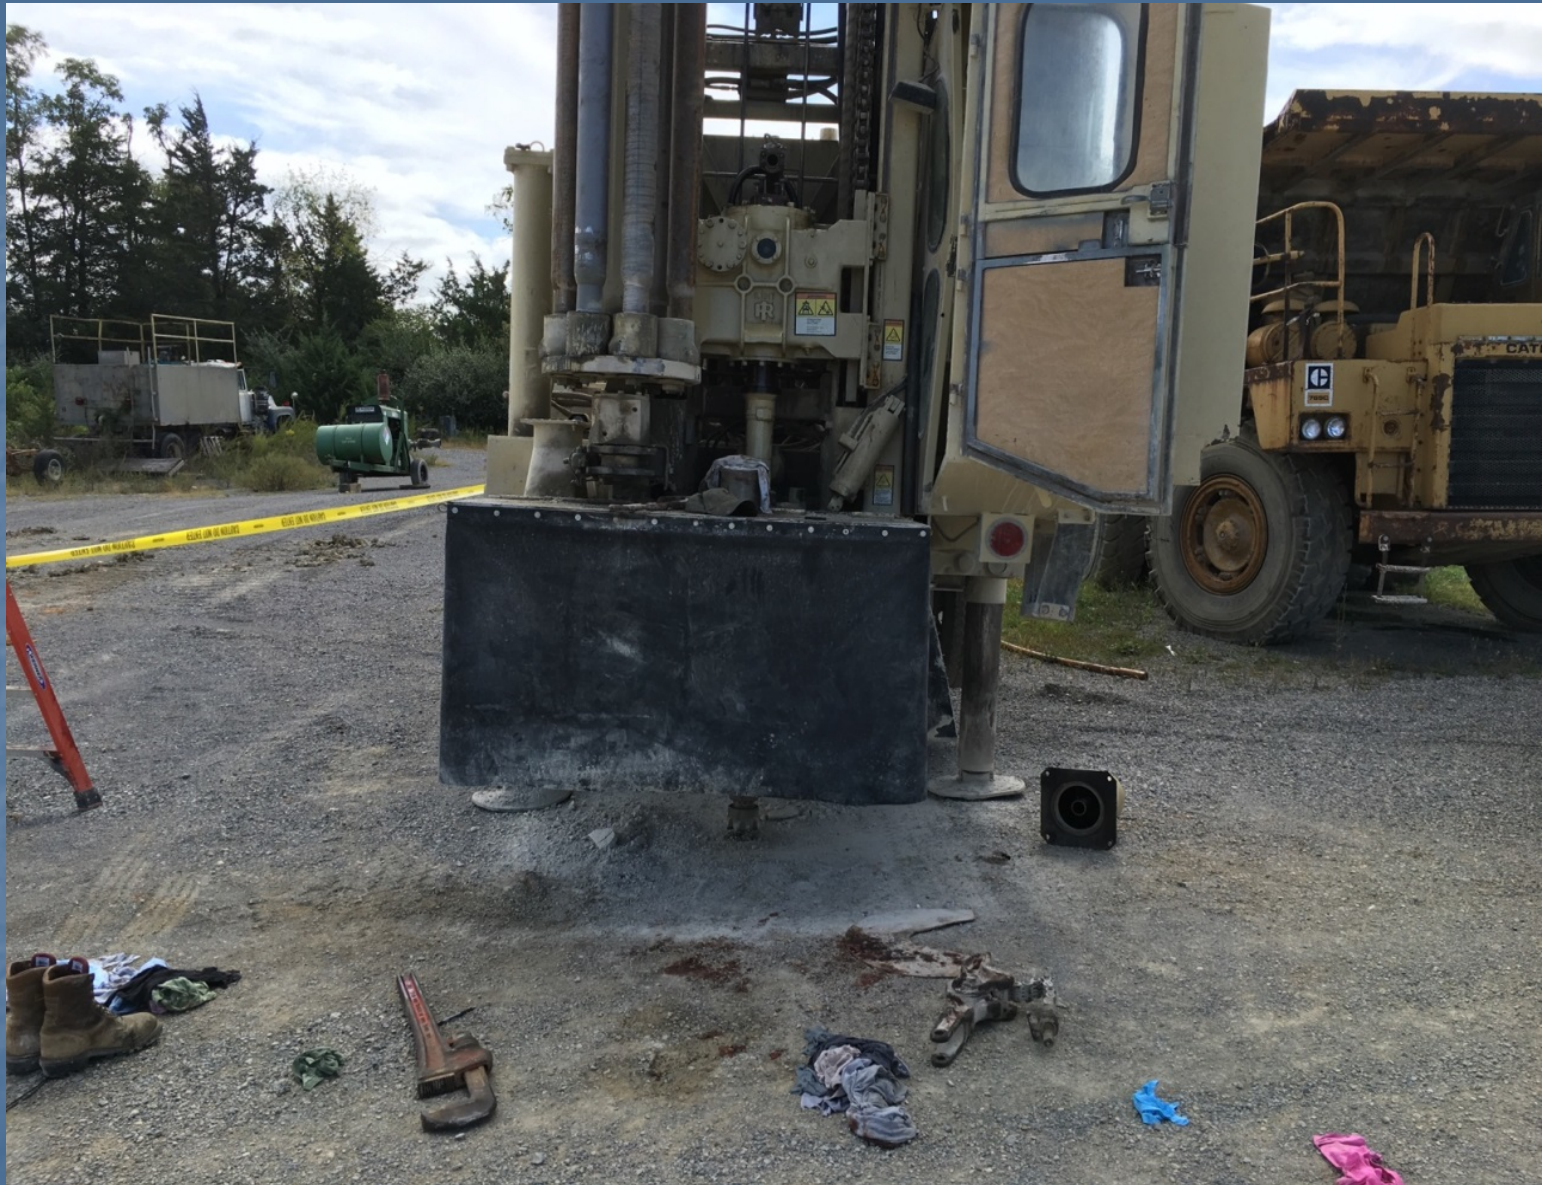
On September 21, 2016, Donald L. Layton (victim), a 52 year old Contract Drill Operator/Mechanic, was fatally injured at a limestone mine while performing maintenance on a truck-mounted rotary drill. Layton was attempting to remove the spindle cap from the rotary drill using a modified pipe wrench and the machine's drill hydraulics. When he activated the drill lever, the wrench swung in a counterclockwise direction and struck him, piercing his abdomen.

The accident occurred due to the contractor's failure to develop and implement safe procedures for maintenance on the rotary drill.

- Establish and discuss safe work procedures to be used while performing maintenance on machinery. Incorporate the manufacturer's recommended operating procedures into related safety and task training programs.
- Train all persons to recognize the potential hazards and understand safe work procedures to eliminate hazards before beginning work.
- Ensure that machinery components are blocked against hazardous motion prior to performing maintenance or repairs.
- Use appropriate equipment and hand tools for the job.
- Do not place yourself in a position that will expose you to hazards while performing a task.
- Stay inside of the drill cab when operating the drill.
- Monitor personnel routinely to determine that safe work procedures are followed.
