**REPORT OF INVESTIGATION**

**Fatal Powered Haulage Accident  
October 31, 2017**

**Marigold Mining Co.  
Marigold Mine  
Valmy, Humboldt County, Nevada  
Mine ID No. 26-02081**

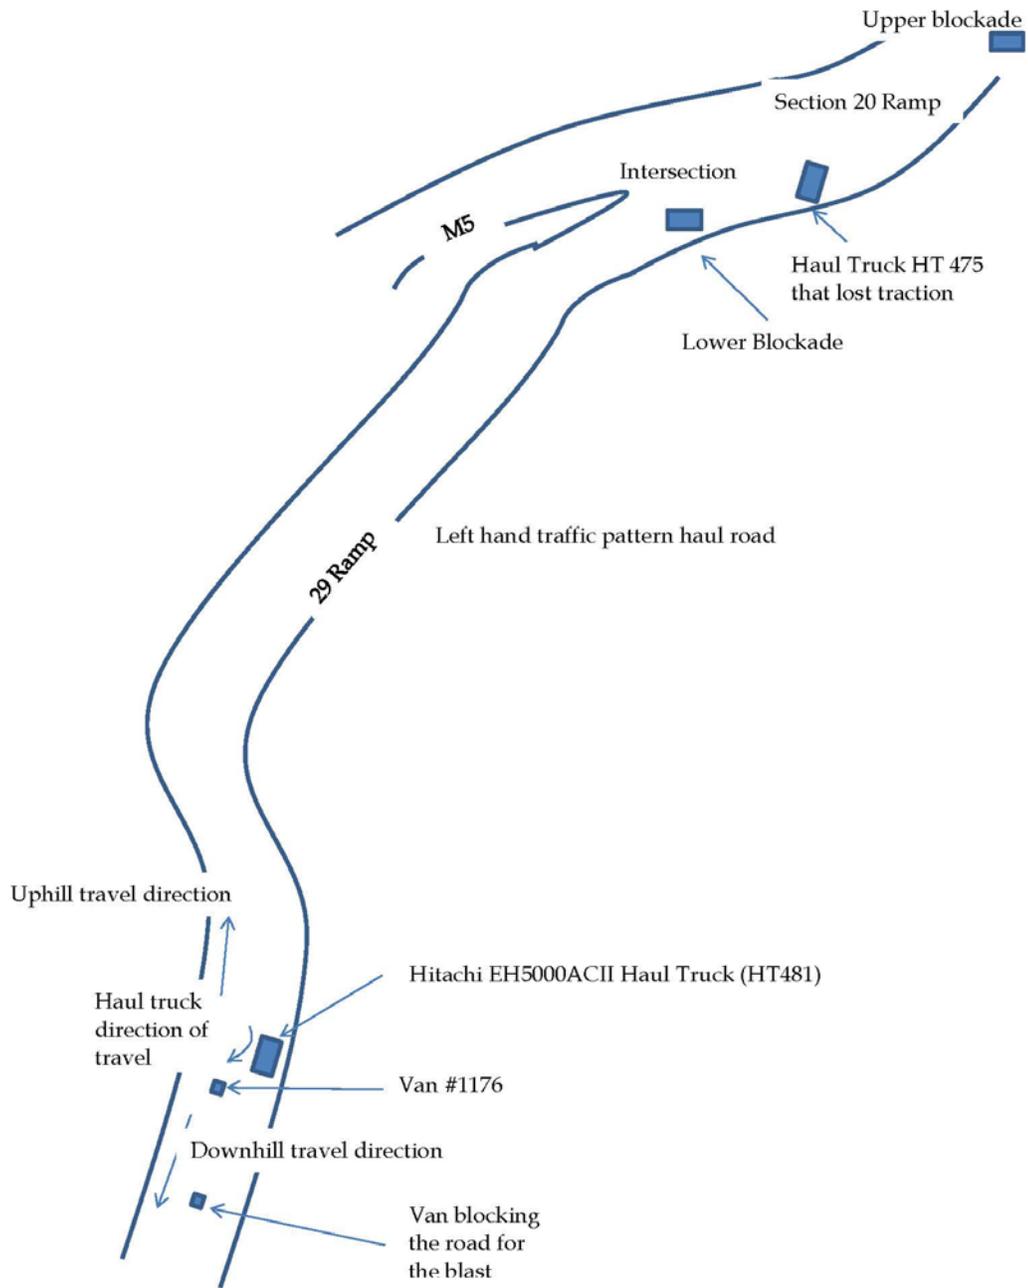
Figure 1: Overview of accident area (not to scale)

The accident occurred on the 29-ramp, which is a section of the road between the Mackay 2 pit and Section 20 facility. Both van #1176 and haul truck #481 were parked on a 6% downhill grade, facing southwest, toward the pit. The roadway was dry, hard packed earth and appeared well maintained.

According to witness accounts, the passenger van stopped along-side the Hitachi truck about 20 feet away. Investigators concluded the van was slightly farther down the haul road than the haul truck since the front of the van was in the turning radius path of the front right tire. Investigators were not able to determine the precise location where the van stopped relative to the truck.
