**REPORT OF INVESTIGATION**

**Surface Non-Metal Mine  
(Crushed, Broken Stone)**

**Fatal Machinery Accident  
October 17, 2017**

**Fighting Creek Materials Inc. Mine  
Fighting Creek Materials, Inc.  
Coeur d'Alene, Kootenai County  
Mine ID No. 10-01915**

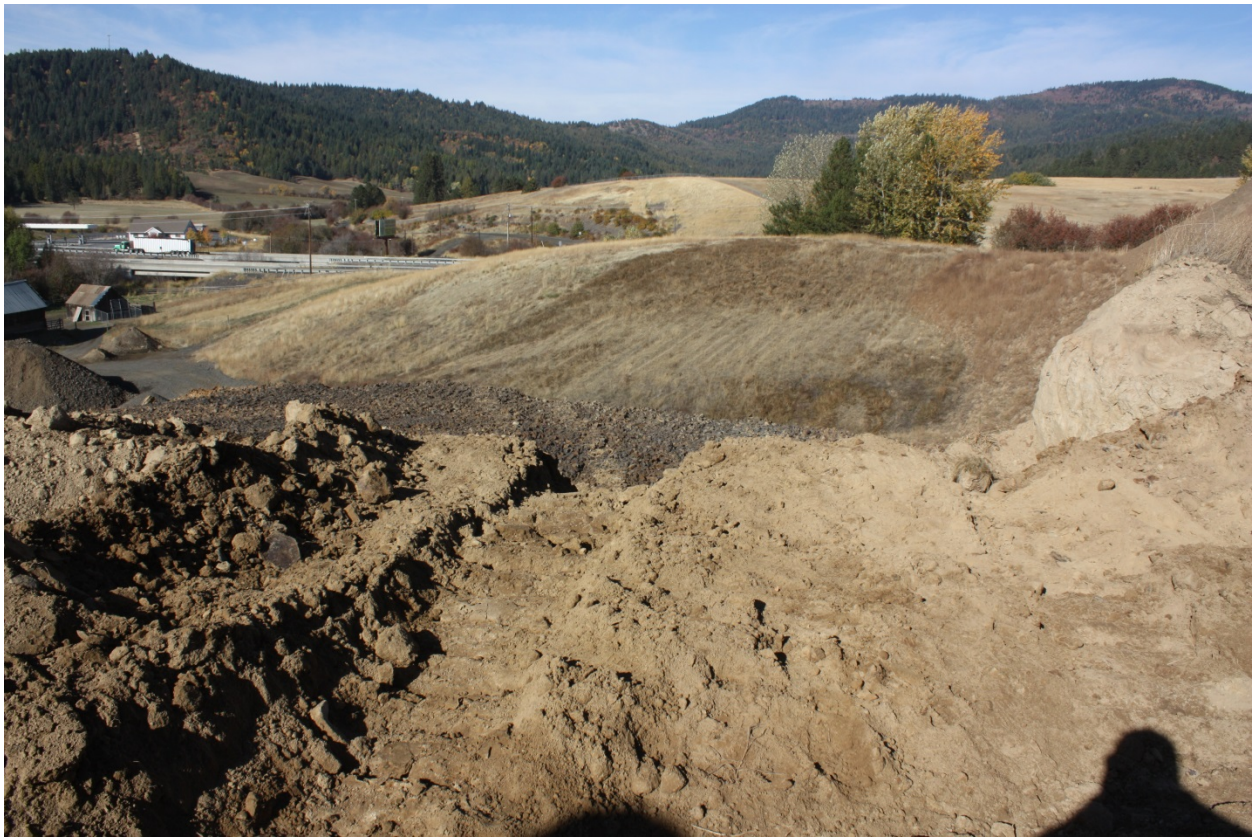
The accident occurred on the Brown Rock Bench in the North Pit. The North Pit consisted of a 58 feet high single bench, topped with a layer of clay-rich overburden varying in thickness up to 20 feet. Miners removed the overburden to expose the basalt rock for a distance of 60 feet from the west edge of the bench. A single trail provided dozer access from the top of the highwall to the cleared and stripped portion of the bench (Appendix C-1). A large pile of broken basalt had been collected from the area and placed on the south end of the bench to be pushed down from the highwall.

**Attachment # C-1 (Downhill view of dozer trail from top of overburden slope looking west onto brown rock bench.)**

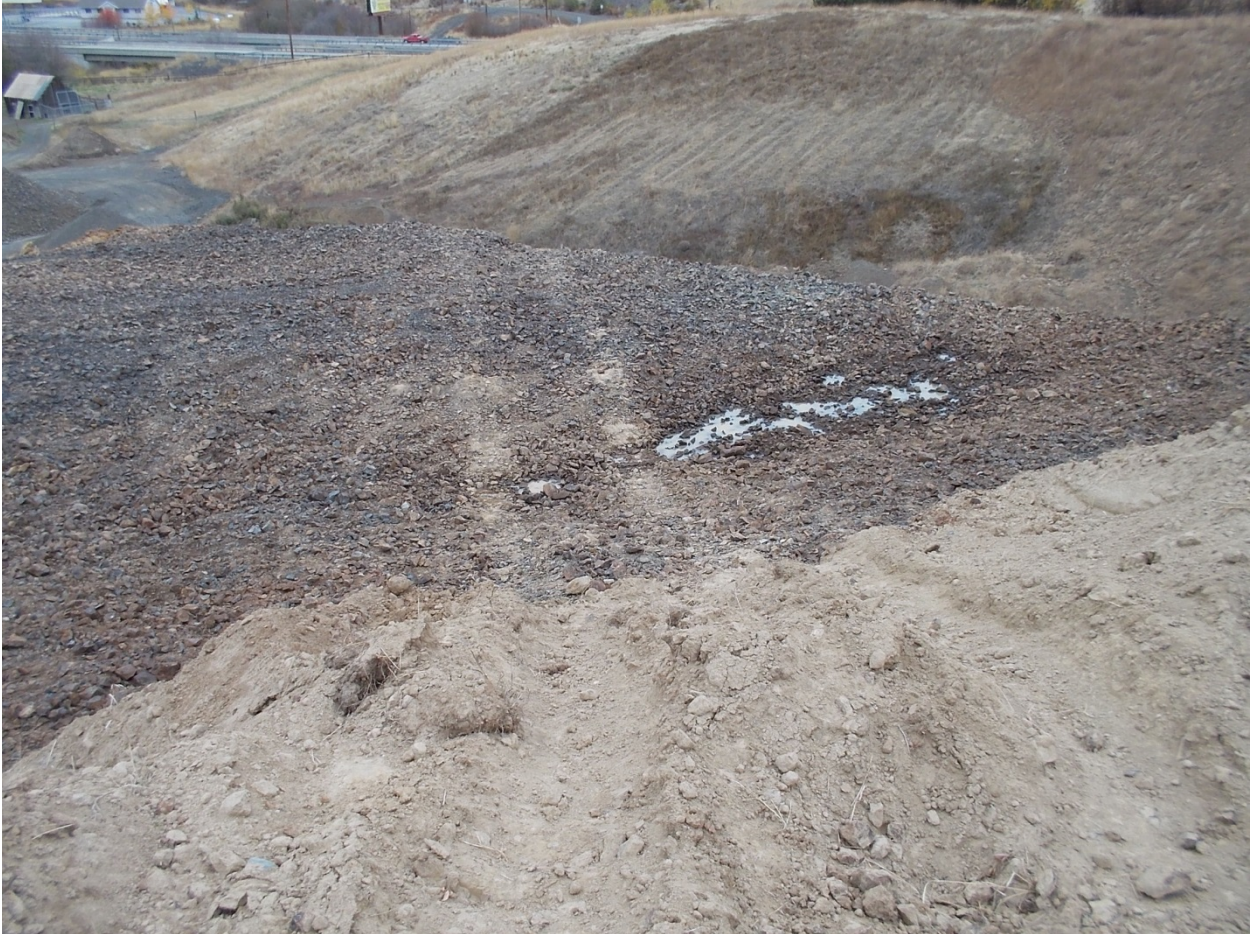
At the transition point between the remaining overburden slope and the bench, there was a near vertical drop that varied from 3 ½ to 5 ½ feet high (Appendix C-2). Investigators found no indication the dozer pushed material in front of the blade while descending the slope (Appendix C-3). Based on the findings, investigators concluded Brand had the blade up to prevent clay material from contaminating the basalt. The dozer pitched forward when the vertical drop was encountered and Brand was thrown in front of the dozer since he was not wearing his seat belt. Investigators believe if Brand had been wearing his seat belt, he could have remained in control of the dozer.

**Attachment # C-2 (Downhill view from dozer trail looking west across transition between overburden and cleared bench)**

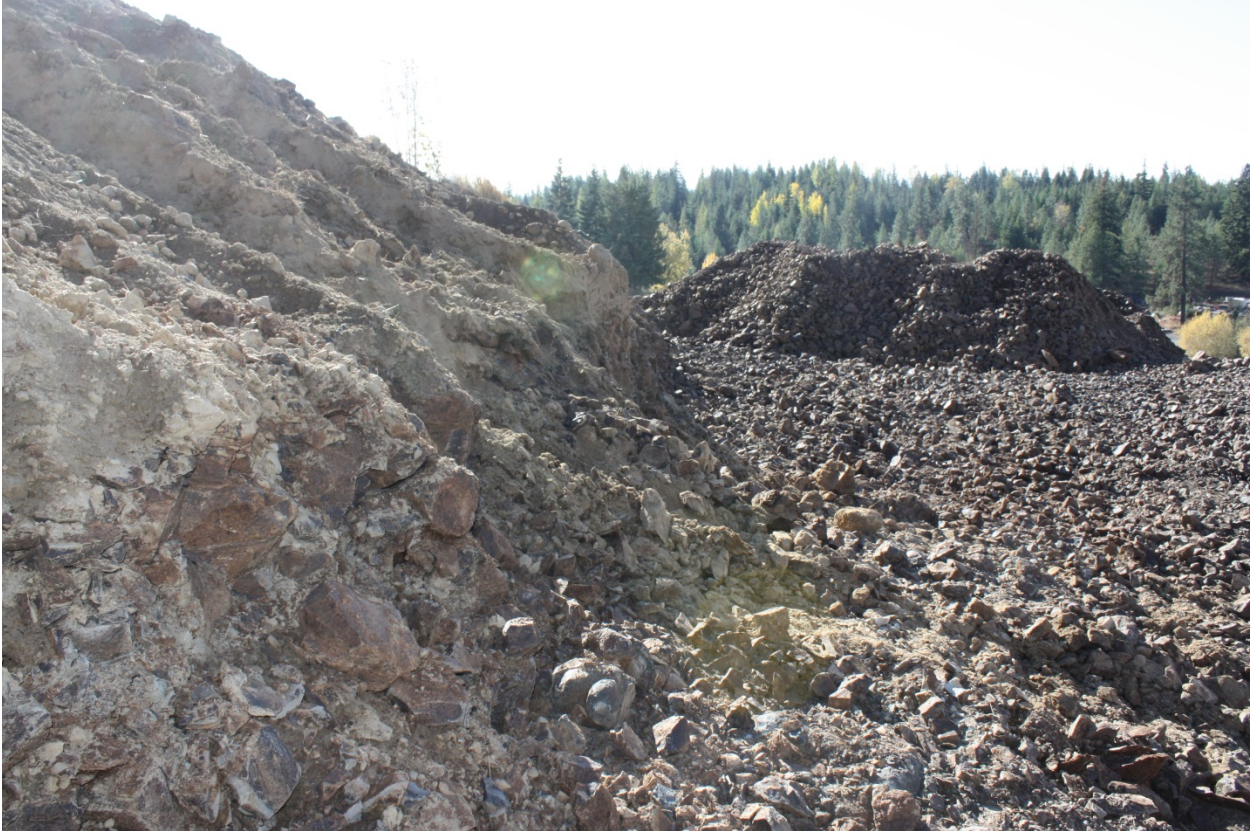
**Attachment # C-3 (Downhill view from bench looking south across transition between overburden and cleared bench where D8H traveled across)**
