REPORT OF INVESTIGATION

Fatal Electrical Accident July 14, 2017

EP Minerals, LLC Celatom Plant Vale, Malheur County, Oregon Mine ID No. 35-03236

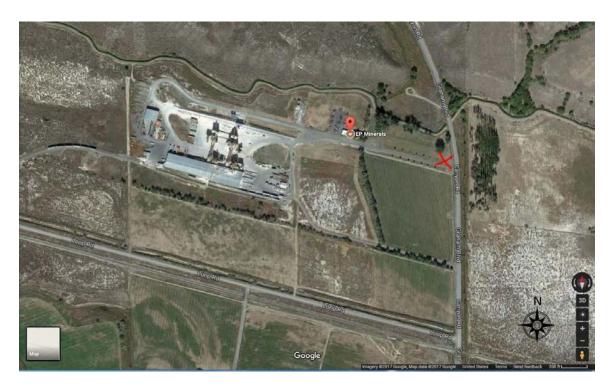
The accident occurred at the entrance road to the plant. Power lines were located directly overhead where Rodriguez was found. The distance from the mine entrance to the main office was approximately 0.2 miles. (See Appendix C, Figure 1 on Page 8).

Figure 1 – Overhead view of the EP Minerals, Celatom Plant. The red "X" was used to show the approximate location of the accident.
