REPORT OF INVESTIGATION

Surface Facility
Dimensional Granite Mine

Fatal Falling, Rolling or Sliding Rock Material Accident July 20, 2017

Blue Sky Quarry #2
Blue Sky Quarries
Carlton, Oglethorpe County, Georgia
Mine I.D. No. 09-01147

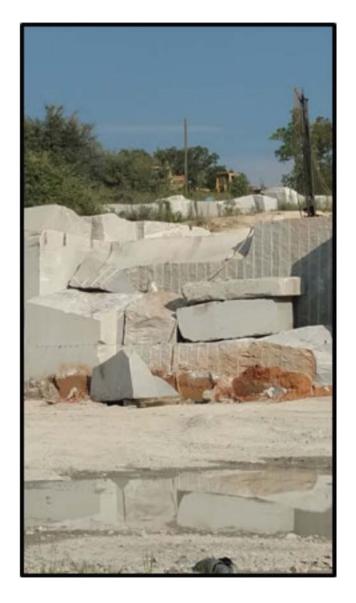
A prominent anomaly is present in the rock formation. This anomaly is an interface between two bands of granite that likely formed at different times and/or cooled at different rates, and creates a plane of weakness within the granite. The anomaly typically allows for breakage in the horizontal plane. Mine management was aware of this anomaly, but did not identify it during workplace examinations so that corrective actions could be taken.

A large section of granite sloughed off at the anomaly because it was not blocked to prevent movement which would endanger persons in the work area. This section of granite was approximately 18-20 feet long and 5 feet thick. While standing on some stacked rock that had been placed on the work bench, the victim was driving wedges into a block of granite in an attempt to break it loose. A piece of granite weighing six tons fell and pushed the victim from the work bench onto the mine floor, approximately 10 feet below. The victim was wearing a fall protection harness, but it was not secured to an anchor and therefore was not protective.

- <u>Root Cause</u>: The mine operator did not block material to prevent movement during secondary breakage operations.
 - <u>Corrective Action</u>: The mine operator purchased new equipment and trained miners in a newly developed plan with procedures for different methods of secondary breakage. This plan addresses and requires the prevention of movement of material.
- <u>Root Cause</u>: The mine operator did not assure that miners used fall protection where there was a danger of falling.
 - <u>Corrective Action</u>: The mine operator purchased new equipment and trained miners in a newly developed plan with procedures for different methods of secondary breakage. This plan addresses and requires the use of fall protection.
- <u>Root Cause</u>: The mine operator did not conduct adequate workplace examinations.

<u>Corrective Action</u>: The mine operator trained miners in a newly developed plan with procedures for different methods of secondary breakage. This plan addresses workplace examinations and actions to be taken to address any hazardous conditions found.
