REPORT OF INVESTIGATION

**Surface Nonmetal Mine
(Construction Sand & Gravel)**

**Fatal Powered Haulage Accident
January 25, 2018**

**Hallett Materials
Stripping #1
Woodbine, Harrison County, Iowa
Mine I.D. No. 13-01825**

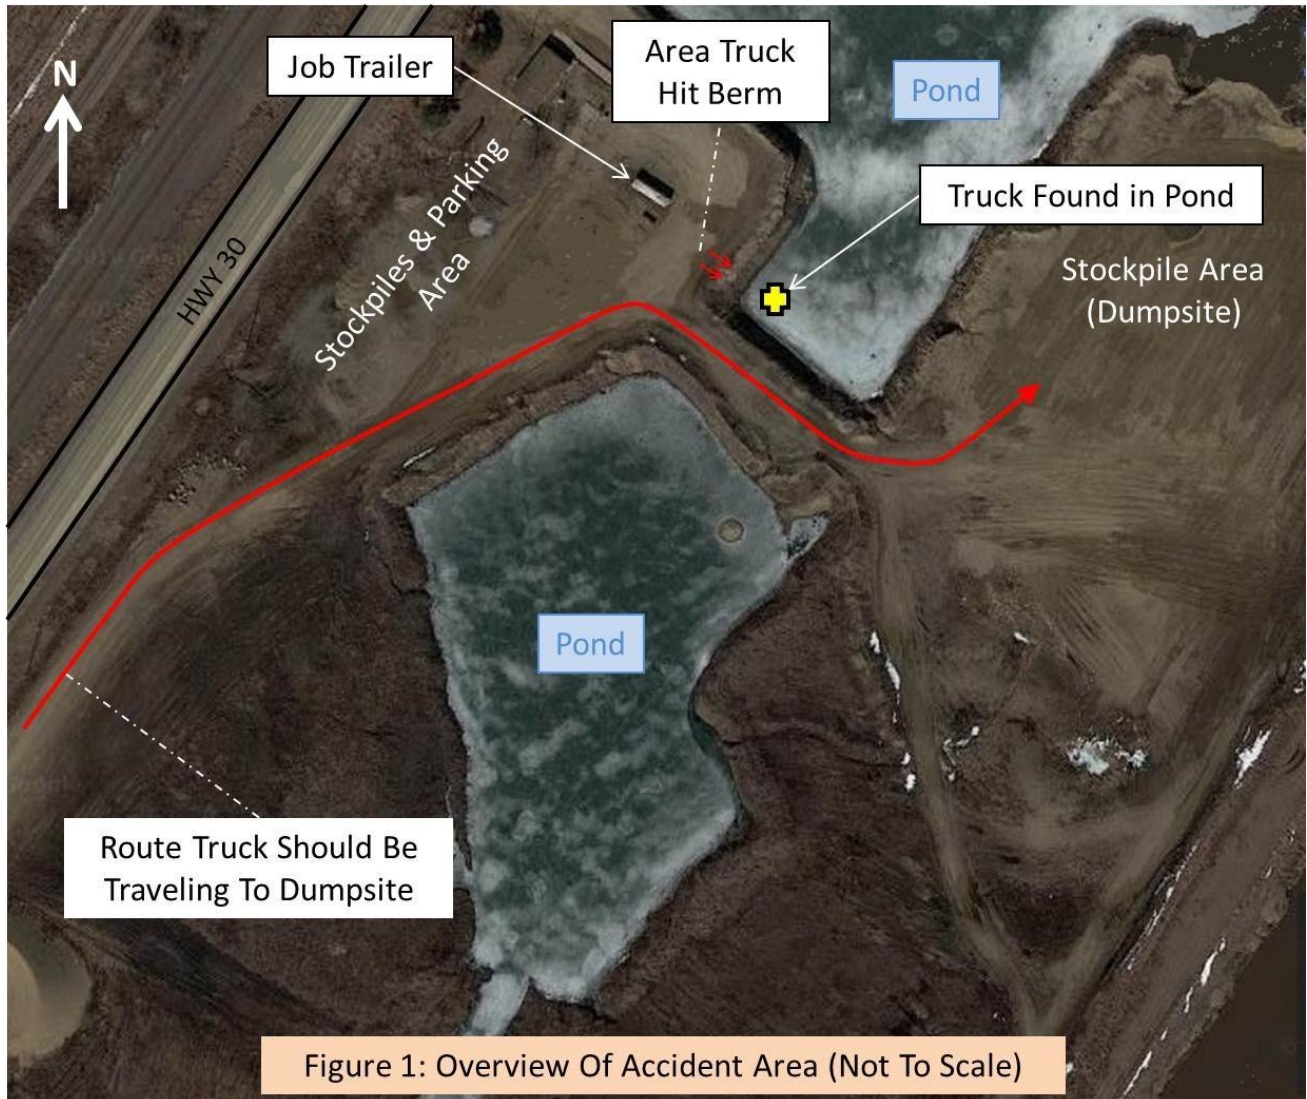
APPENDIX C

At approximately 5:11 a.m., Ritter saw what appeared to be McMullen's truck submerged in a pond that is adjacent to the operator's job trailer (Attachment C) and immediately called 911. Employees searched along the pond's banks and other locations in an effort to locate McMullen but did not find him.

The accident occurred in the mine's northern pond, located near the job trailer. The depth of the pond varied from twenty to thirty feet. Winter weather conditions caused the pond to freeze, and ice thickness varied between eight to ten inches. The pond had a surrounding four foot high earthen berm located along the elevated roadway. The berm met requirements of 30 CFR 56.9300.
