REPORT OF INVESTIGATION

**Underground Metal Mine
(Lead-Zinc Ore)**

**Fatal Exploding Vessels under Pressure Accident
October 2, 2018**

**Empire State Mines
Empire State Mines LLC
Gouverneur, St. Lawrence County, New York
Mine ID No. 30-01185**

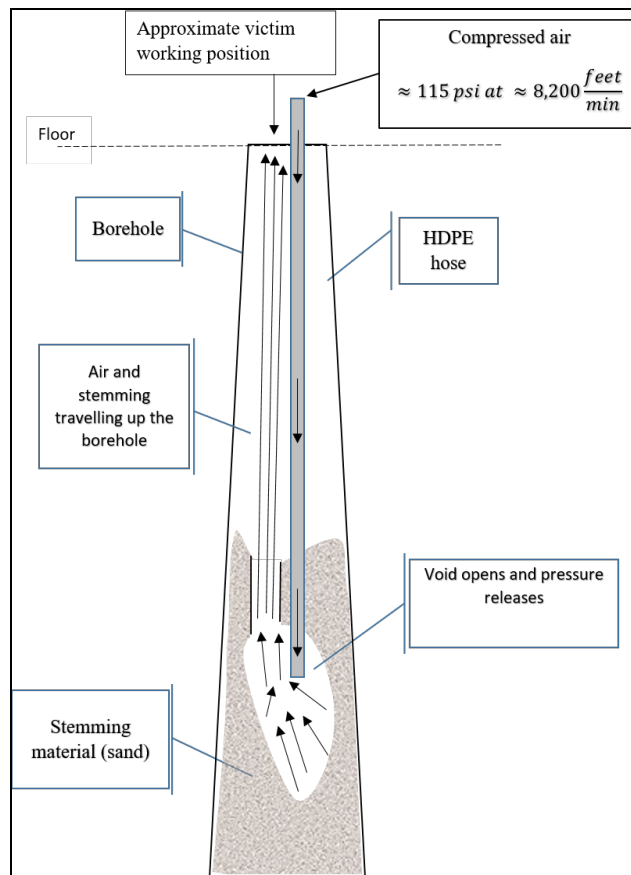
Interviews indicated one 50-pound bag of sand was used as stemming in each borehole, which Major Drilling Underground claimed would fill about 10 feet of a drilled hole. The No. 11 drill hole was a wet borehole and would have caused the sand to bond together, making it harder to clean out the hole. After reportedly blowing out approximately 3 feet of material, the contractor encountered a blockage. As the grout hose was pushed through the blockage, a pressure void was filled with the compressed air until it could no longer be contained (see Figure 6). When the air released, a column of stemming was thrust to the surface of the borehole. This evacuation of air and stemming material struck the contractor foreman, who was in close proximity to the borehole opening, causing fatal injuries. No evidence of residual explosive material was found in the hole.

Figure 6 – Schematic Showing Pressure Release Propelling Stemming from No. 11 Hole.

Corrective Action: The contractor developed a plan and procedures and then trained employees on the new plan with procedures for cleaning previously blasted vertical drill holes when an obstruction has been encountered. This plan addresses safe work procedures and where personnel are to be positioned during the various phases of drill hole cleaning process.
